CORPORATION OF THE TOWNSHIP OF MCKELLAR

OSIM Inspection Report 2025

October 2025

TULLOCH Engineering Inc. (TULLOCH) has been retained by the Township of McKellar to undertake detailed visual inspections of the Township owned bridges and structural culverts within their jurisdiction. According to Ontario Regulation 104/97 – Standards for Bridges, the structural integrity, safety, and condition of every bridge shall be determined through the performance of at least one inspection in every second calendar year under the direction of a Professional Engineer and in accordance with the Ontario Structure Inspection Manual (OSIM). O. Reg. 472/10, s. 2.

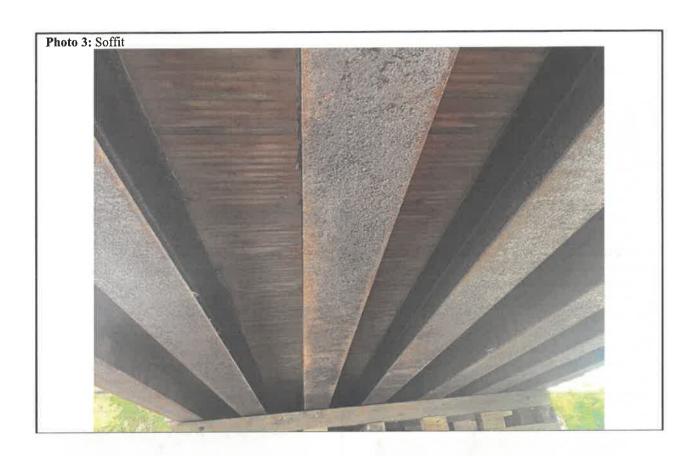
Element Grou	p:	Abutment						
Element Name	e:	Abutment Wall	Abutment Walls			4,9		
Location:		East and West		Height:		2.4		
Material:		Timber	Γimber		Count: 2			
Element Type	:	8x8 timber crib	crib Total Quantity:		ity:	23.52		
Environment:		Benign		Limited Ins	pection	□ Yes	☑ No	
Protection Sys	stem:							Perform.
Condition		Units	Exc.	Good	Fa	ir	Poor*	Deficiencies
Data:		m2 0		16.52	16.52 5		2	14,03

Comments: Very severe soft rot with section loss in southwest and north crib timbers below the waterline. Light to medium splits, checks, and shakes in the crib timbers. Abutment cribs are only approximately 30% full. Moderate to severe sections of undermining at the west crib corners. Gap between the crib top and the girders at the front of the west abutment.

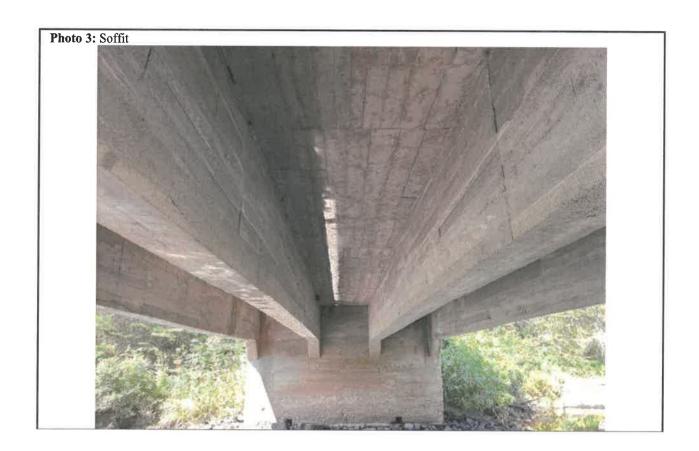
Element Group:	Abutment		Length:					
Element Name:	Abutment Wall	S	Width:		5.6			
Location:			Height:	3.2				
Material:	Cast-in-place co	oncrete	Count:		2			
Element Type:	N/A	N/A			35.84			
Environment:	Benign		Limited Insp	Limited Inspection ☐ Yes ☑ No				
Protection System:	: N/A						Perform.	
Condition	Units	Exc.	Good	F	air	Poor*	Deficiencies	
Data:	m2	0	23.34		8	4.5	none	
Comments: Light e	erosion at the base of

Comments: Light erosion at the base of abutments. Cold joint across the abutments. Light spalls and delamination and narrow to medium cracks at the east abutment wall. Very severe (>1m) delamination, narrow to medium map cracking, and medium scaling at the west abutment wall. Medium to wide crack at the south end of the west abutment.
