CORPORATION OF THE TOWNSHIP OF MCKELLAR

December 5, 2023 – 6:30 p.m.

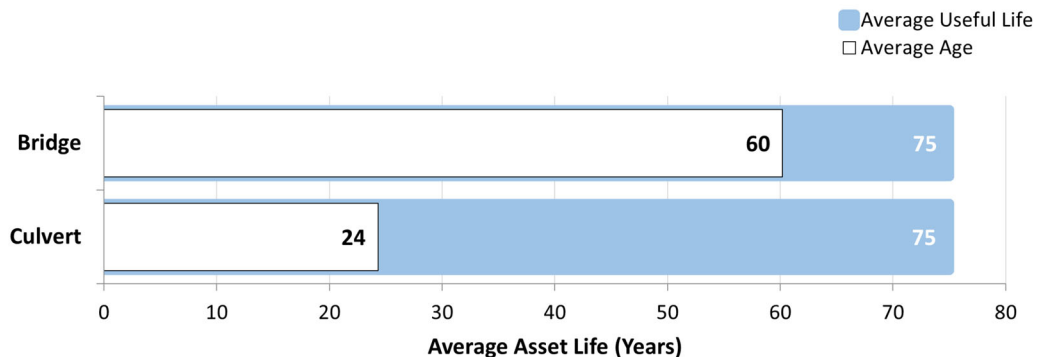
4. Structure Inventory and Identification of Maintenance, Repair and Replacement Needs

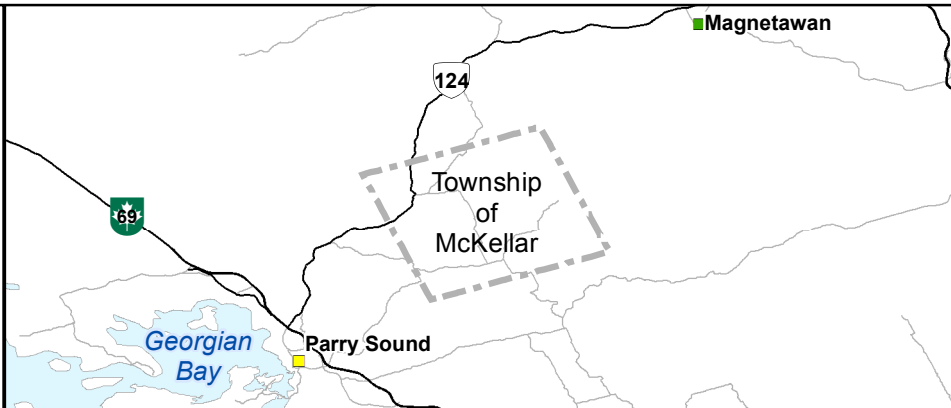
© 2019. Whilst every care has been taken to prepare this map, GHD (and R. Galos) make no representations or warranties about its accuracy, reliability, completeness or suitability for any particular purpose and cannot accept liability and responsibility of any kind (whether in contract, tort or otherwise) for any expenses, losses, damages and/or costs (including indirect or consequential damage) which are or may be incurred by any party as a result of the map being inaccurate, incomplete or unsuitable in any way and for any reason.

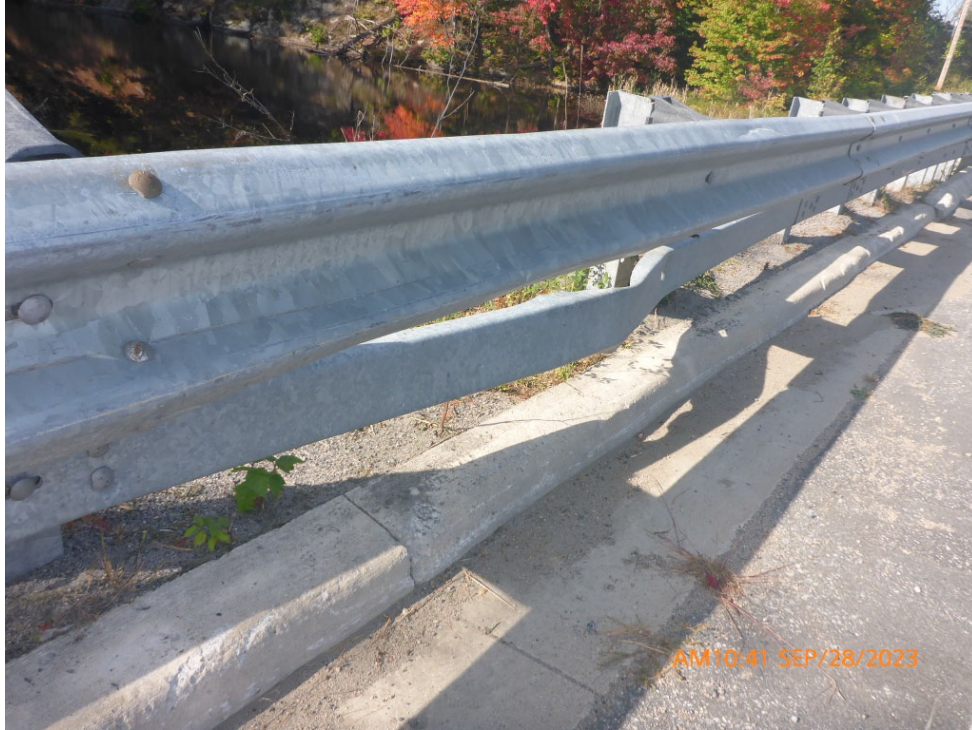
Comments: COLLISION DAMAGE APPROACH GUIDE RAIL

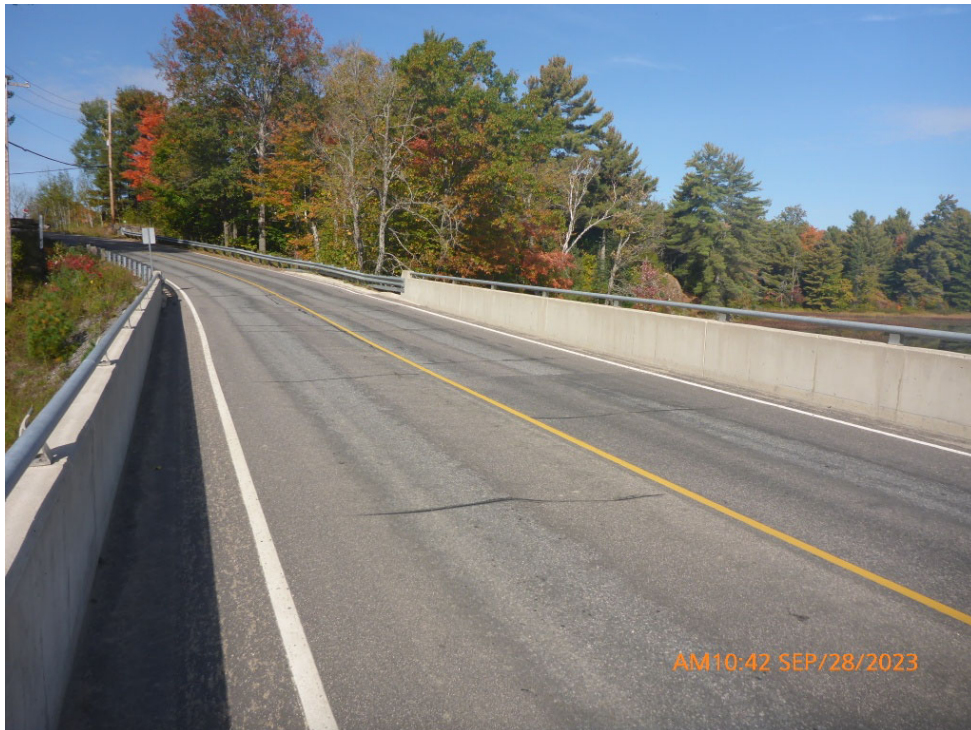
Comments: TYPICAL WEARING SURFACE

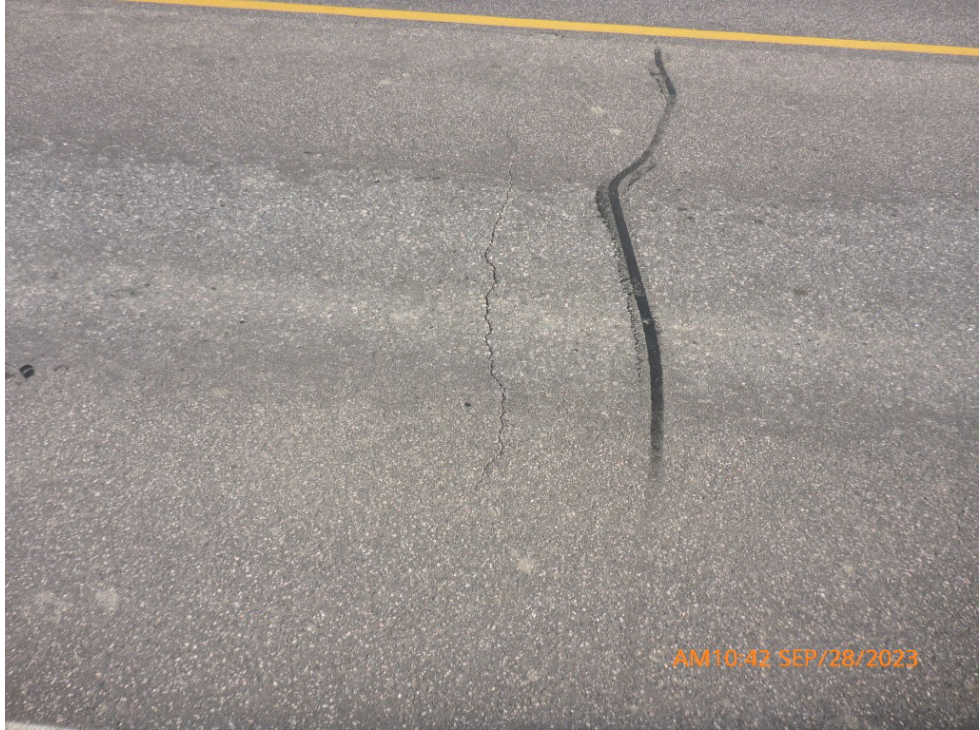
Comments: NARROW TRANSVERSE CRACK IN WEARING SURFACE
Path: P:\McKellar\2023\P1080132.jpg

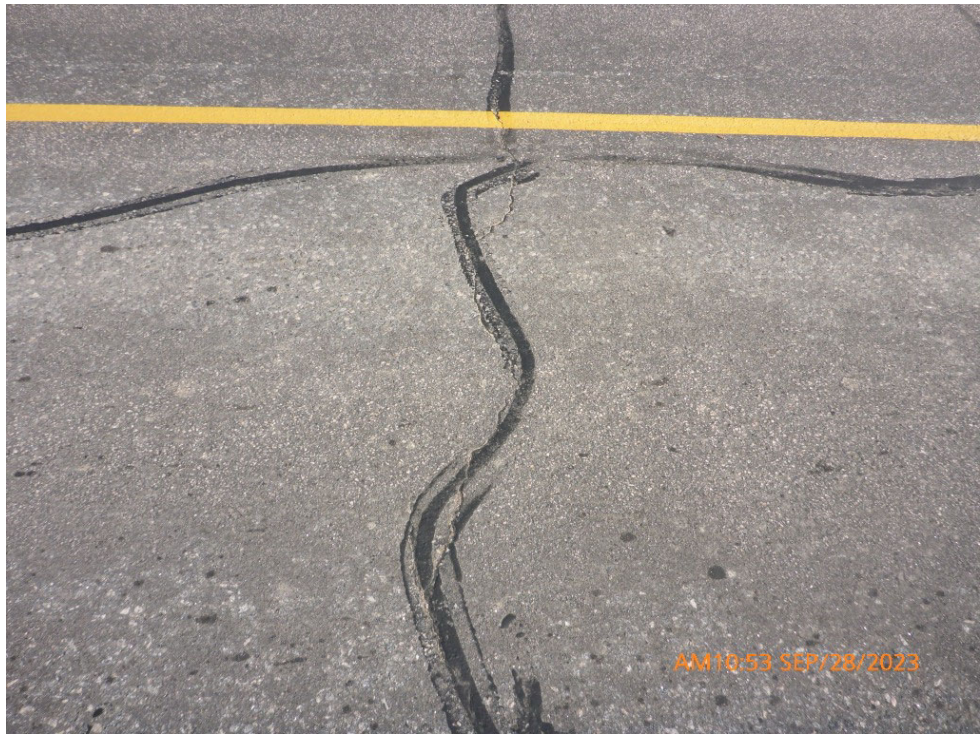
Comments: NARROW TRANSVERSE CRACK IN WEARING SURFACE
Path: P:\McKellar\2023\P1080149.jpg

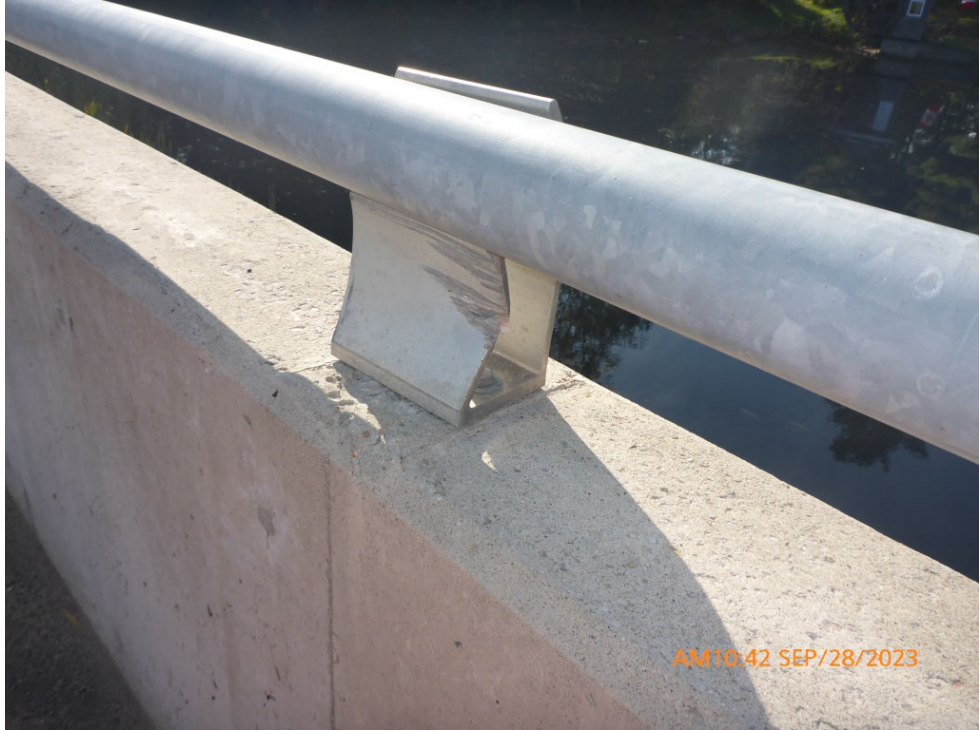
Comments: COLLISION DAMAGE PARAPET HAND RAILING
Path: P:\McKellar\2023\P1080133.jpg

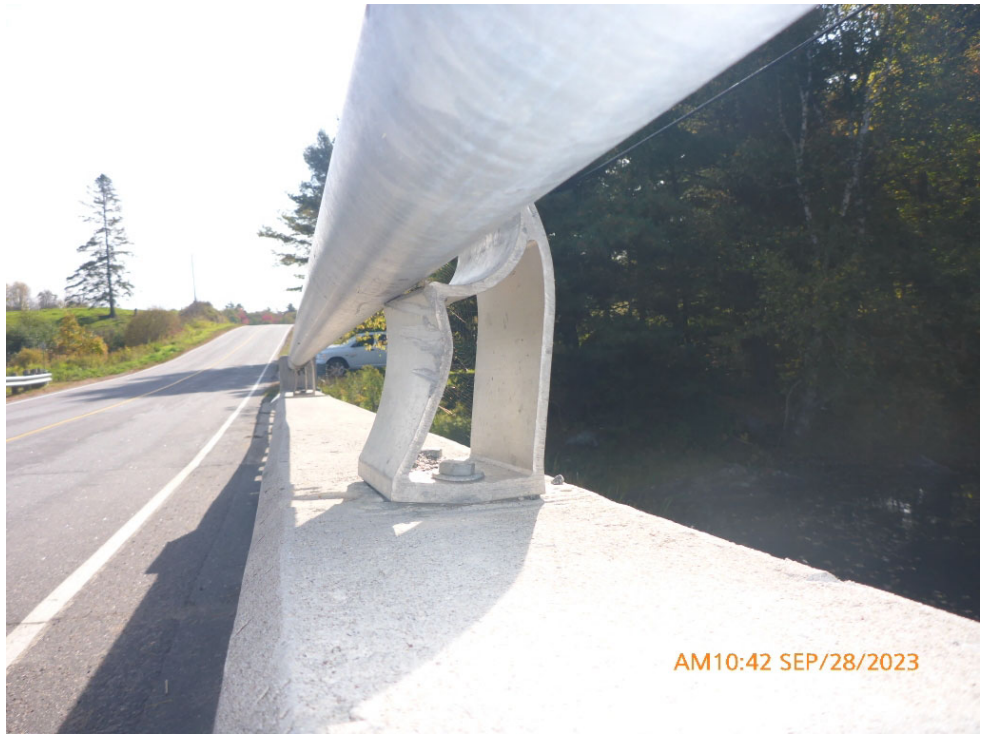
Comments: MISSING BOLT PARAPET HAND RAILING
Path: P:\McKellar\2023\P1080134.jpg

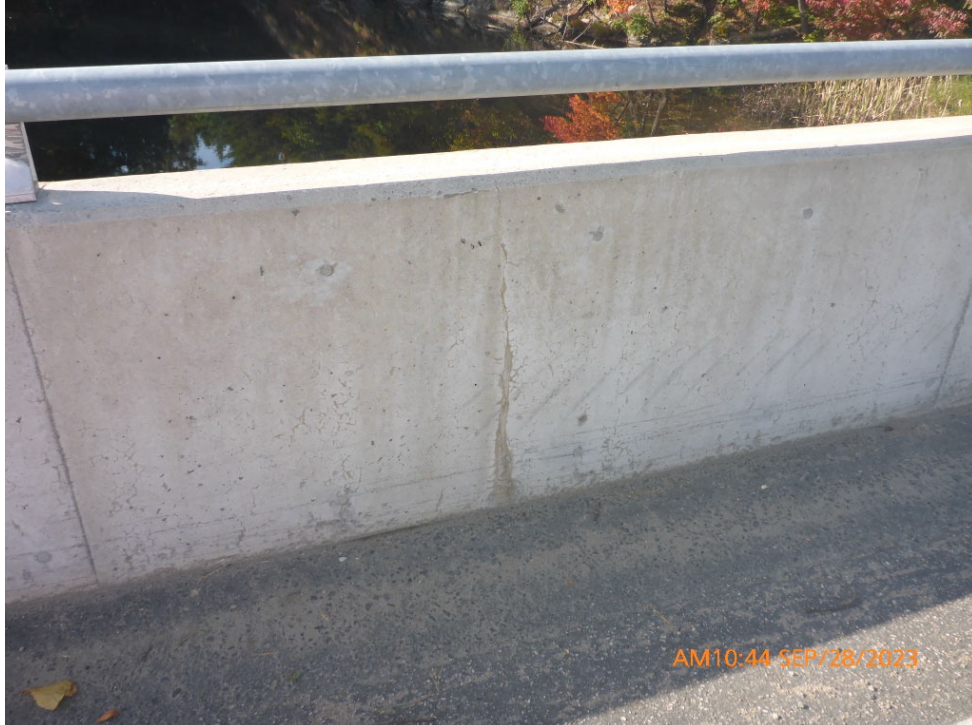
Comments: NARROW STAINED CRACK IN INTERIOR PARAPET WALL

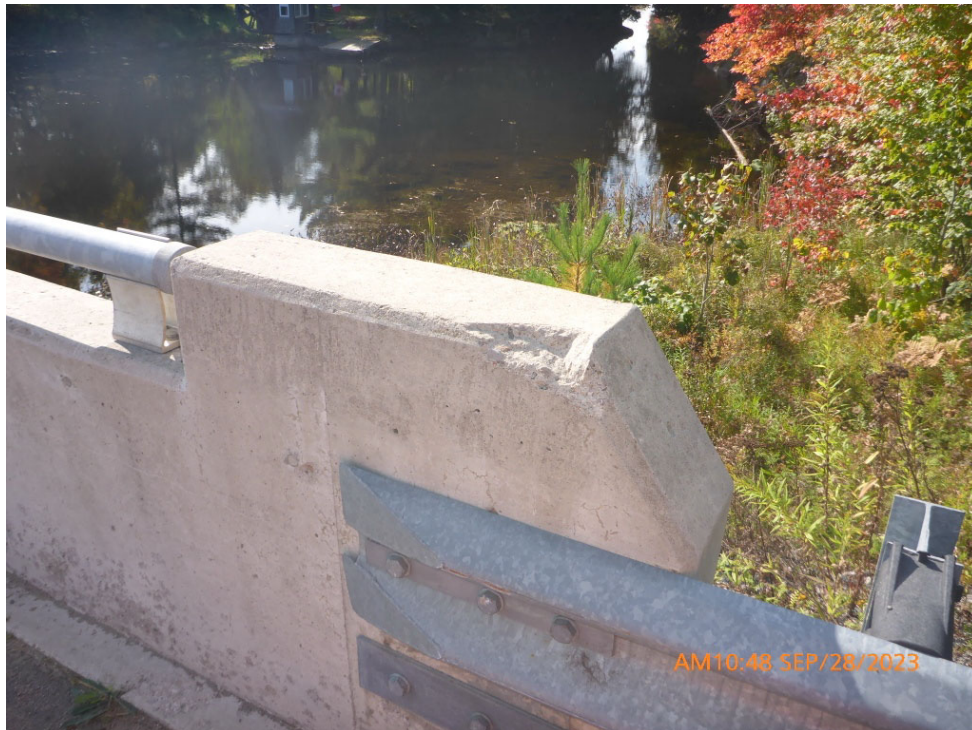
Comments: ABRASION PARAPET END POST

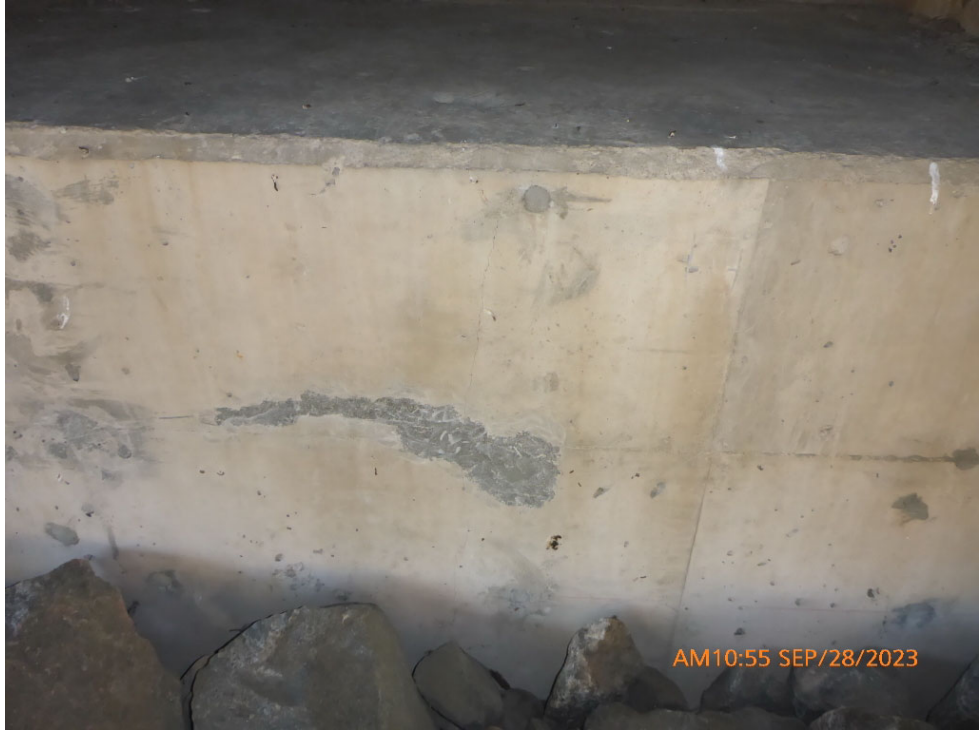
Comments: NARROW VERTICAL CRACK EAST ABUTMENT
Path: P:\McKellar\2023\P1080151.jpg

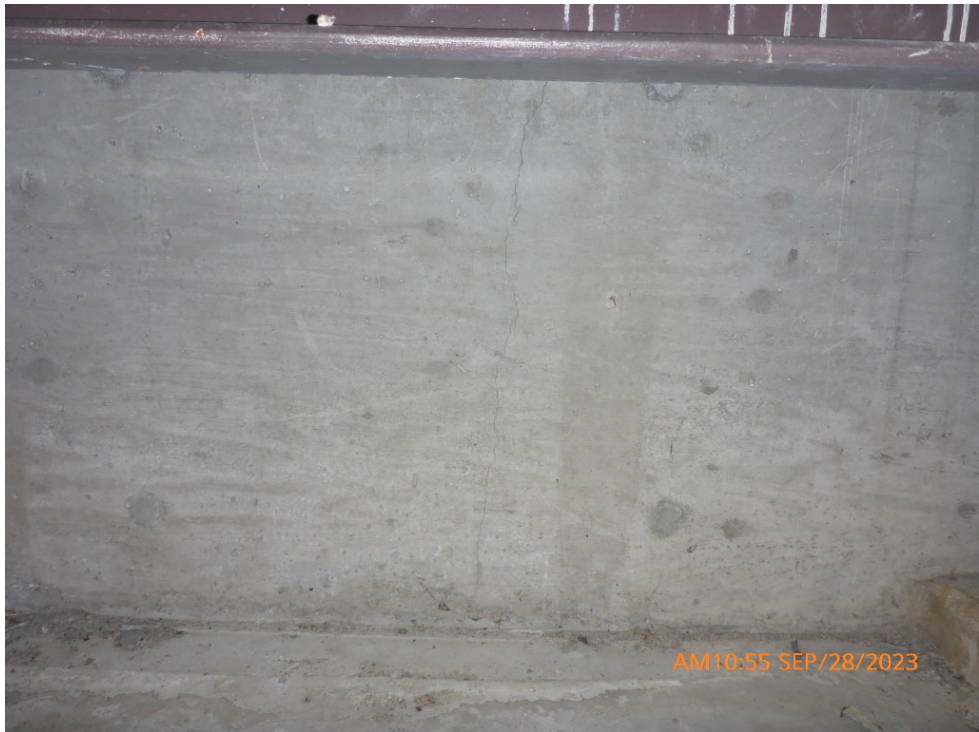
Comments: NARROW VERTICAL CRACK EAST BALLAST WALL
Path: P:\McKellar\2023\P1080152.jpg

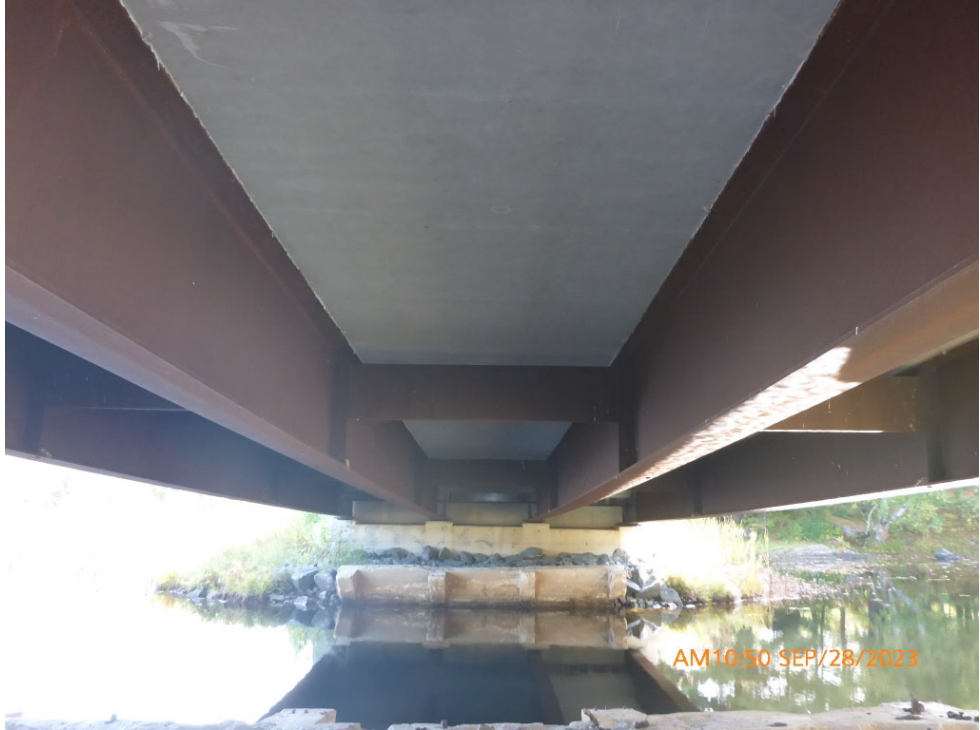
Comments: TYPICAL SOFFIT
Path: P:\McKellar\2023\P1080140.jpg

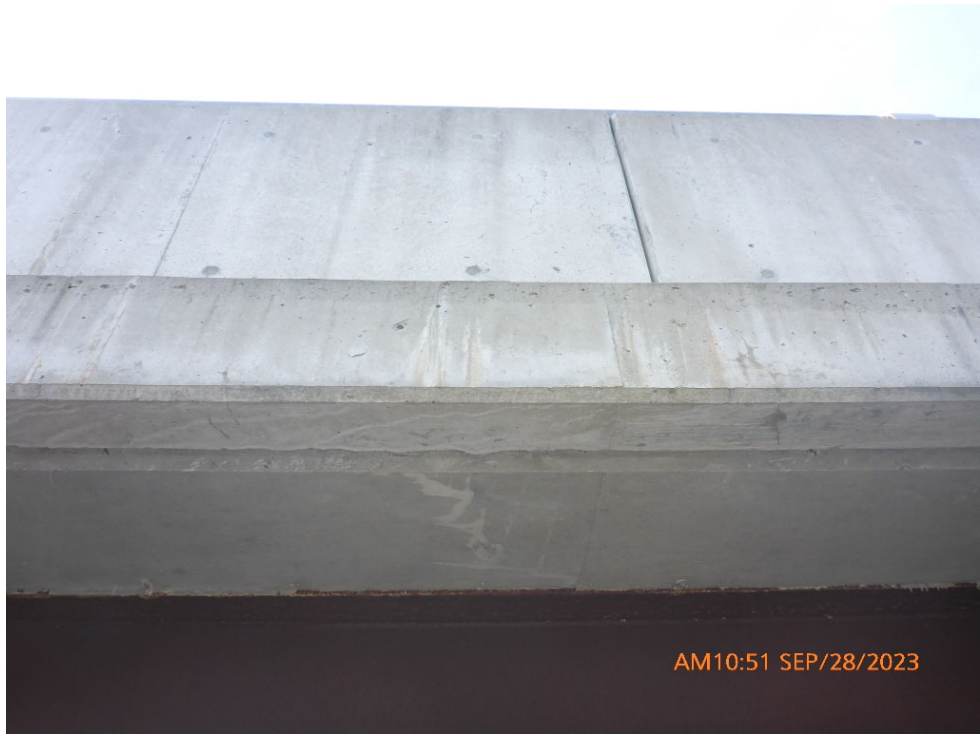
Comments: NARROW STAINED CRACK EXTERIOR SOFFIT
Path: P:\McKellar\2023\P1080147.jpg

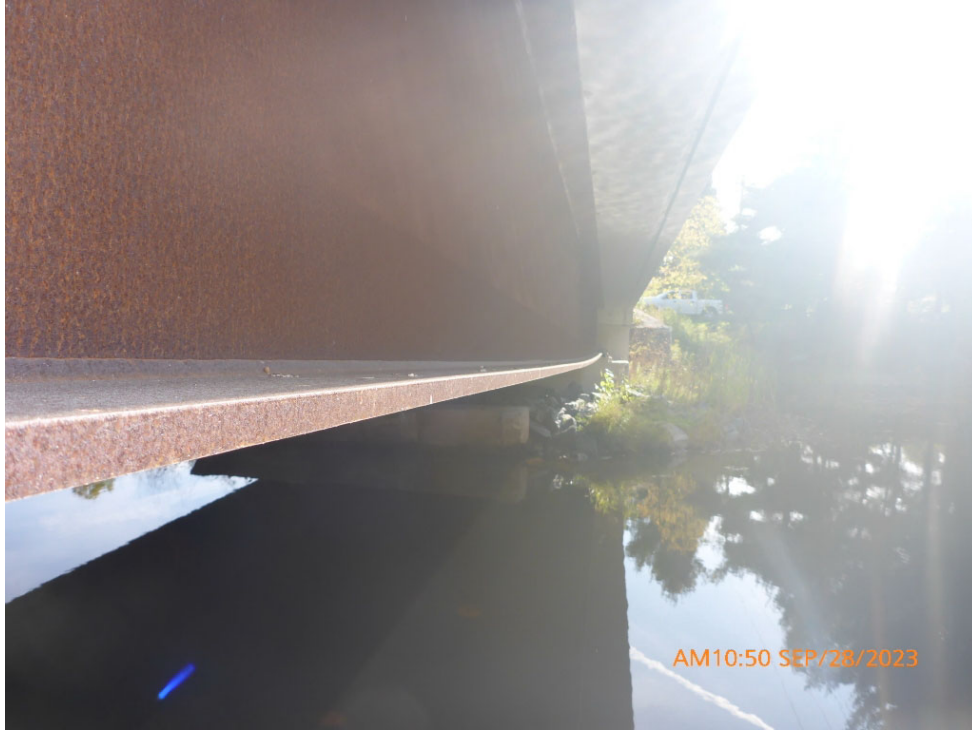
Comments: REVERSE CAMBER ON EXTERIOR GIRDER
Path: P:\McKellar\2023\P1080143.jpg

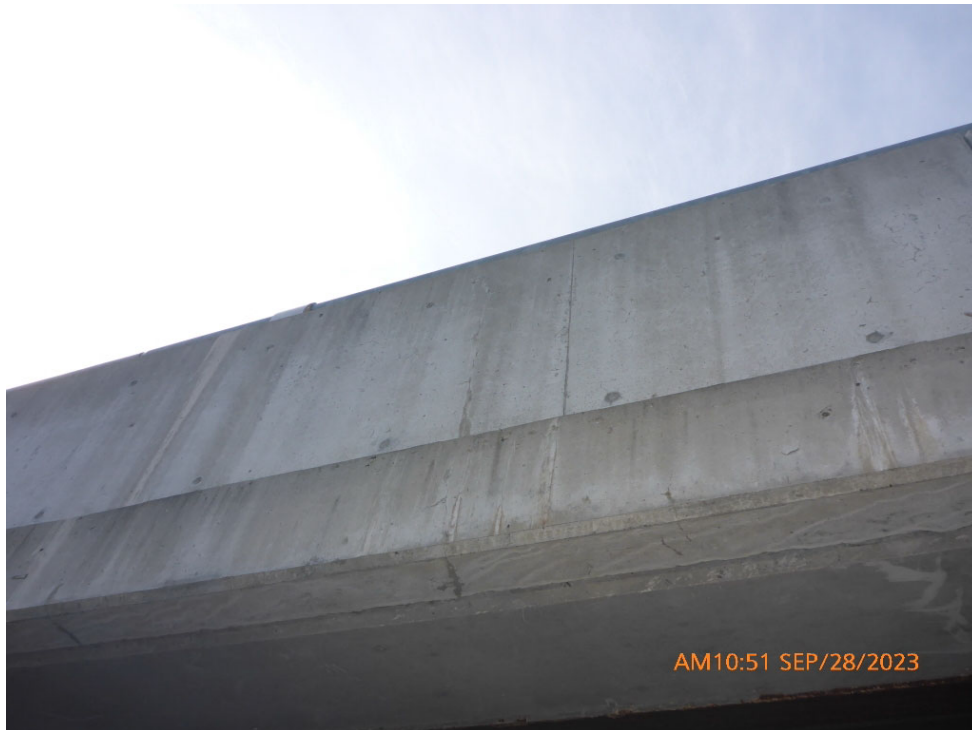
Comments: NARROW STAINED CRACK EXTERIOR PARAPET WALL
Path: P:\McKellar\2023\P1080148.jpg

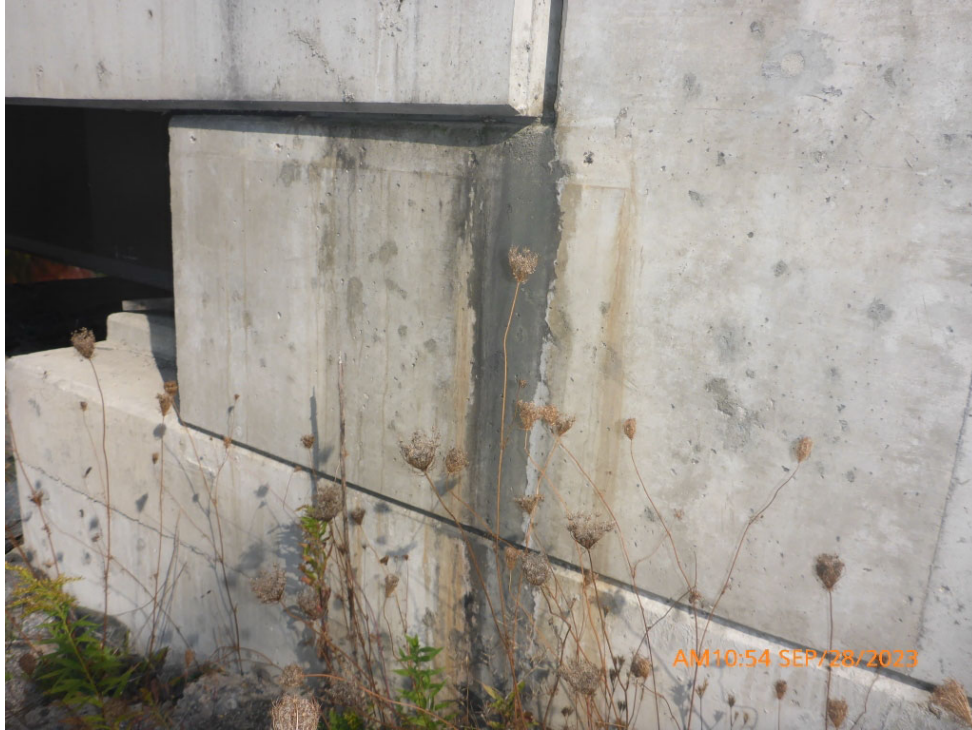
Comments: WATER STAINING ON WINGWALL

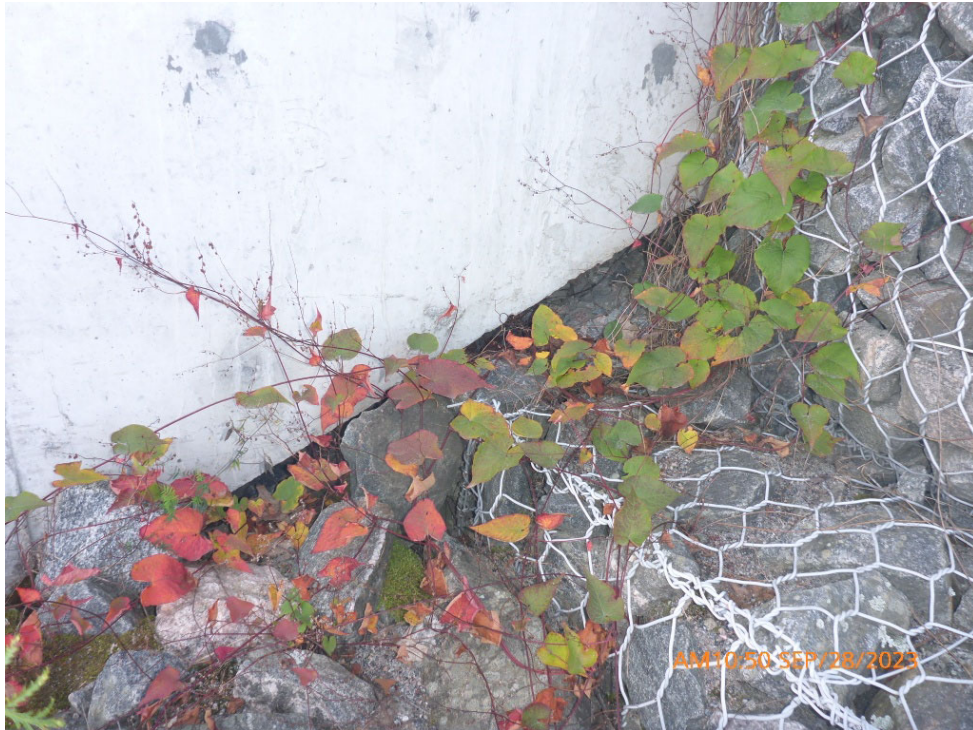
Comments: MODERATE UNDERMINING BELOW WINGWALL

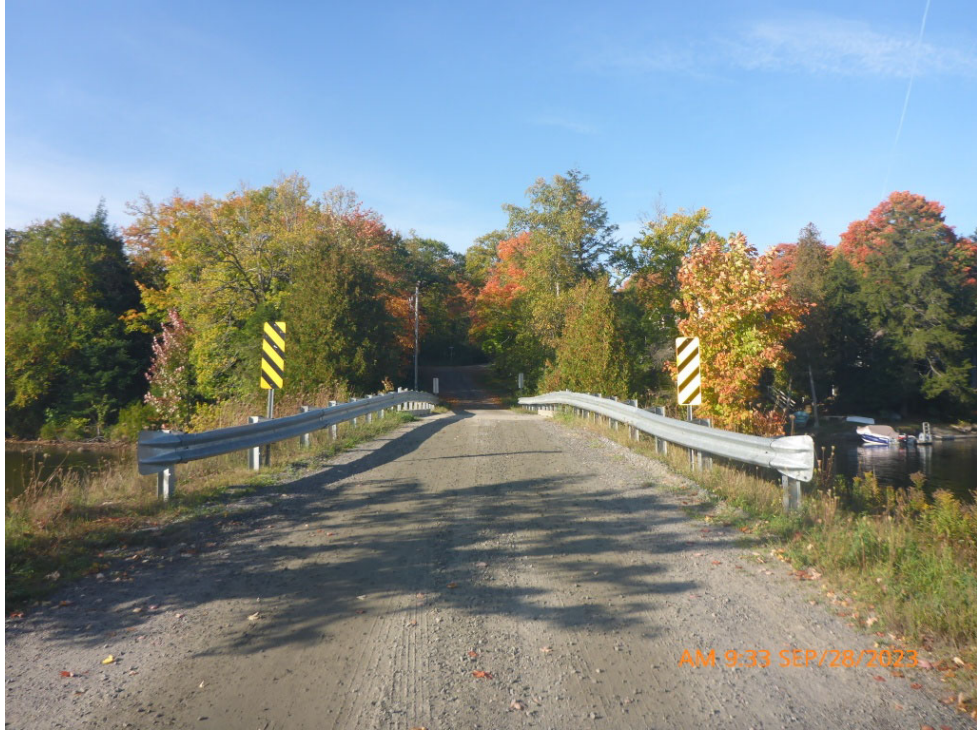
Comments: LOOKING WEST AT BRIDGE

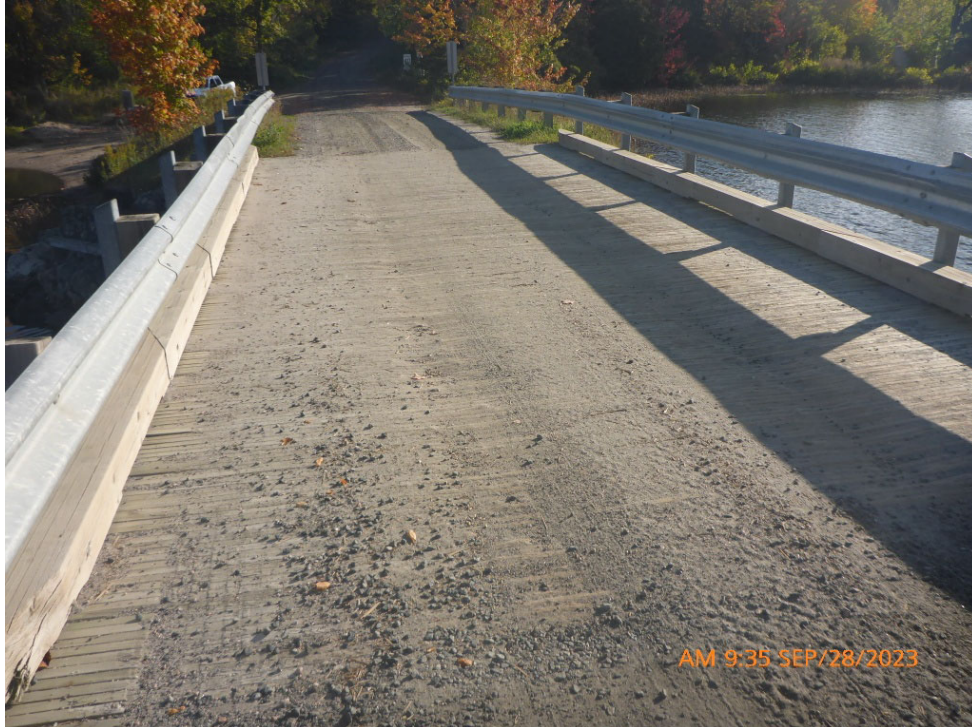
Comments: TYPICAL WEARING SURFACE

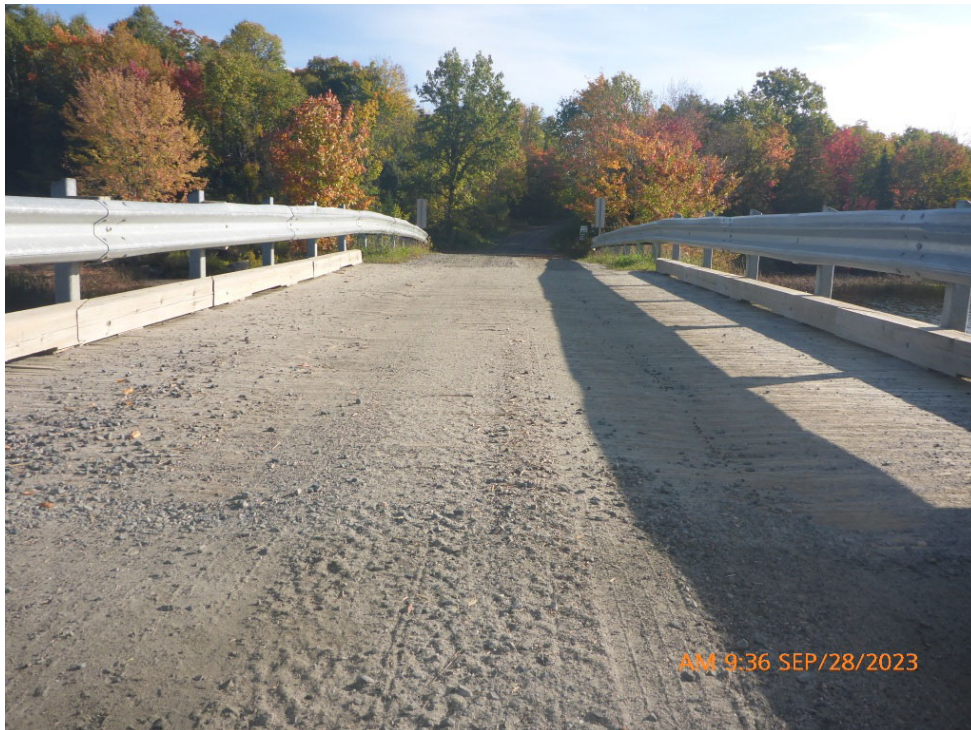
Comments: MEDIUM WHEEL TRACK RUTTING IN TIMBER DECK

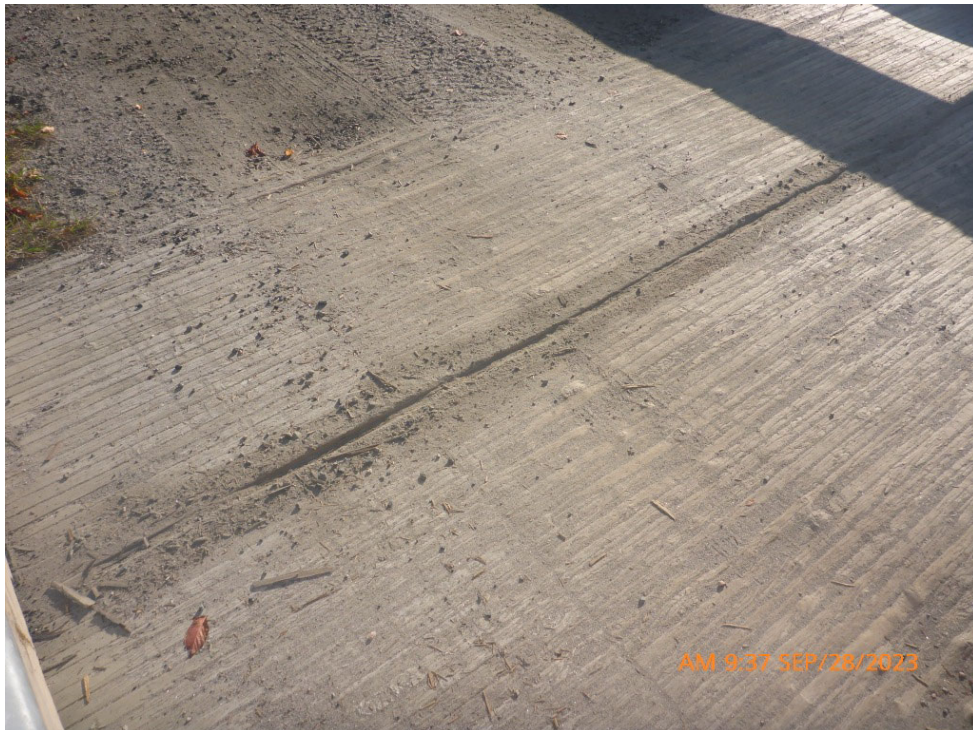
Comments: LOCALIZED SEVERE ROT OF TIMBER DECK MEMBER

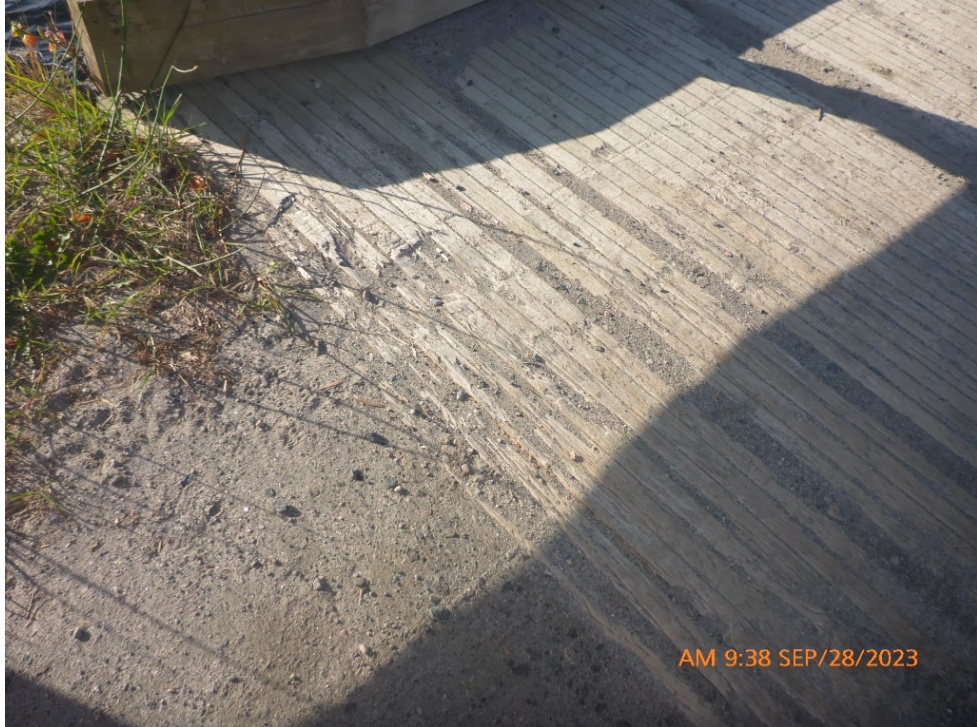
Comments: SEVERE WEATHERING OF TIMBER DECK MEMBERS

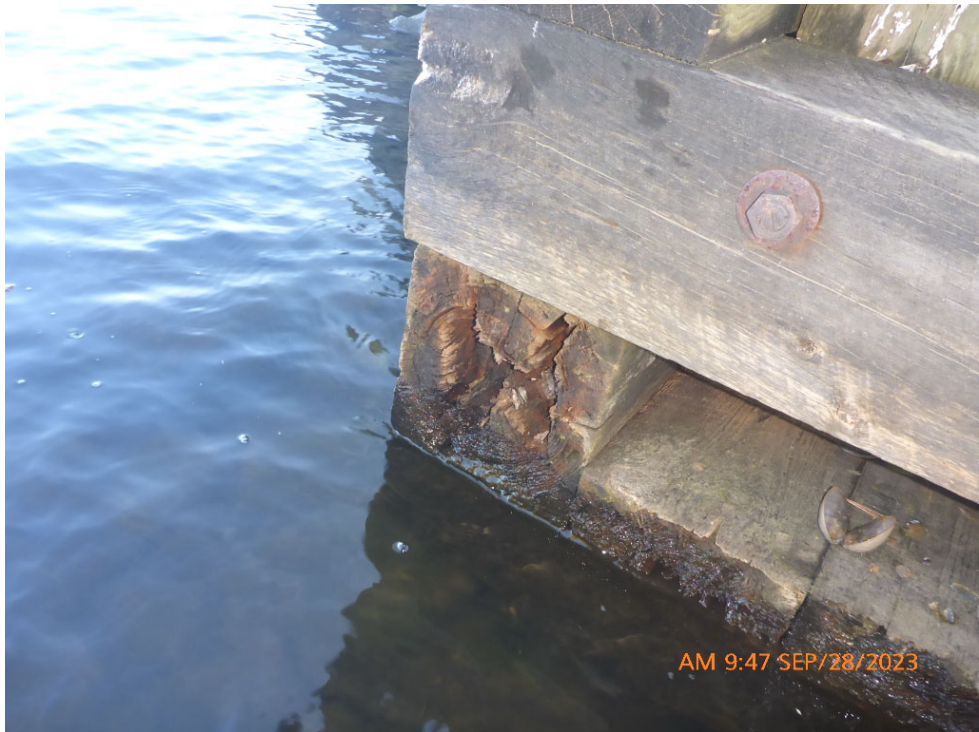
Comments: MEDIUM ROT OF TIMBER CRIB MEMBER

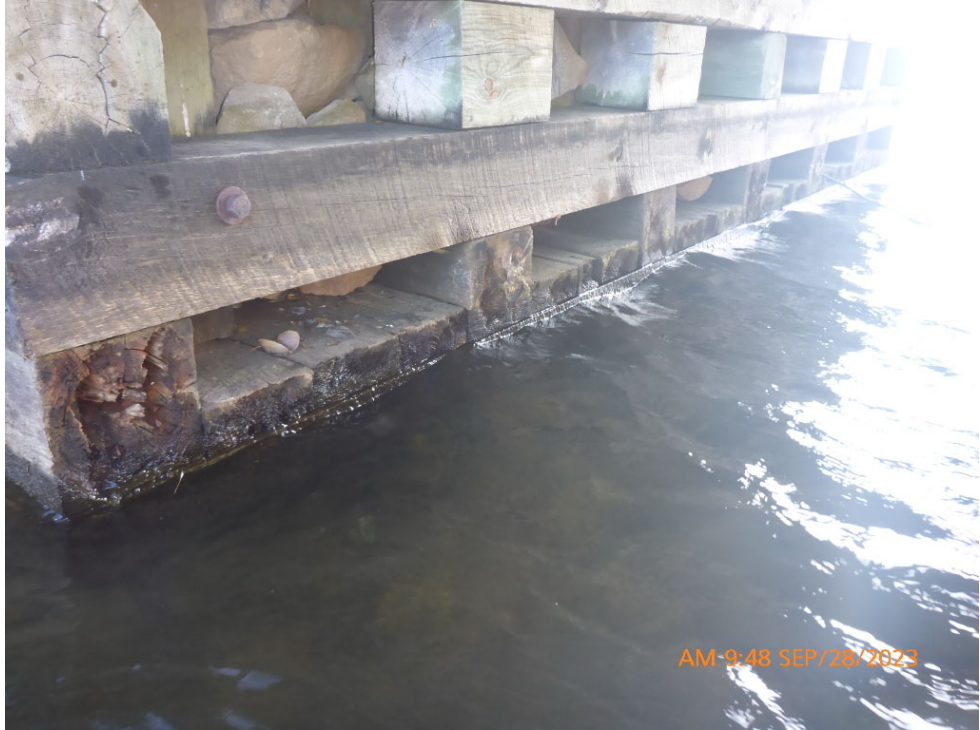
Comments: MEDIUM ROT OF TIMBER CRIB MEMBERS EAST ABUTMENT

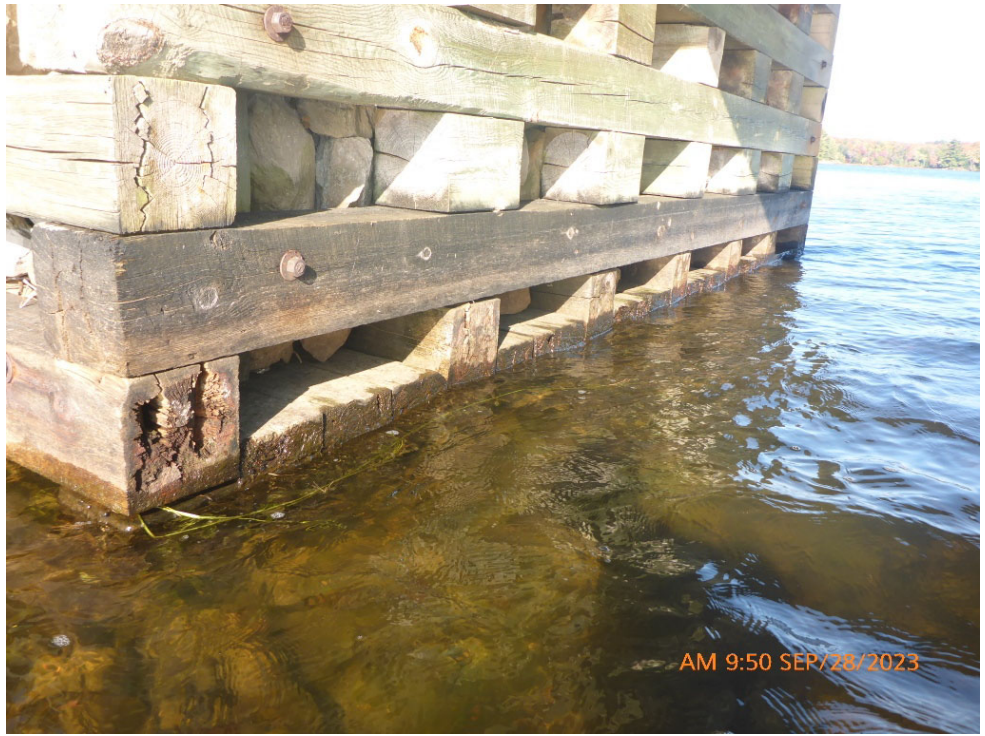
Comments: MEDIUM ROT OF TIMBER CRIB MEMBERS WEST ABUTMENT

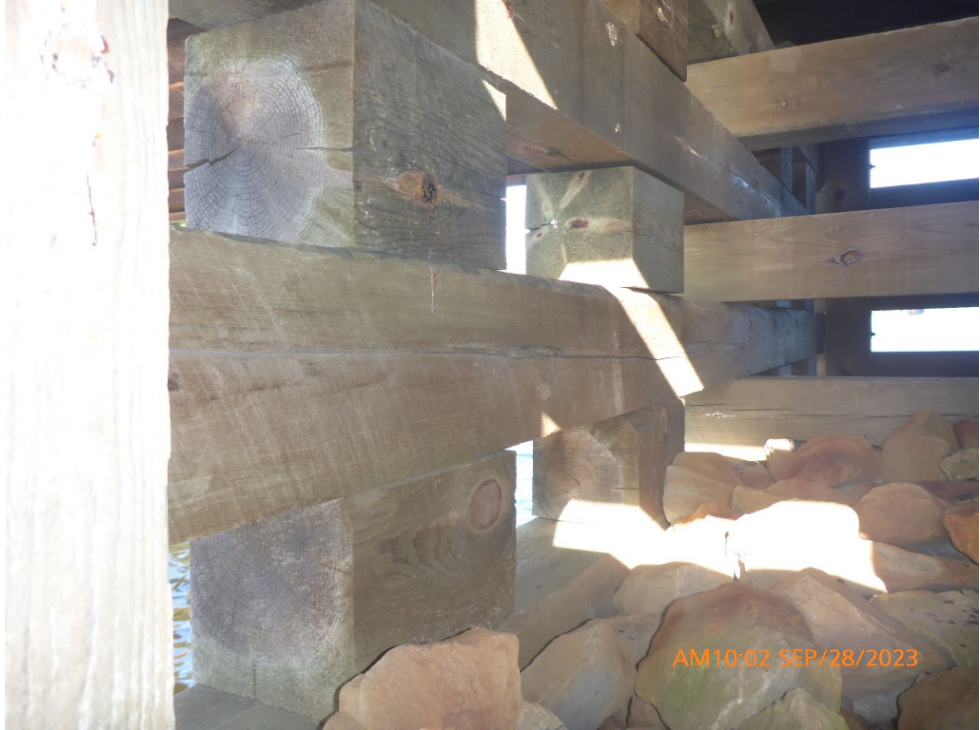
Comments: SEVERE CHECK IN TIMBER CRIB MEMBER
Path: P:\McKellar\2023\P1080124.jpg

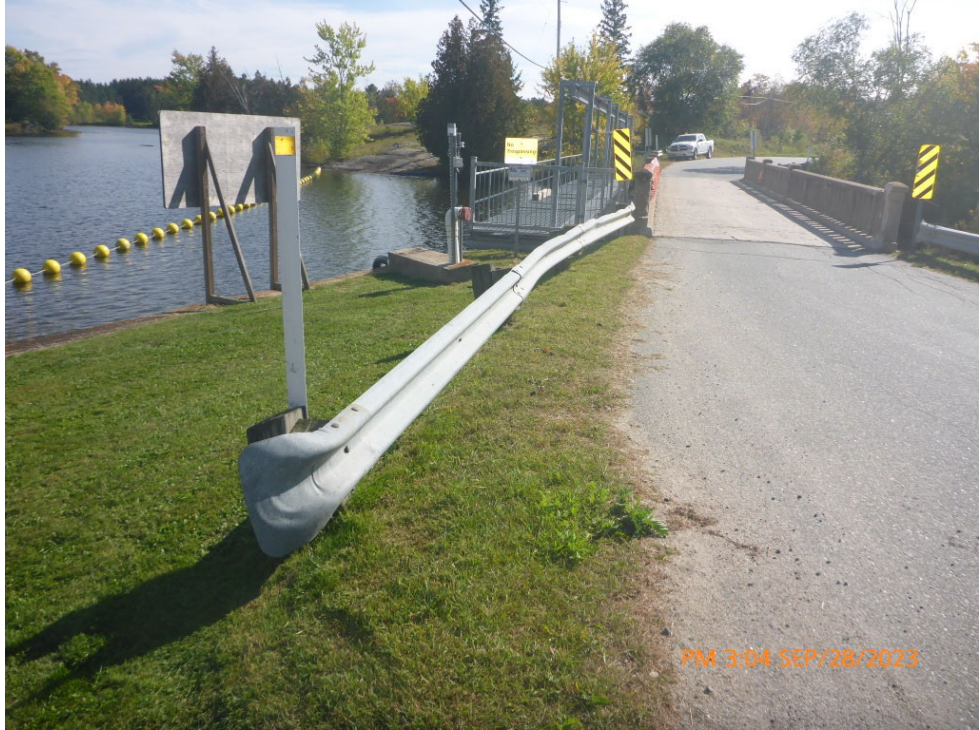
Comments: COLLISION DAMAGE TO NORTHEAST GUIDE RAIL

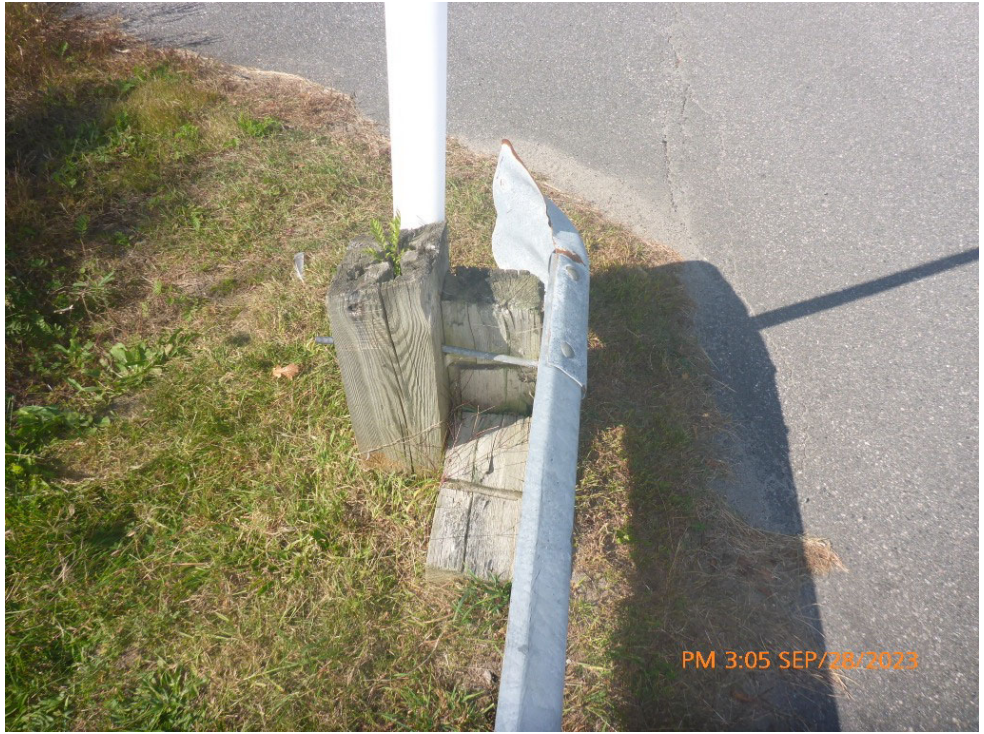
Comments: BROKEN OFFSET BLOCK

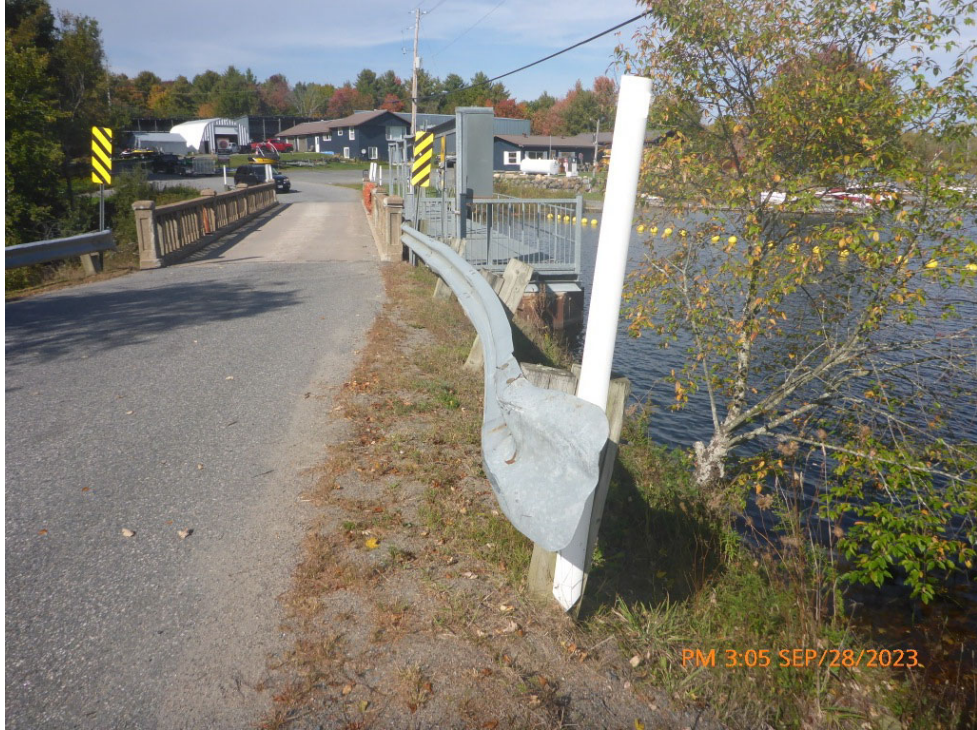
Comments: OUTWARD ROTATION OF APPROACH GUIDE RAIL SOUTHEAST QUADRANT

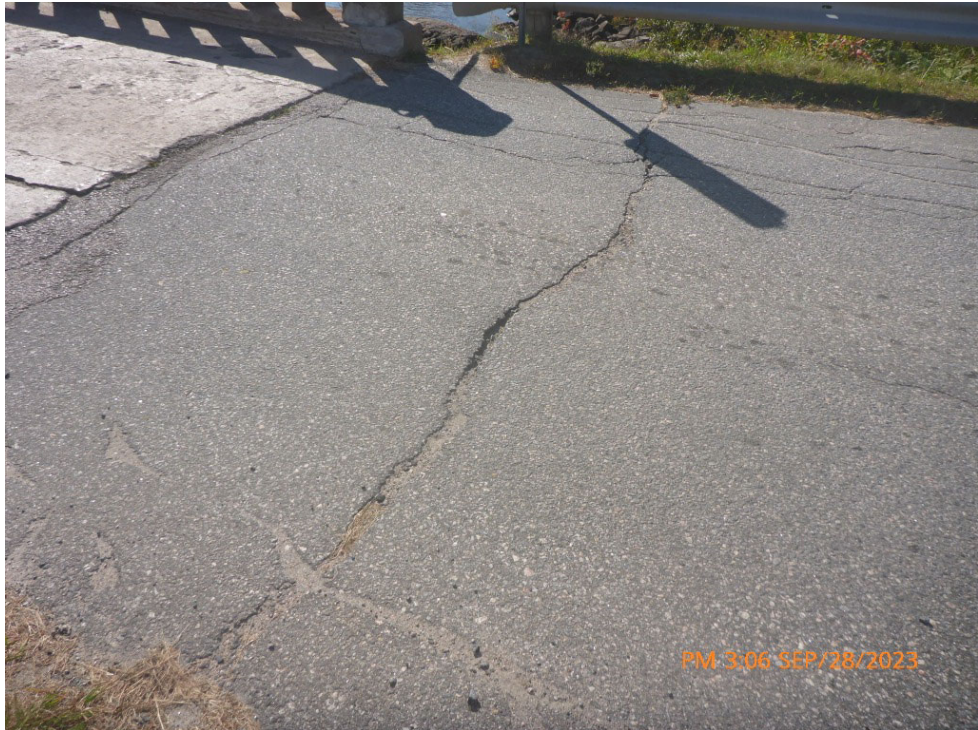
Comments: WIDE TRANSVERSE CRACK APPROACH

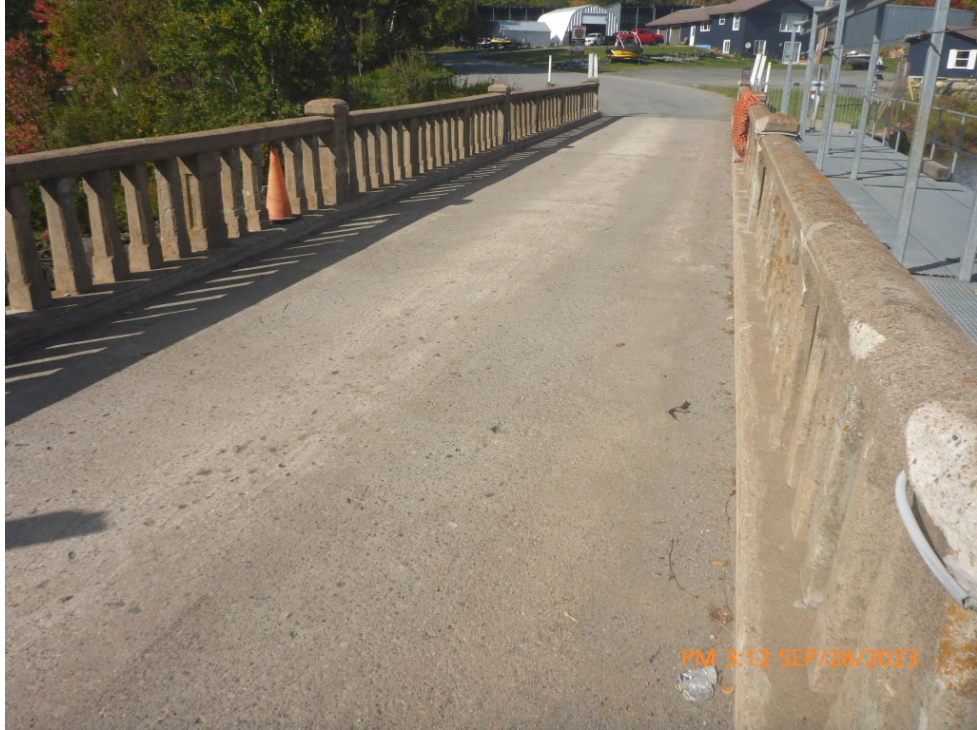
Comments: TYPICAL WEARING SURFACE
