CORPORATION OF THE TOWNSHIP OF MCKELLAR

December 5, 2023 – 6:30 p.m.

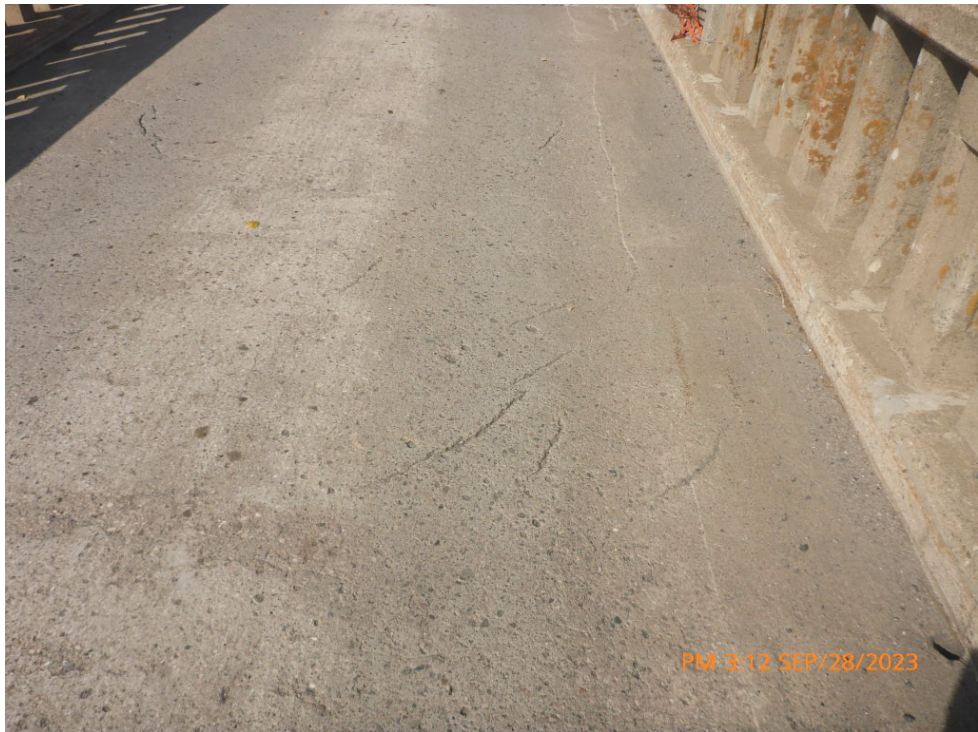
Comments: WIDE CRACKS IN CONCRETE DECK

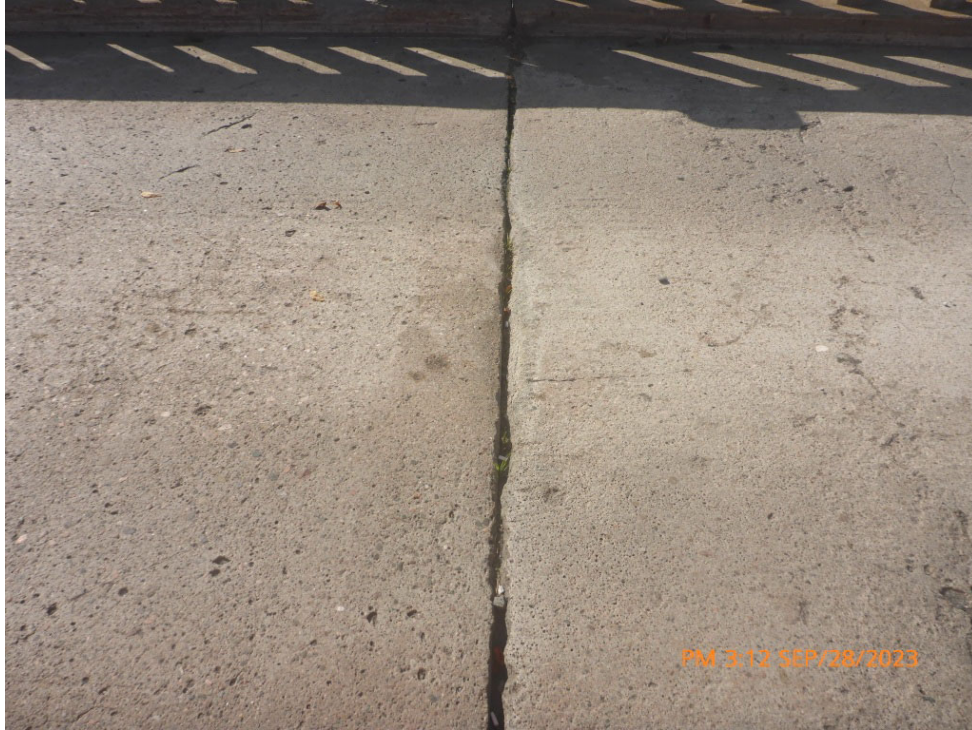
Comments: GAP AT MIDSPAN OF DECK

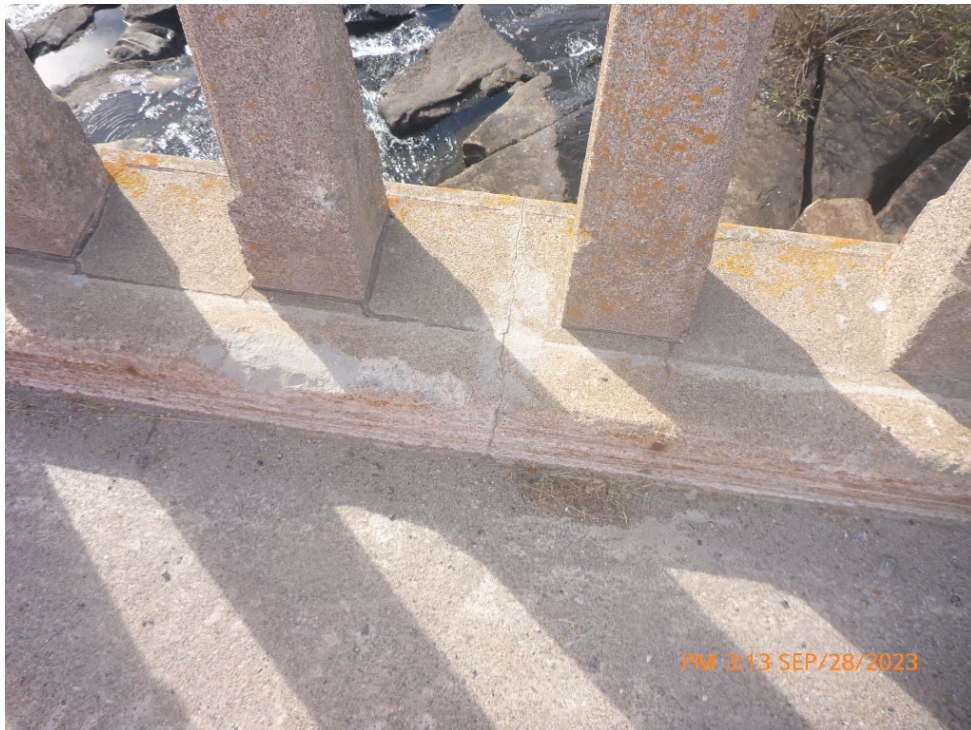
Comments: WIDE CRACK IN CONCRETE CURB

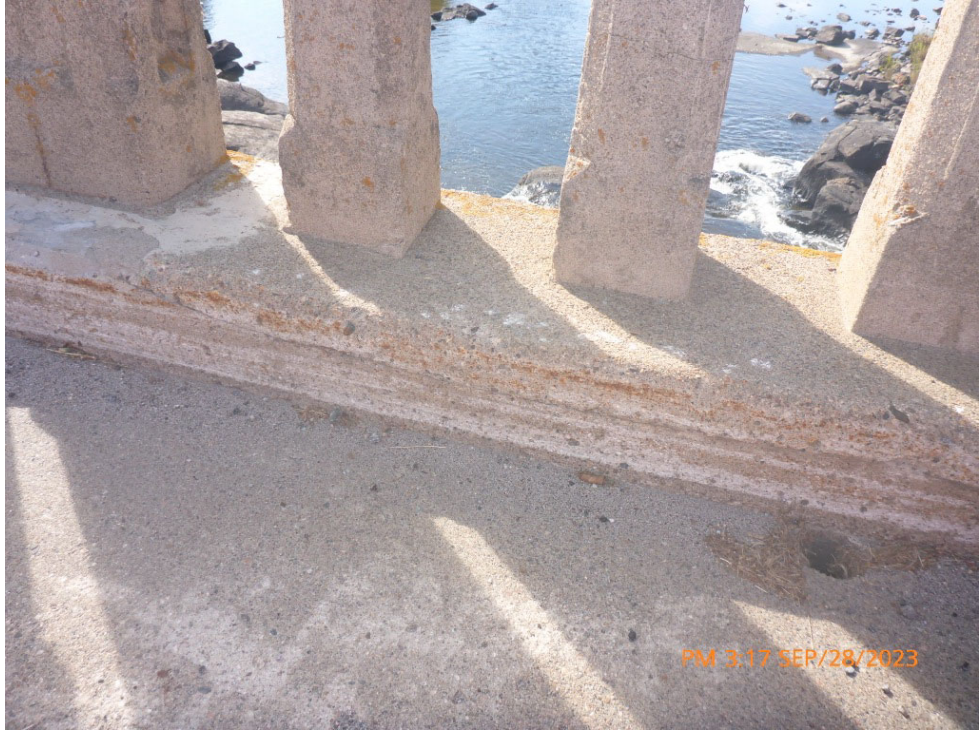
Comments: DELAMINATION IN CONCRETE CURB

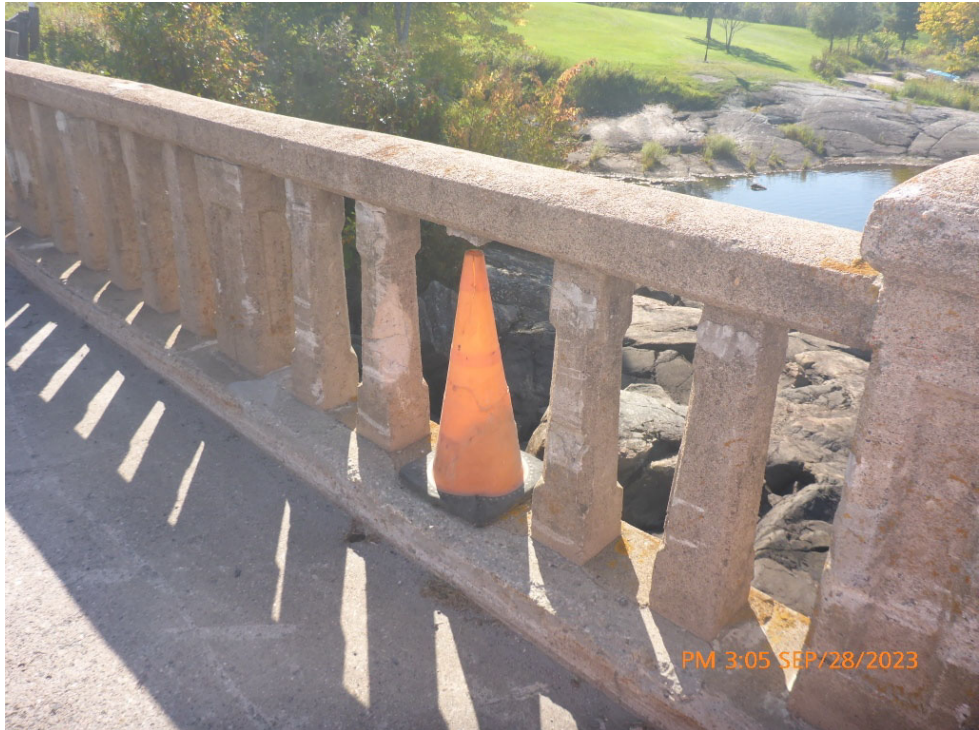
Comments: MISSING BALUSTRADE WEST RAILING

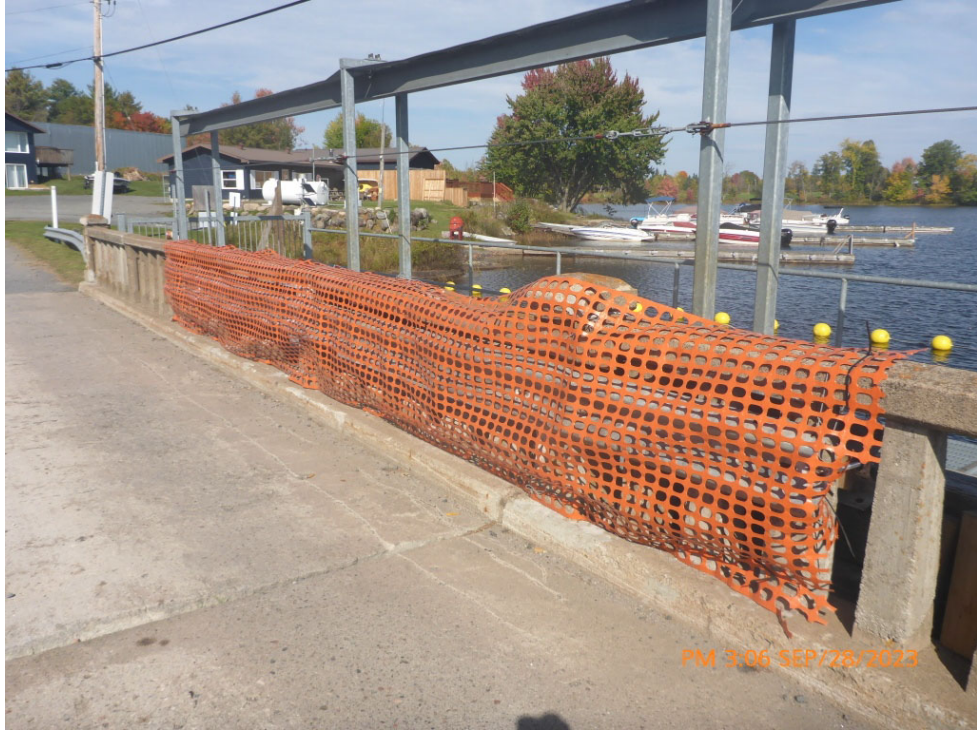
Comments: MISSING BALUSTRADES ON EAST RAILING

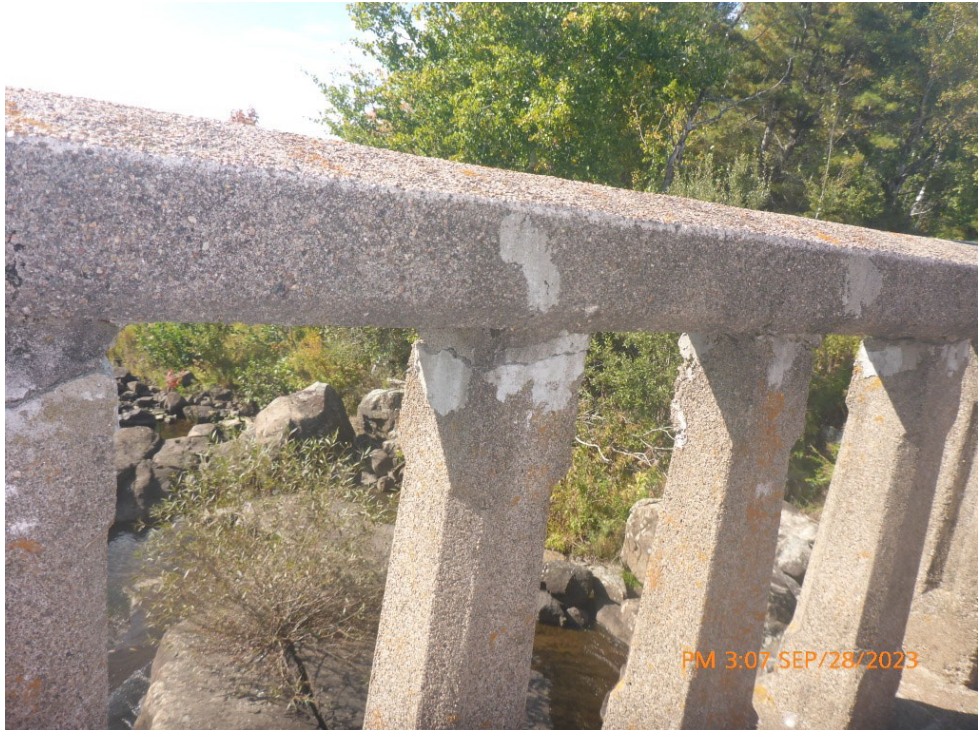
Comments: WIDE CRACKS IN BALUSTRADE

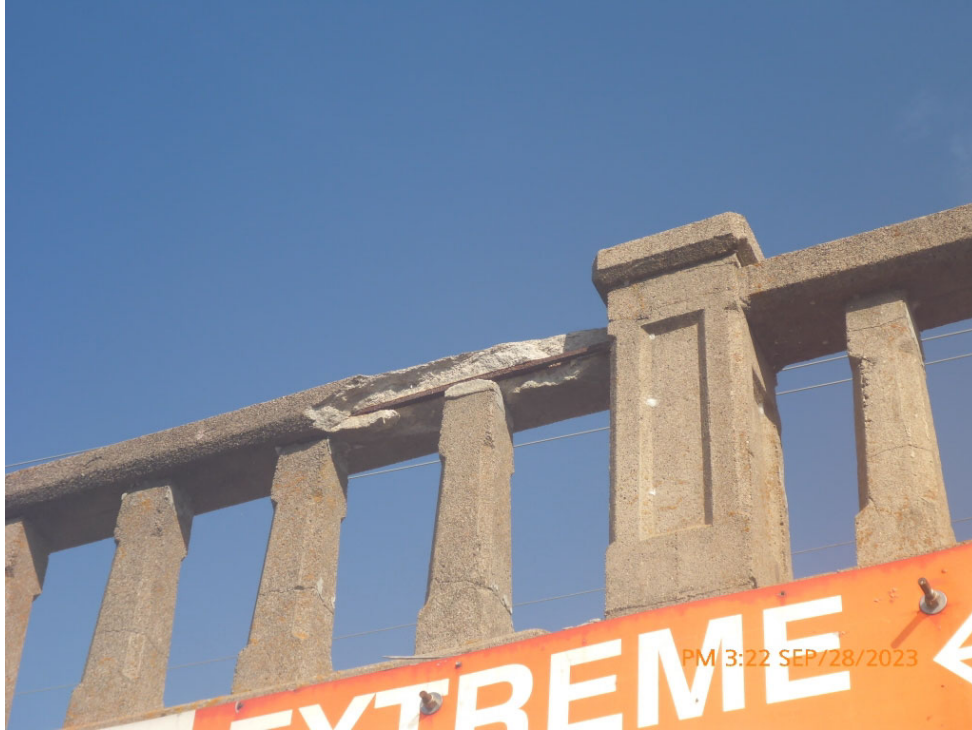
Comments: SPALLING OF BALUSTRADE RAILING
Path: P:\McKellar\2023\P1080295.jpg

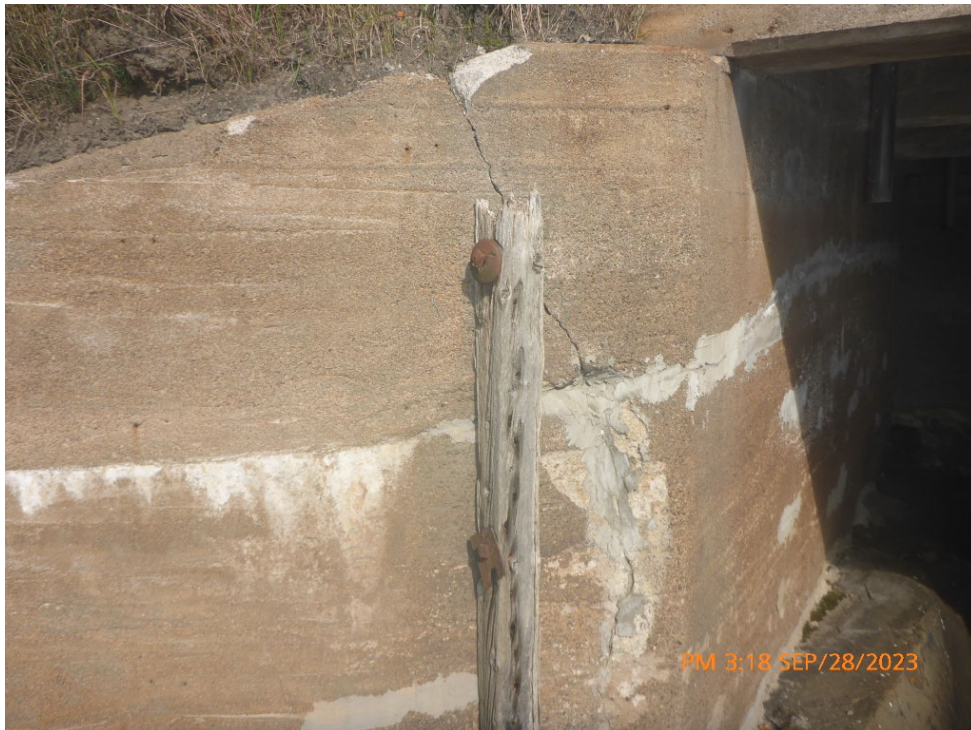
Comments: WIDE CRACK IN NORTHWEST WINGWALL
Path: P:\McKellar\2023\P1080283.jpg

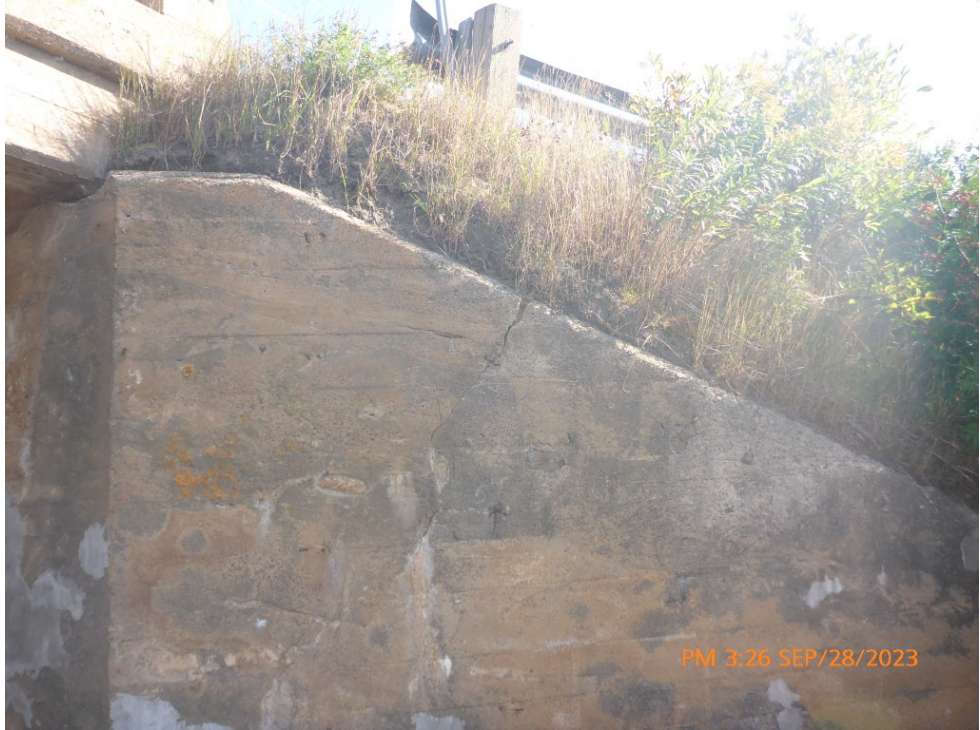
Comments: WIDE VERTICAL CRACK IN WINGWALL

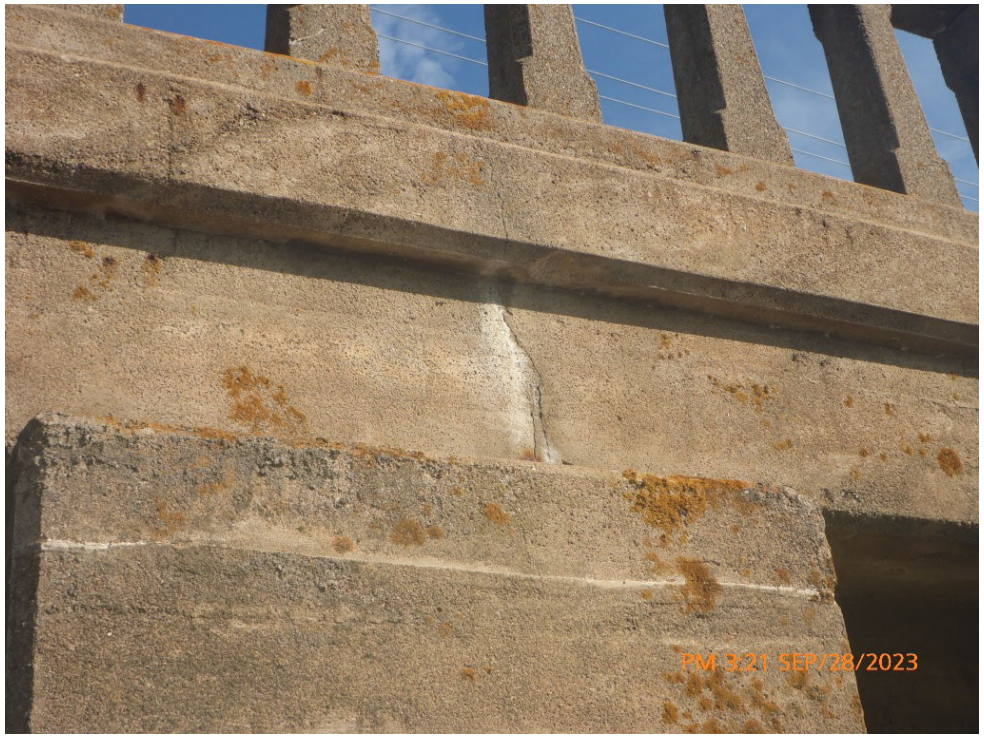
Comments: WIDE CRACK IN EXTERIOR FASCIA

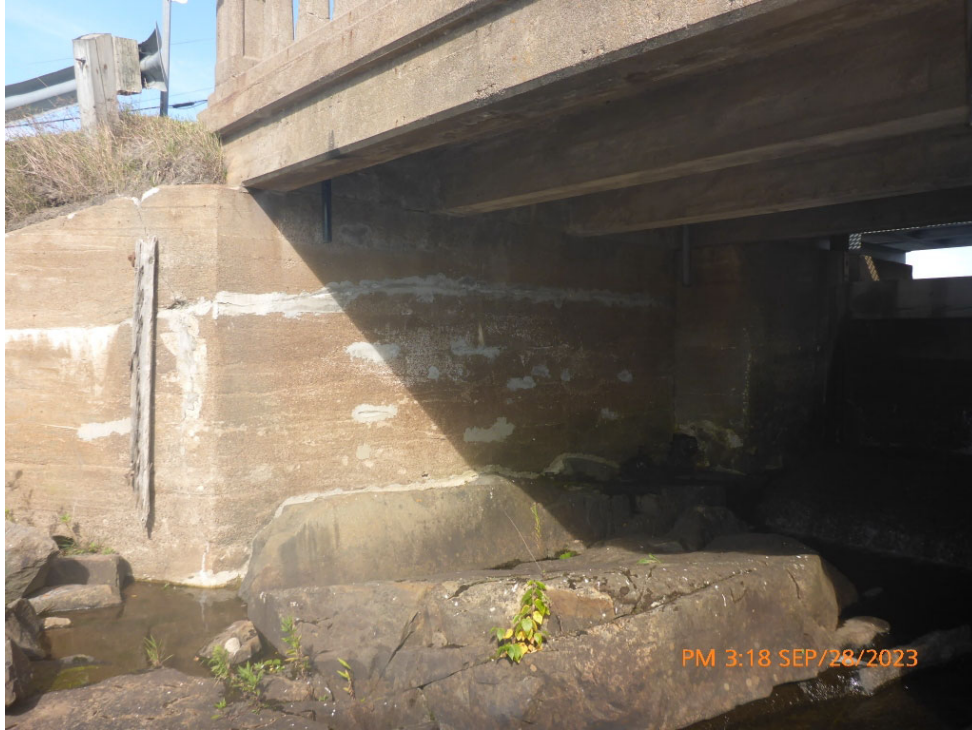
Comments: TYPICAL NORTH ABUTMENT
Path: P:\McKellar\2023\P1080284.jpg

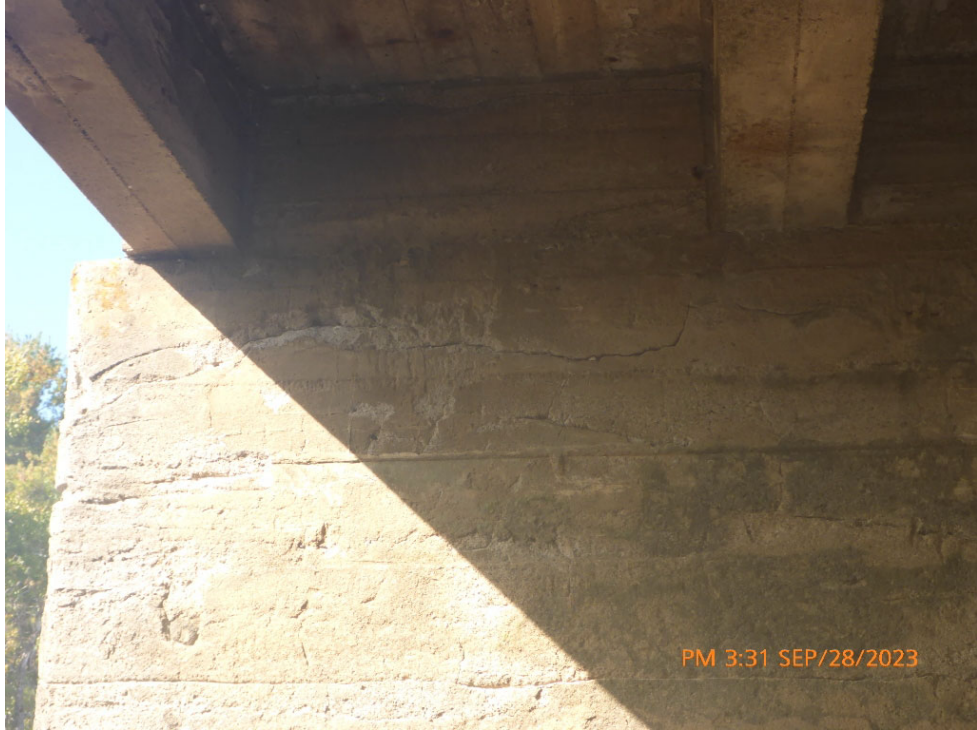
Comments: WIDE HORIZONTAL CRACK IN PIER

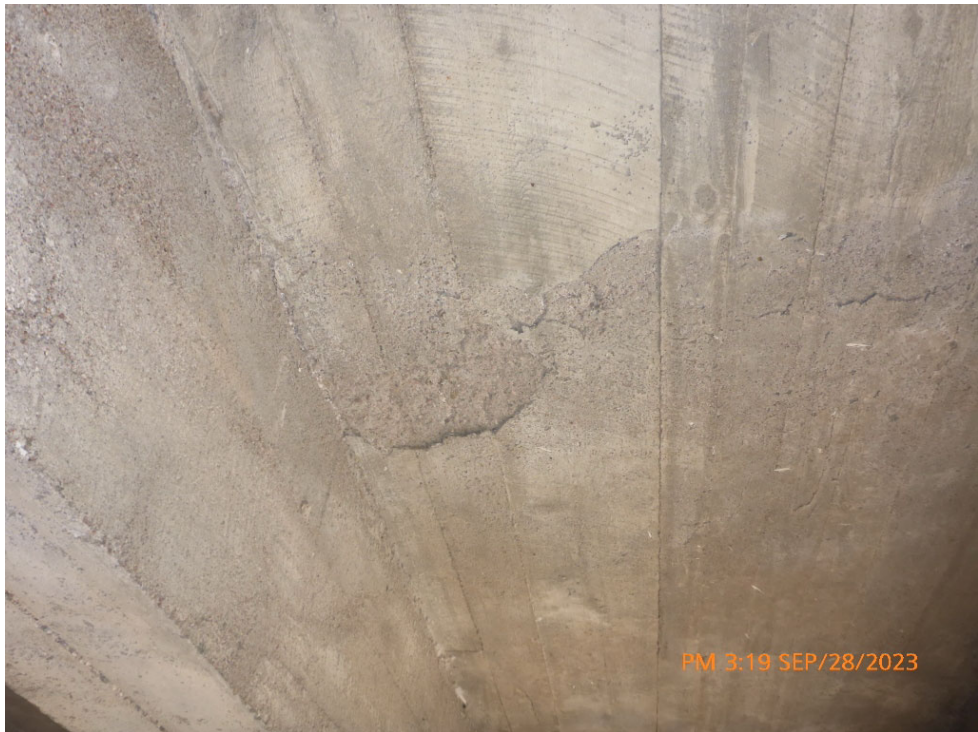
Comments: DELAMINATION INTERIOR SOFFIT

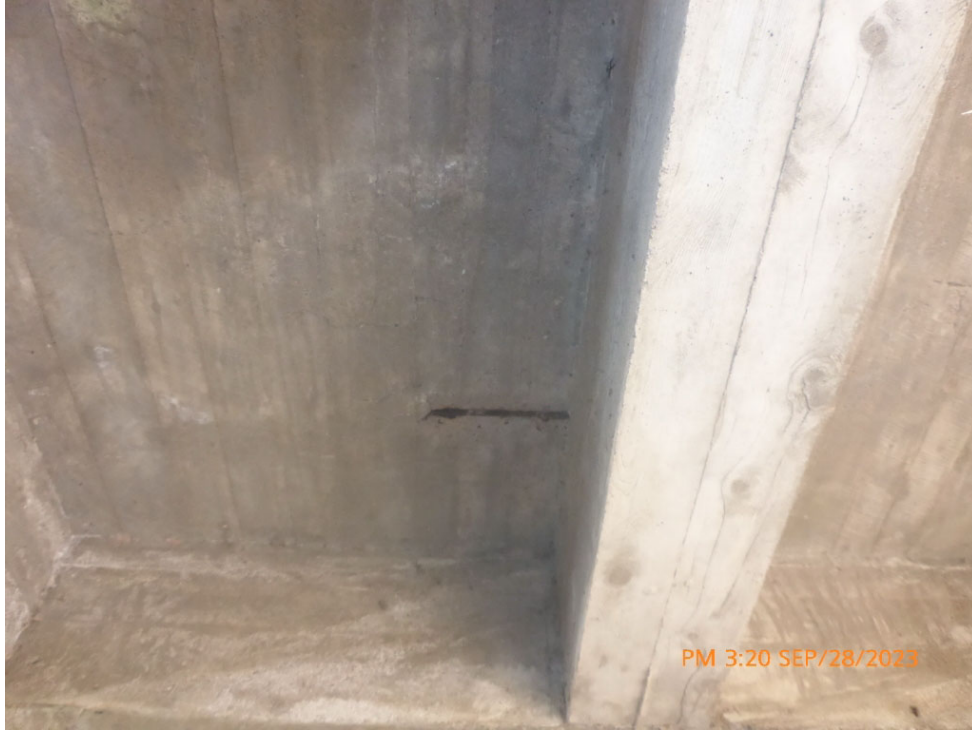
Comments: SPALLING INTERIOR SOFFIT
Path: P:\McKellar\2023\P1080289.jpg

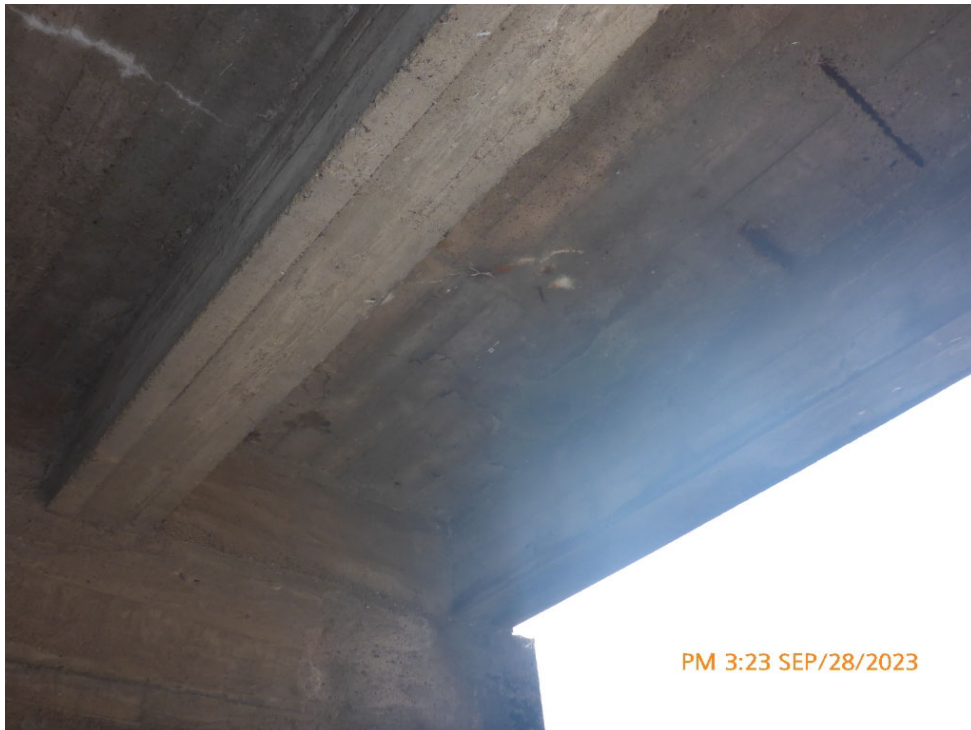
Comments: SEVERE DELAMINATIONS INTERIOR SOFFIT
Path: P:\McKellar\2023\P1080296.jpg

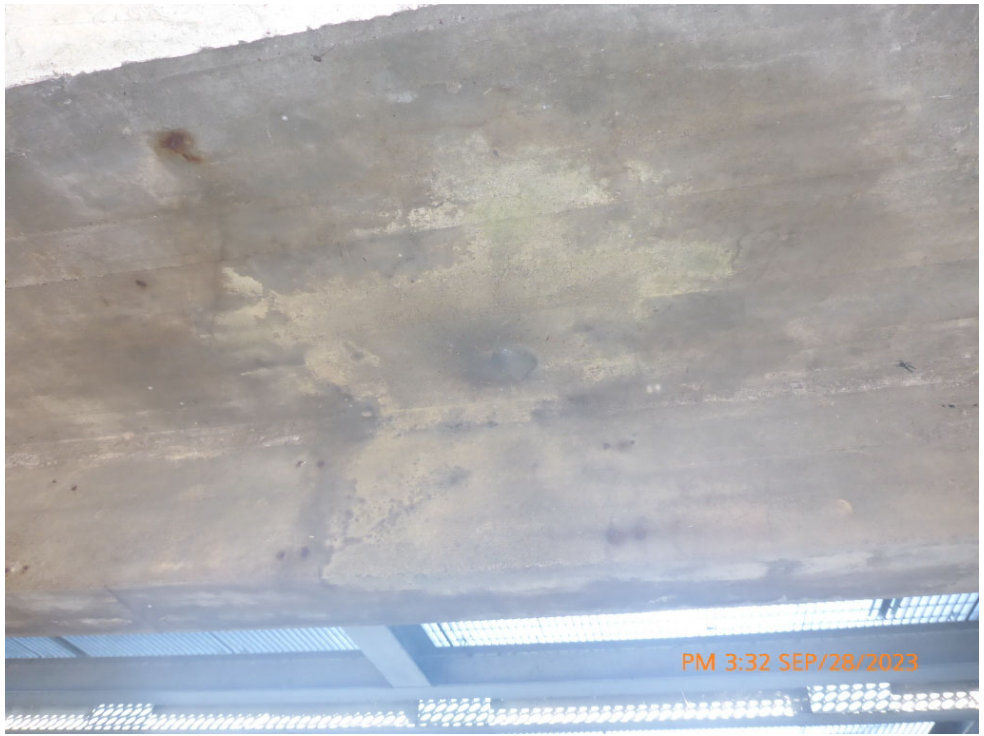
Comments: MISSING DECK DRAIN
Path: P:\McKellar\2023\P1080305.jpg

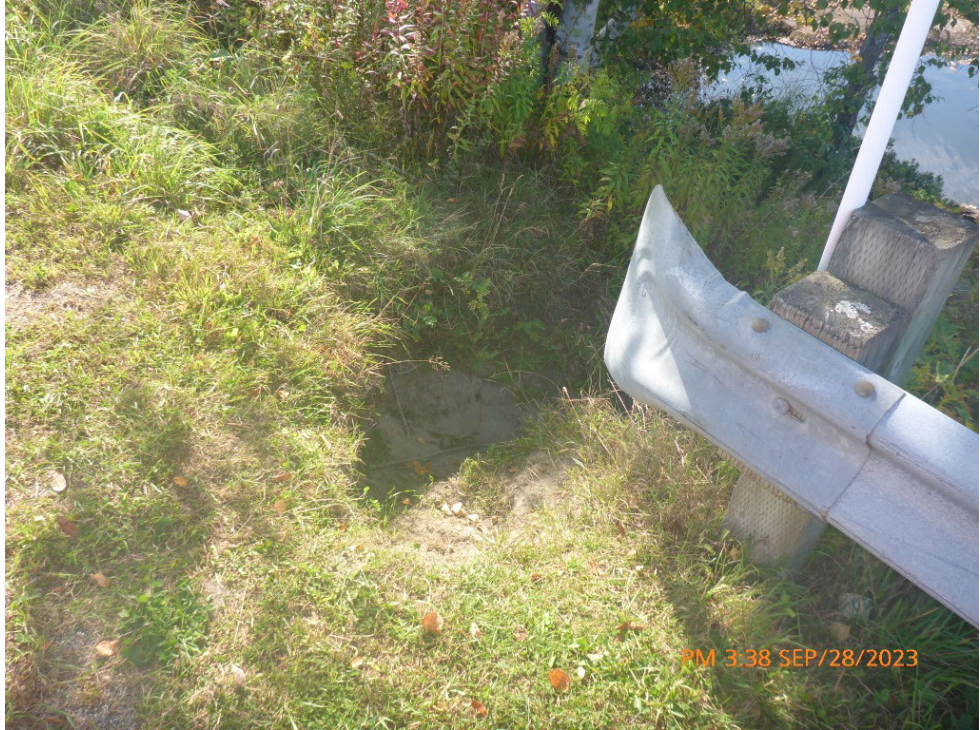
Comments: SEVERE EROSION OF ROADWAY EMBANKMENT SOUTHWEST QUADRANT

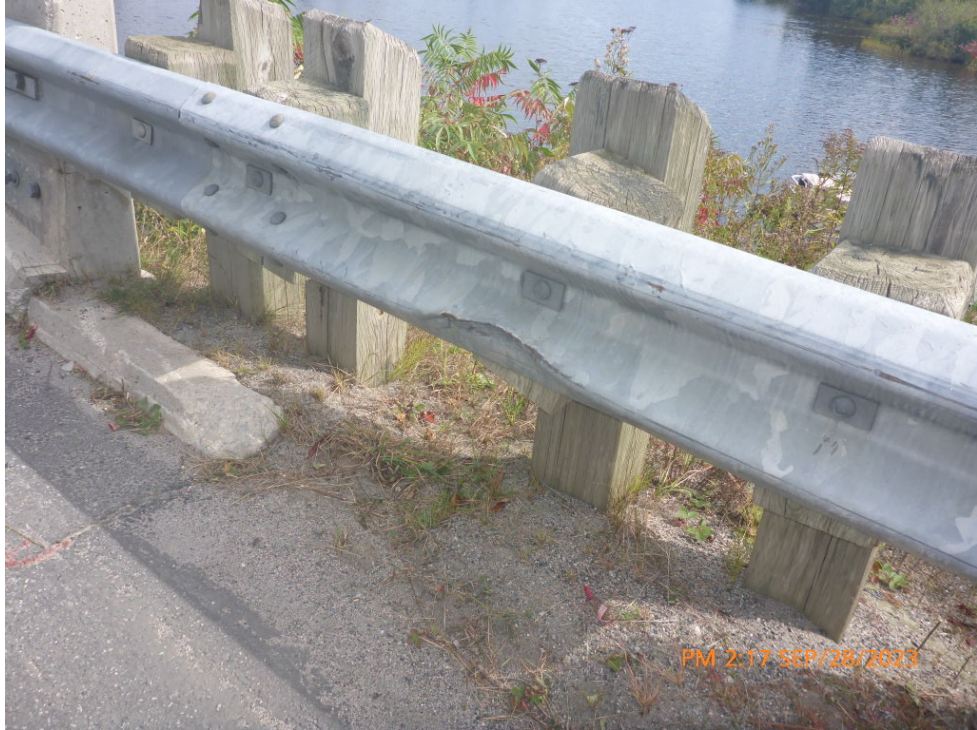
Comments: COLLISION DAMAGE APPROACH GUIDE RAIL

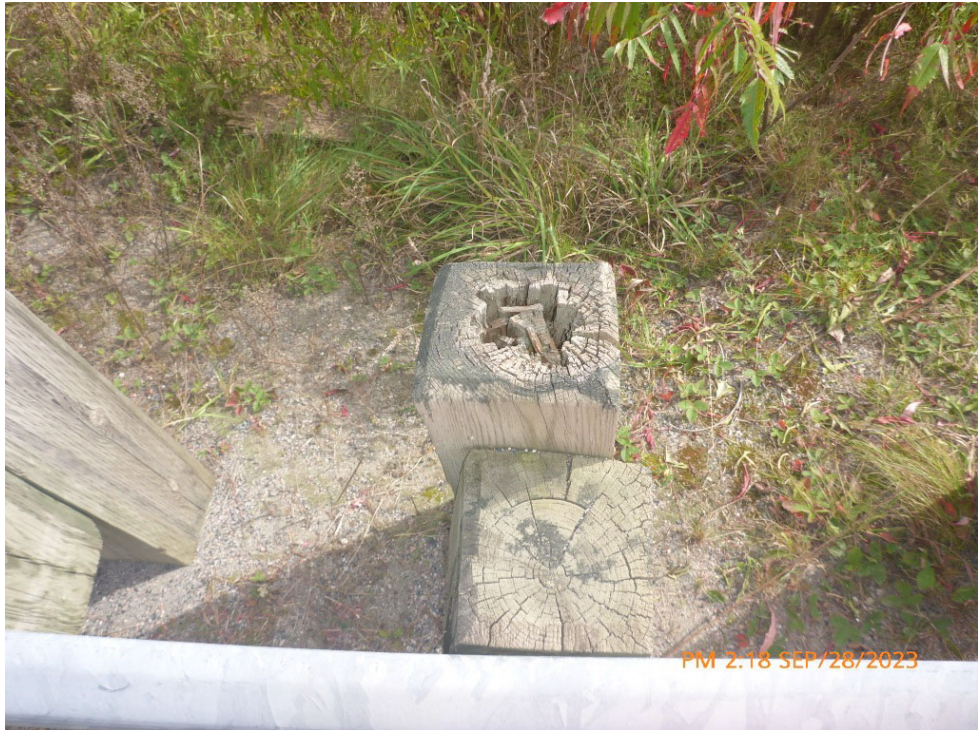
Comments: CENTRE ROT OF TIMBER GUIDE RAIL POST

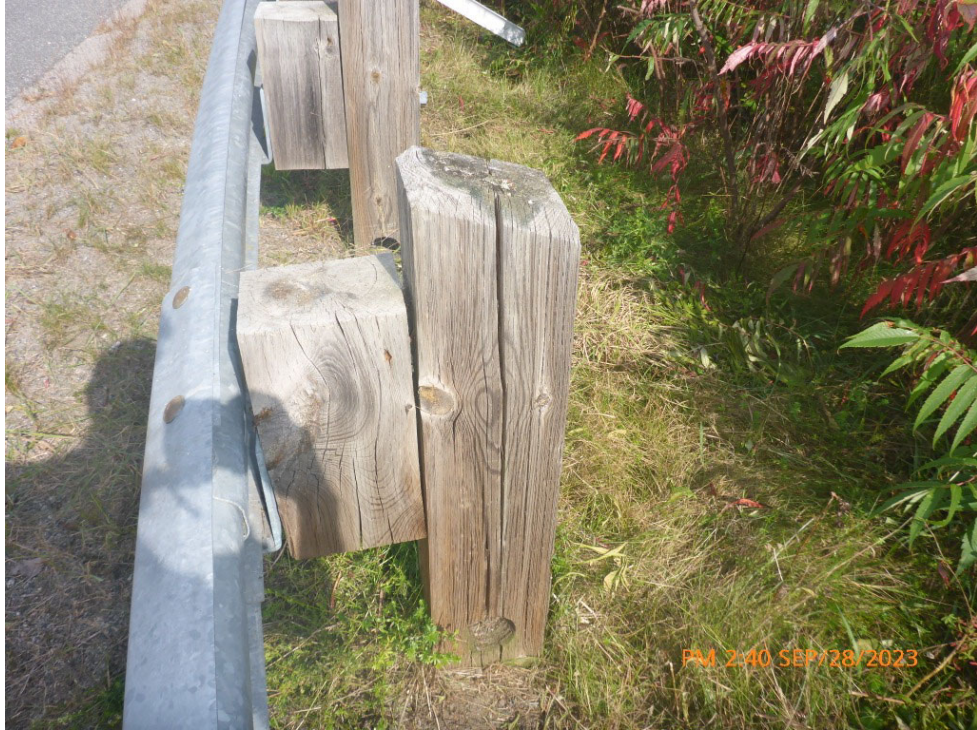
Comments: MEDIUM CHECK IN TIMBER GUIDE RAIL POST

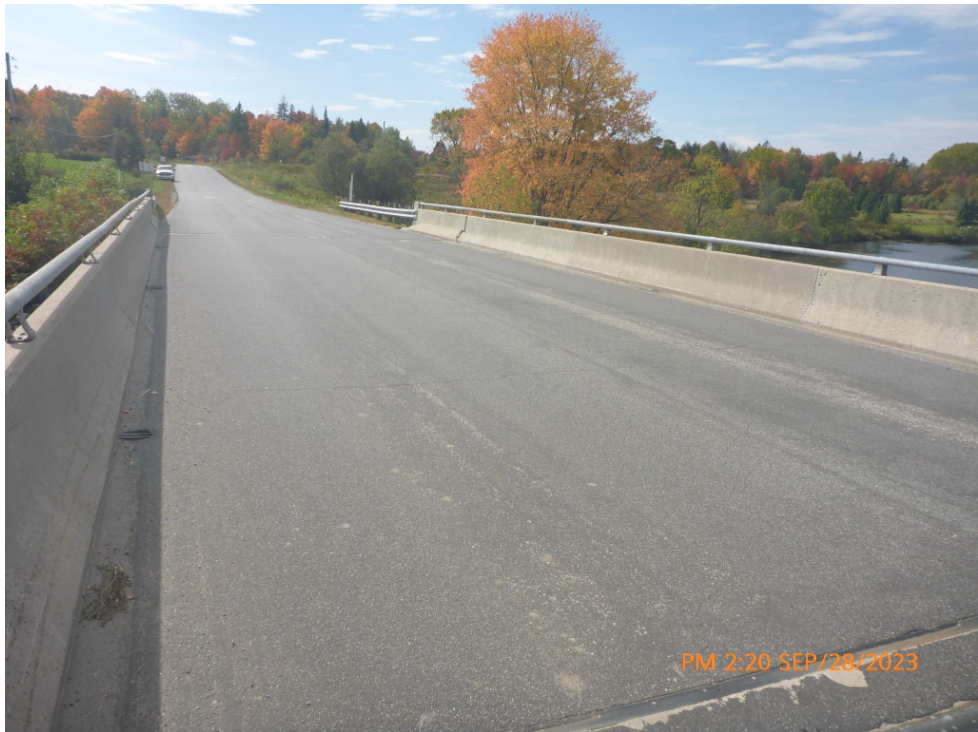
Comments: TYPICAL WEARING SURFACE

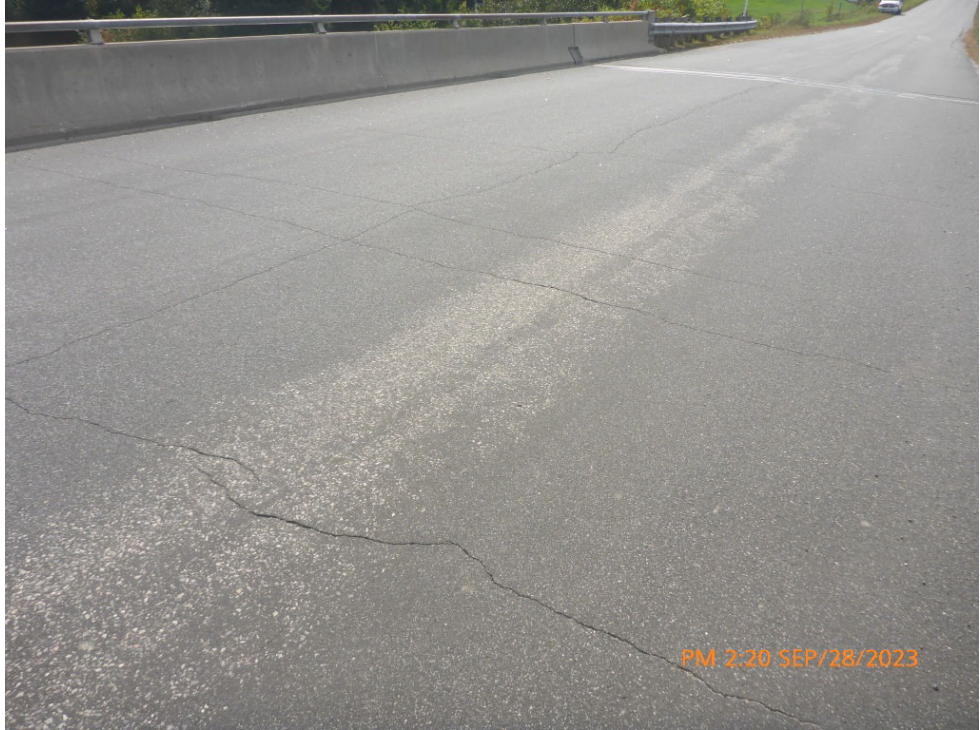
Comments: NARROW CRACKS IN DECK WEARING SURFACE

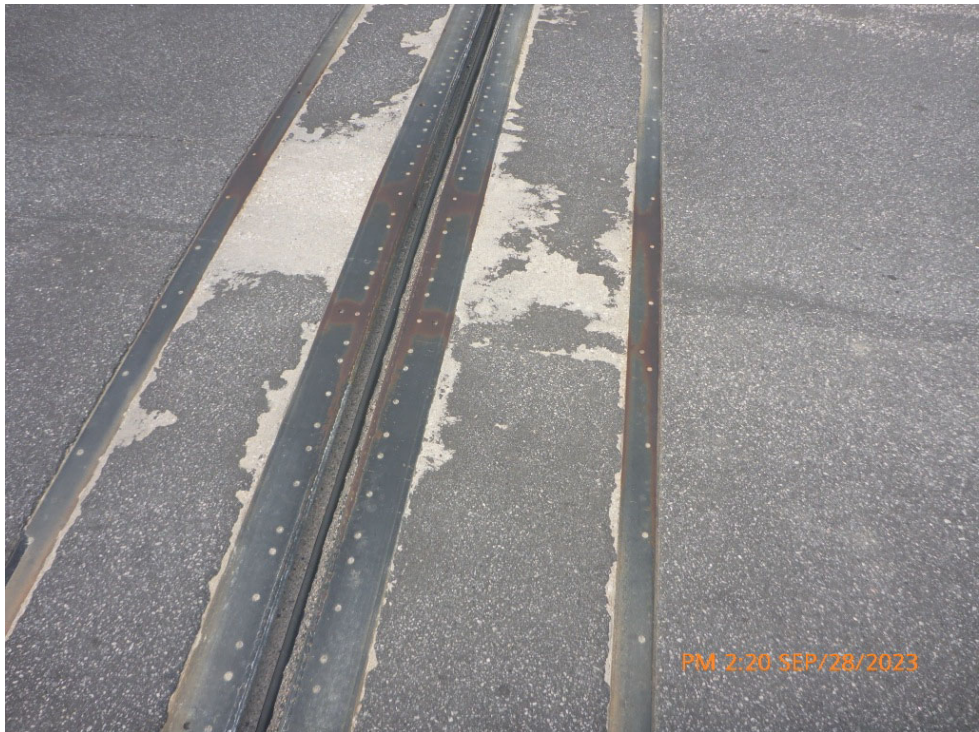
Comments: LIGHT CORROSION OF ARMOURING ANGLE

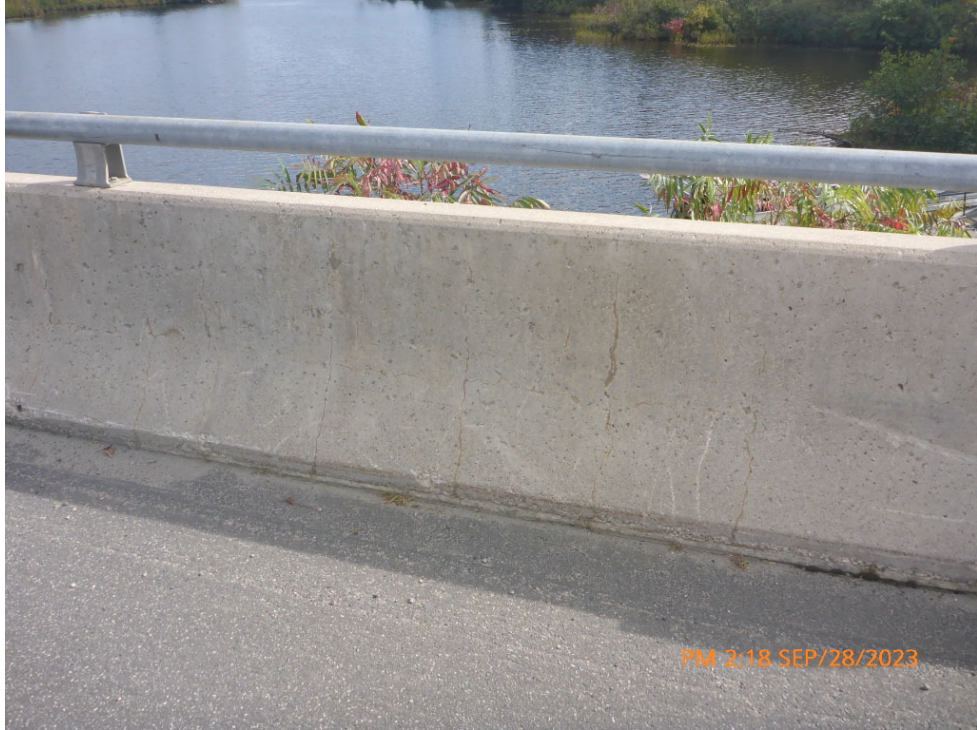
Comments: NARROW STAINED CRACKS INTERIOR PARAPET WALL

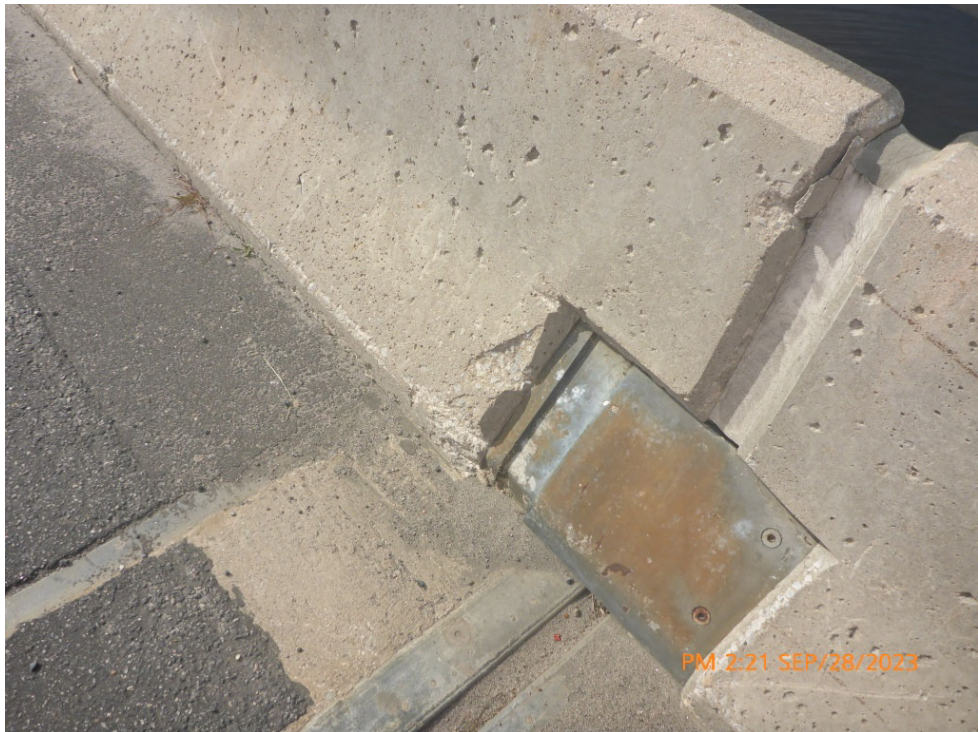
Comments: LIGHT ABRASION INTERIOR PARAPET WALL

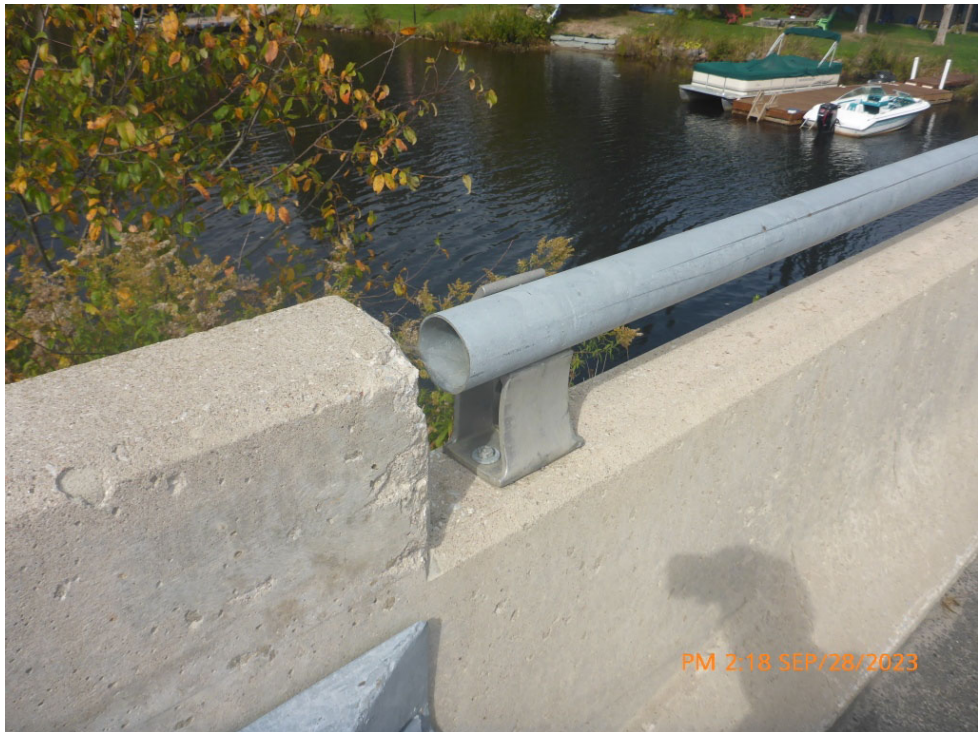
Comments: MISSING END CAP SOUTHWEST QUADRANT

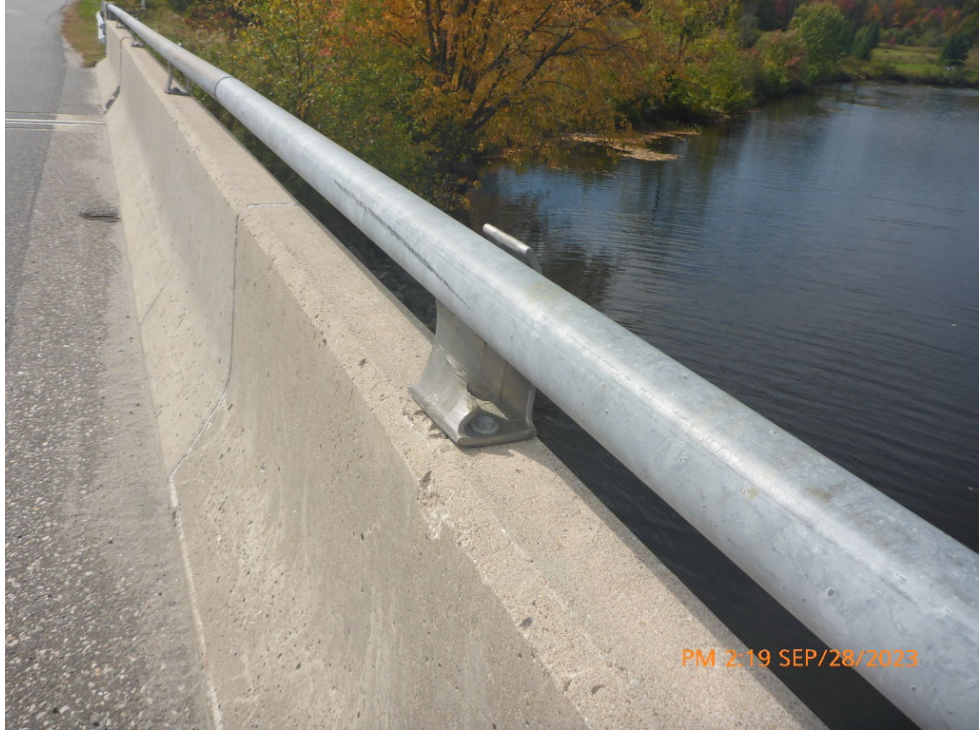
Comments: COLLISION DAMAGE TO HANDRAIL POST
Path: P:\McKellar\2023\P1080242.jpg

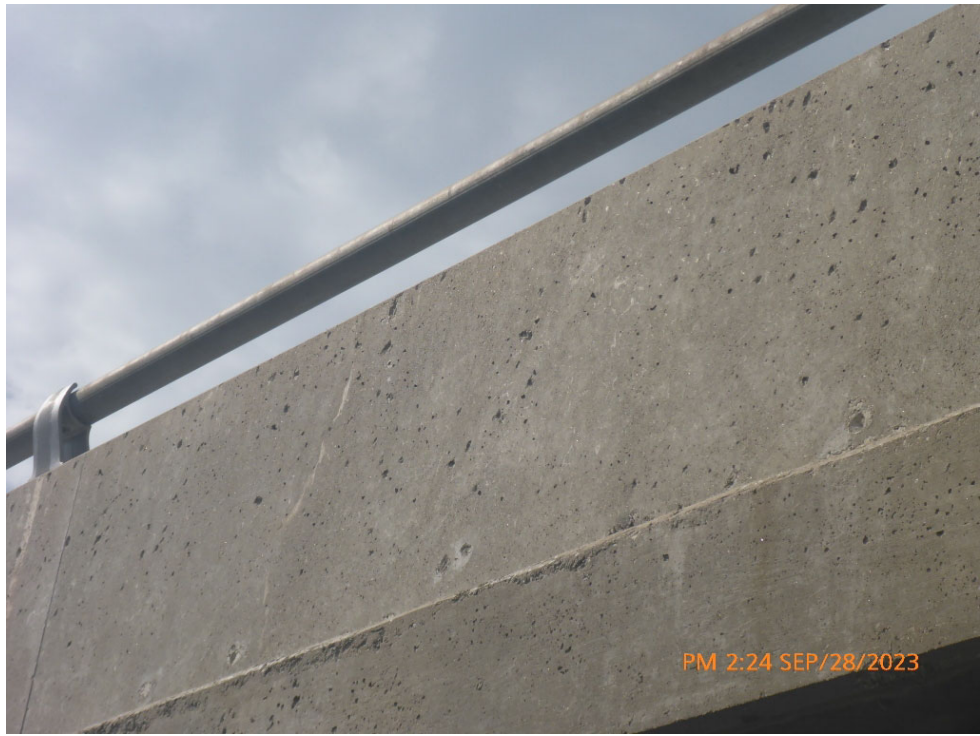
Comments: NARROW STAINED CRACK EXTERIOR PARAPET WALL
Path: P:\McKellar\2023\P1080251.jpg

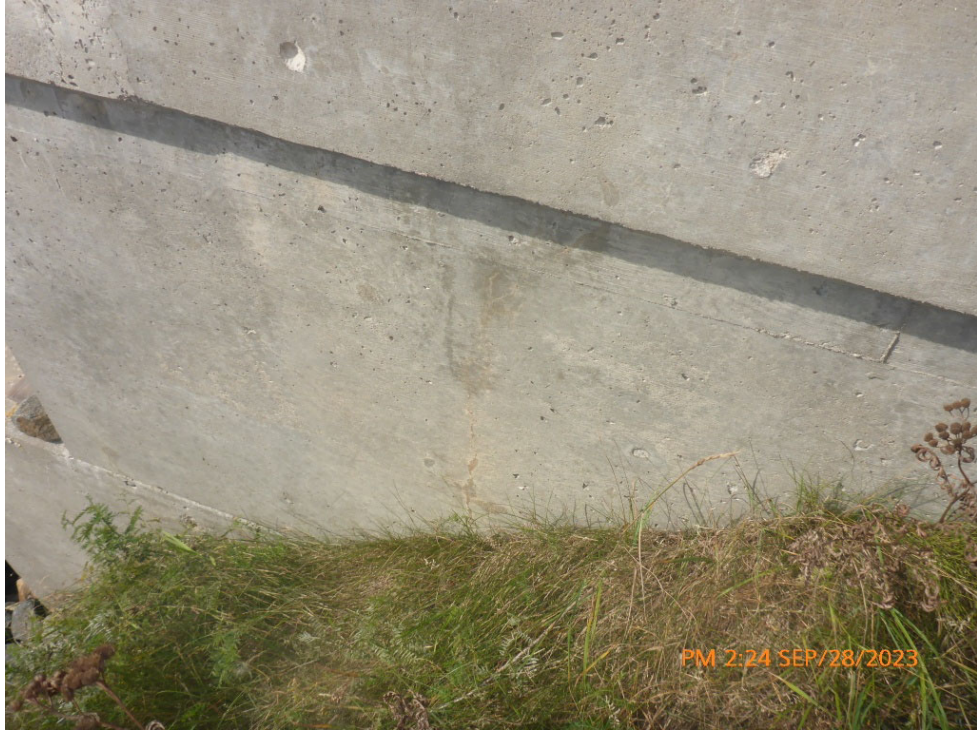
Comments: NARROW STAINED CRACK IN WINGWALL

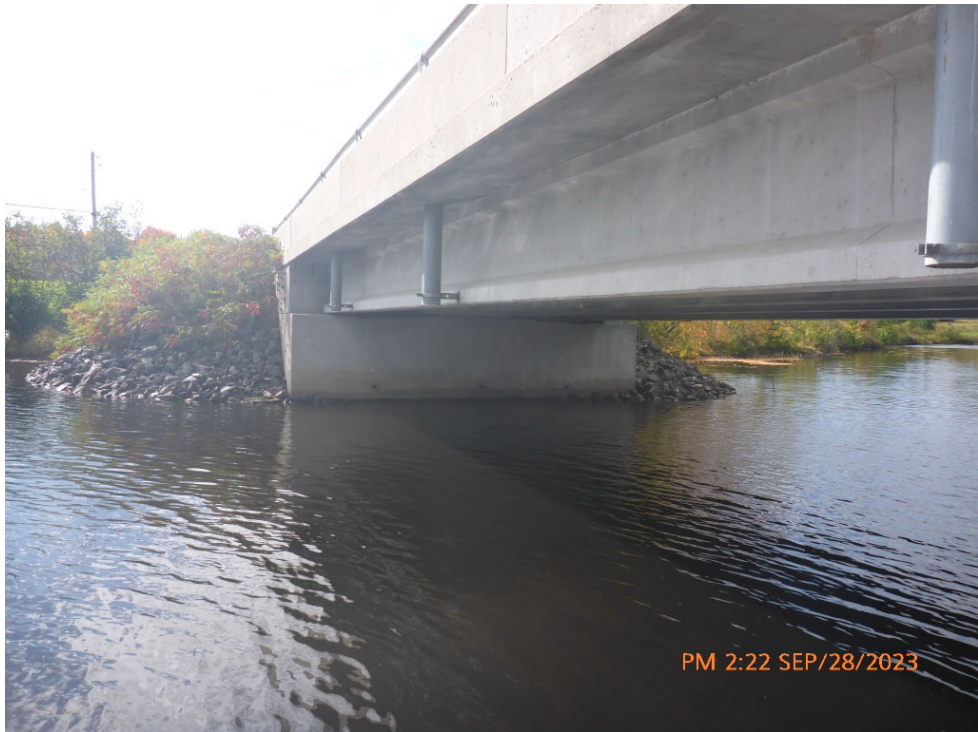
Comments: TYPICAL SOUTH ABUTMENT

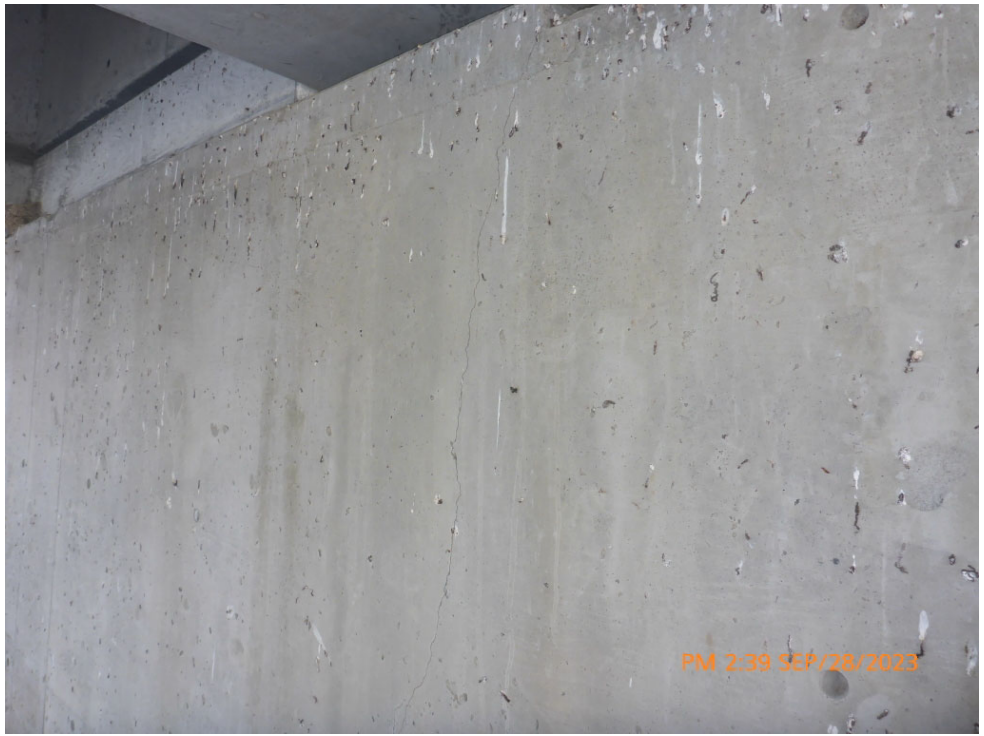
Comments: MEDIUM VERTICAL CRACK SOUTH ABUTMENT
