CORPORATION OF THE TOWNSHIP OF MCKELLAR

December 5, 2023 – 6:30 p.m.

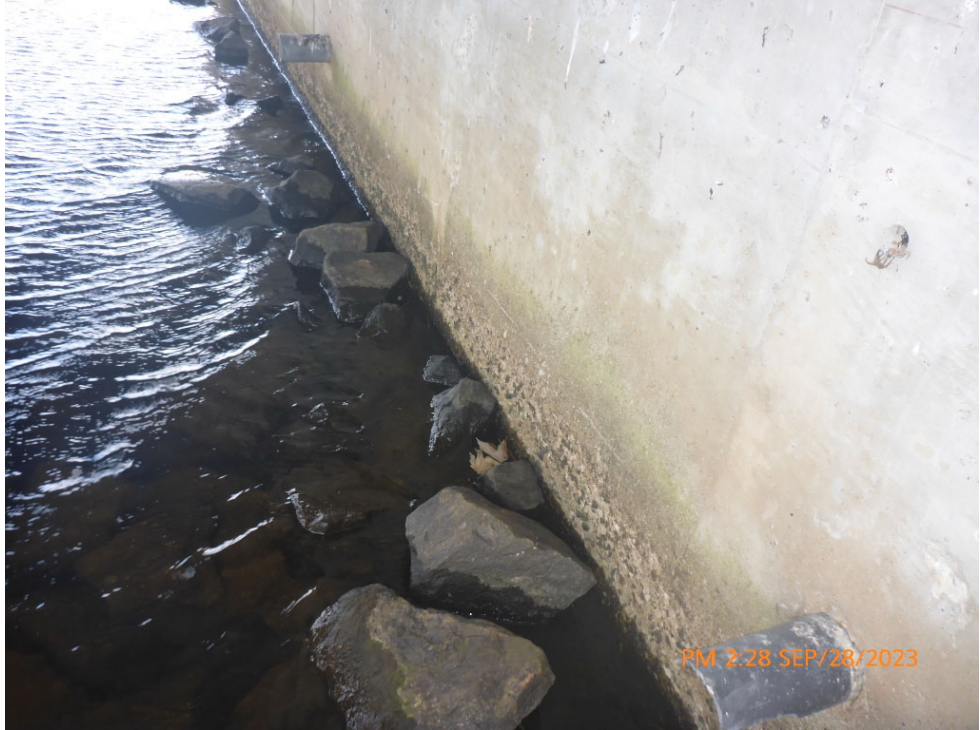
Comments: LIGHT EROSION OF SOUTH ABUTMENT AT WATERLINE
Path: P:\McKellar\2023\P1080258.jpg

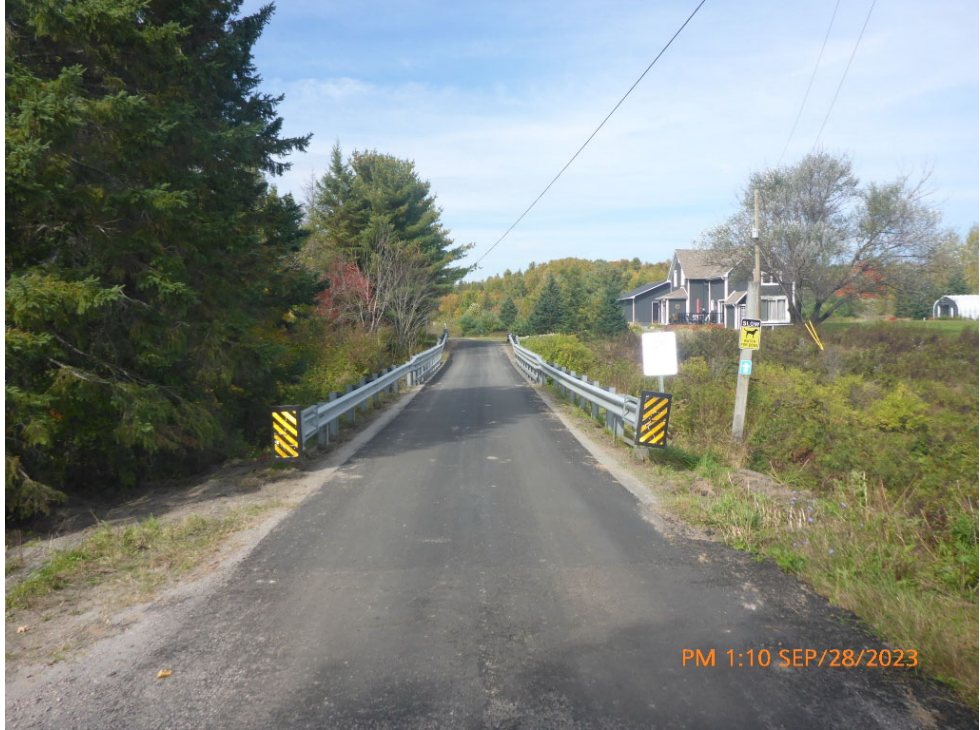
Comments: LOOKING NORTH AT BRIDGE
Path: P:\McKellar\2023\P1080206.jpg

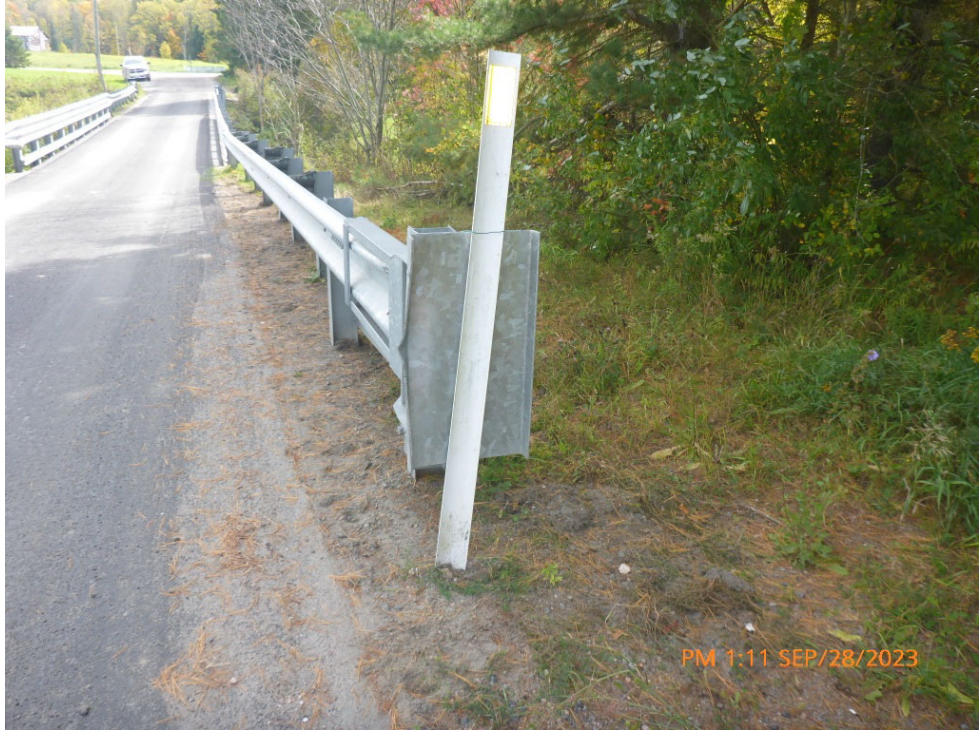
Comments: MISSING END TREATMENT HAZARD MARKER NW QUADRANT
Path: P:\McKellar\2023\P1080208.jpg

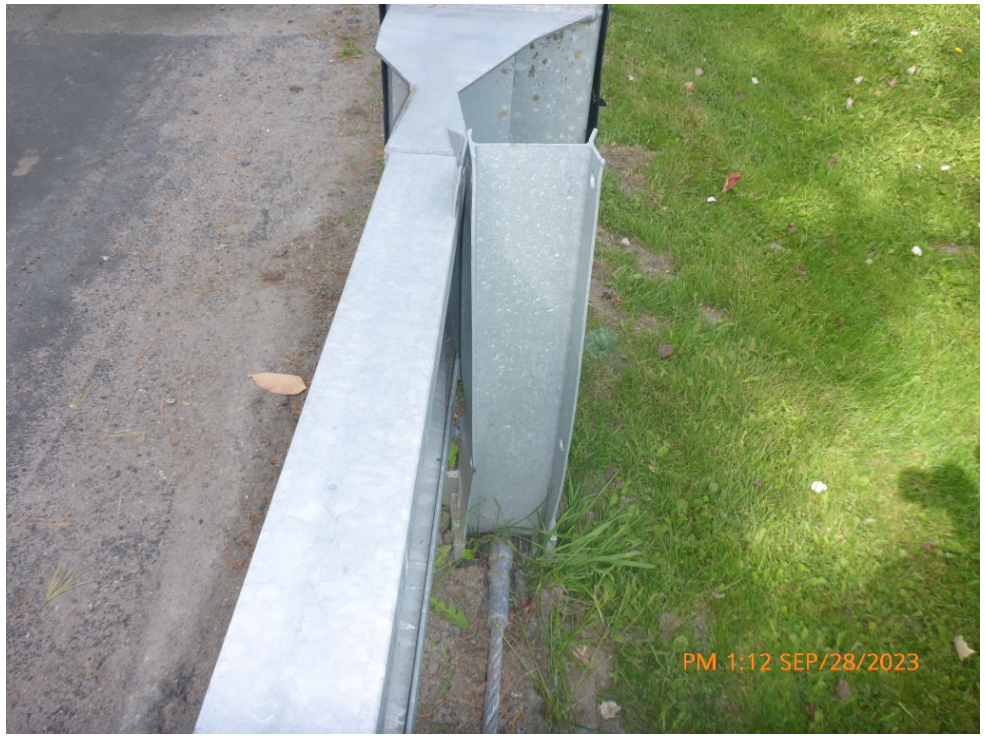
Comments: COLLISION DAMAGE NORTHEAST END TREATMENT POST
Path: P:\McKellar\2023\P1080209.jpg

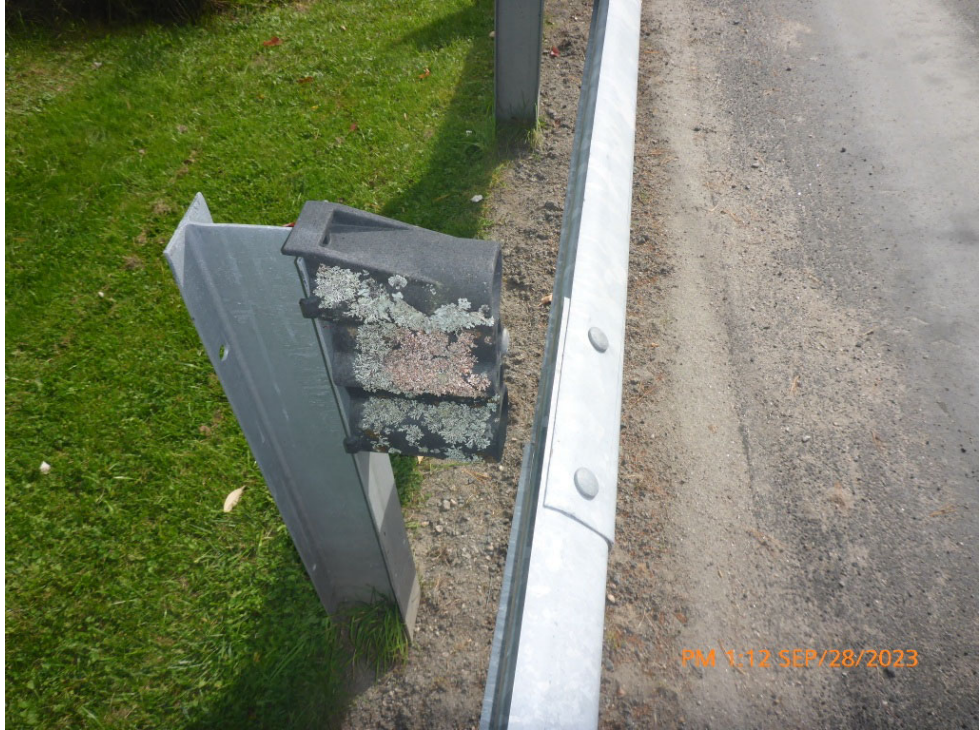
Comments: GUIDE RAIL DISCONNECTED GUIDE RAIL NORTH APPROACH

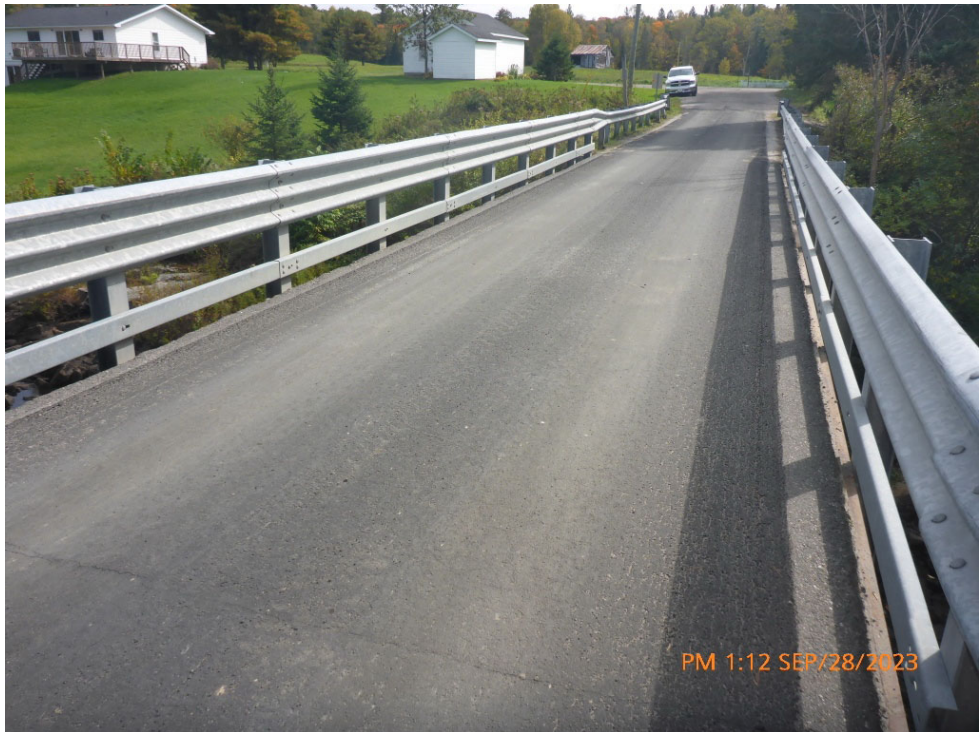
Comments: TYPICAL WEARING SURFACE

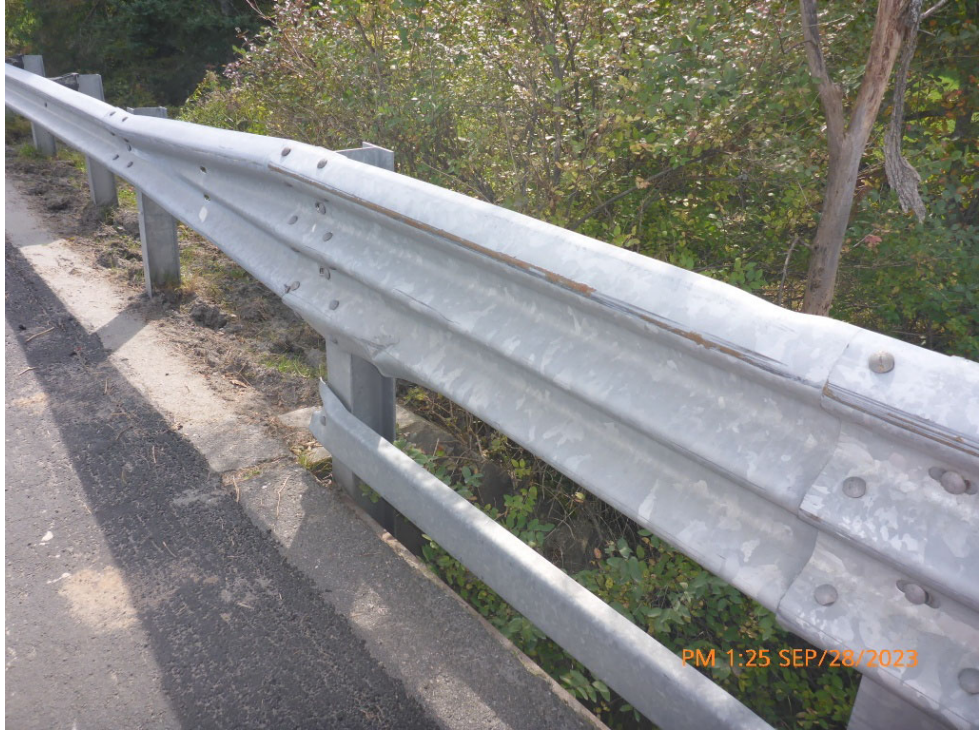
Comments: MINOR COLLISION DAMAGE THRIE BEAM GUIDE RAIL
Path: P:\McKellar\2023\P1080233.jpg

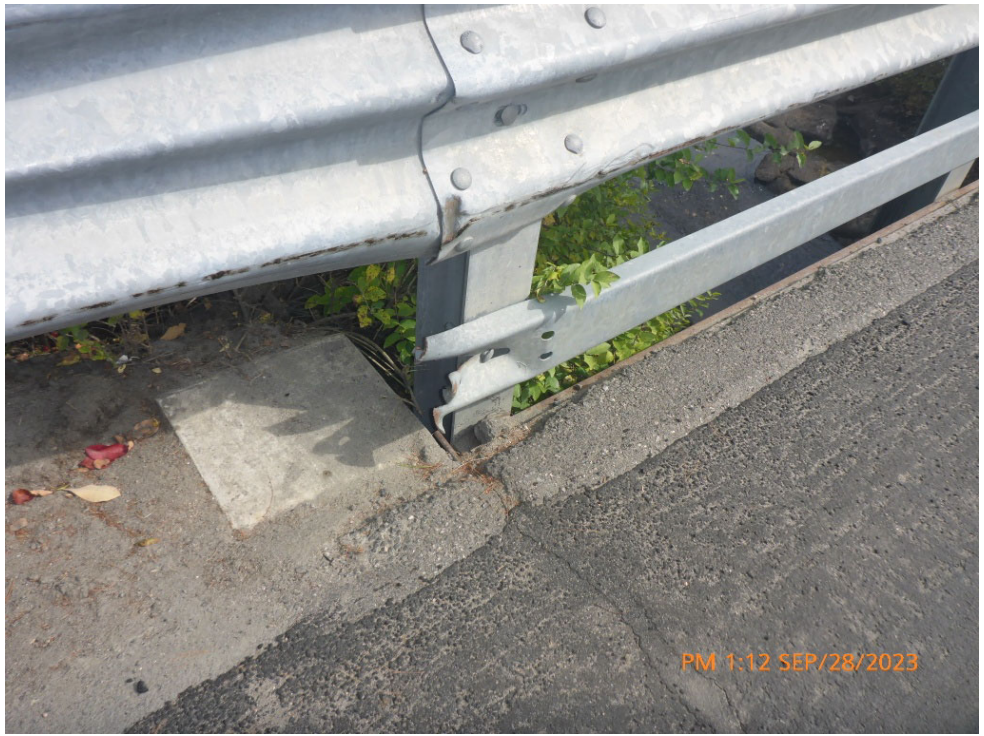
Comments: COLLISION DAMAGE GUIDE RAIL C-CHANNEL
Path: P:\McKellar\2023\P1080212.jpg

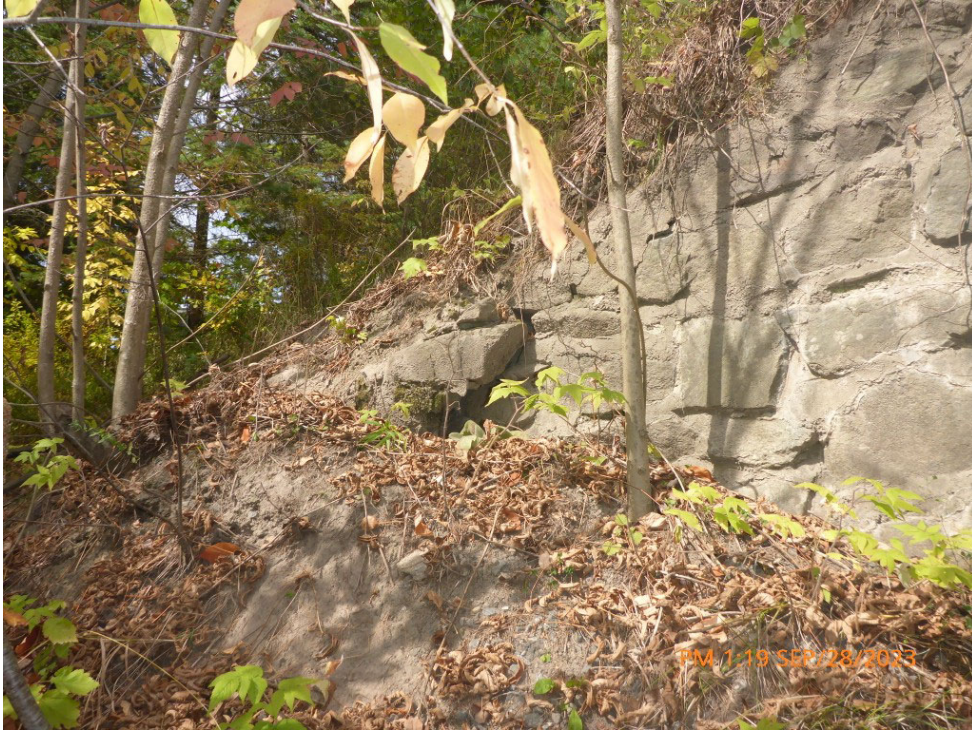
Comments: BROKEN SECTION OF NORTHWEST WINGWALL

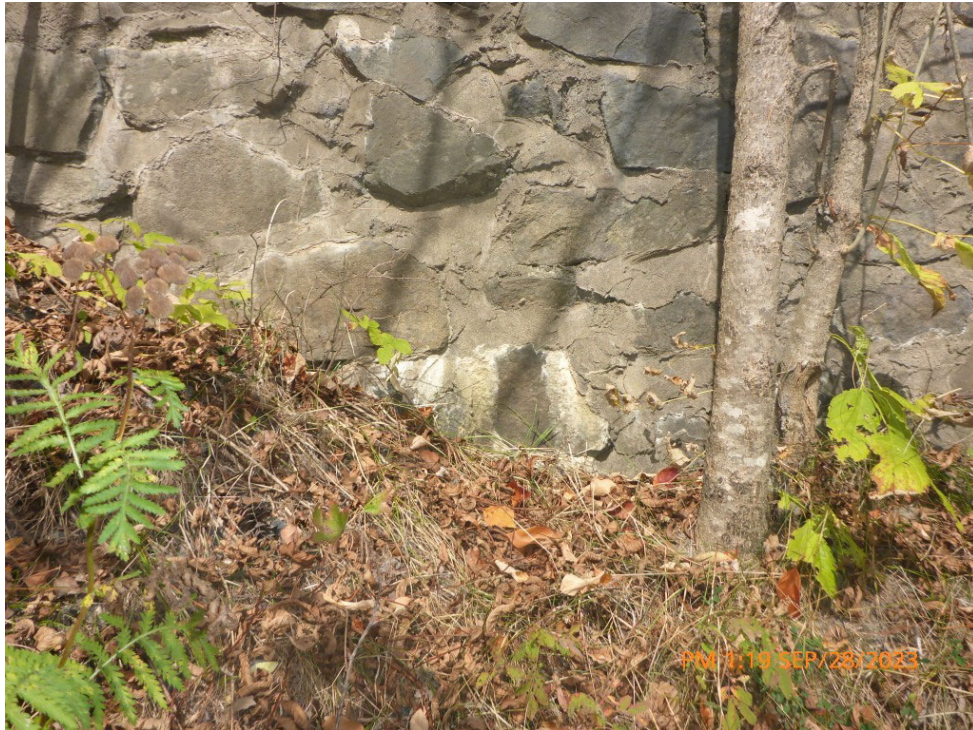
Comments: EFFLORESCENT STAINING NORTHWEST WINGWALL

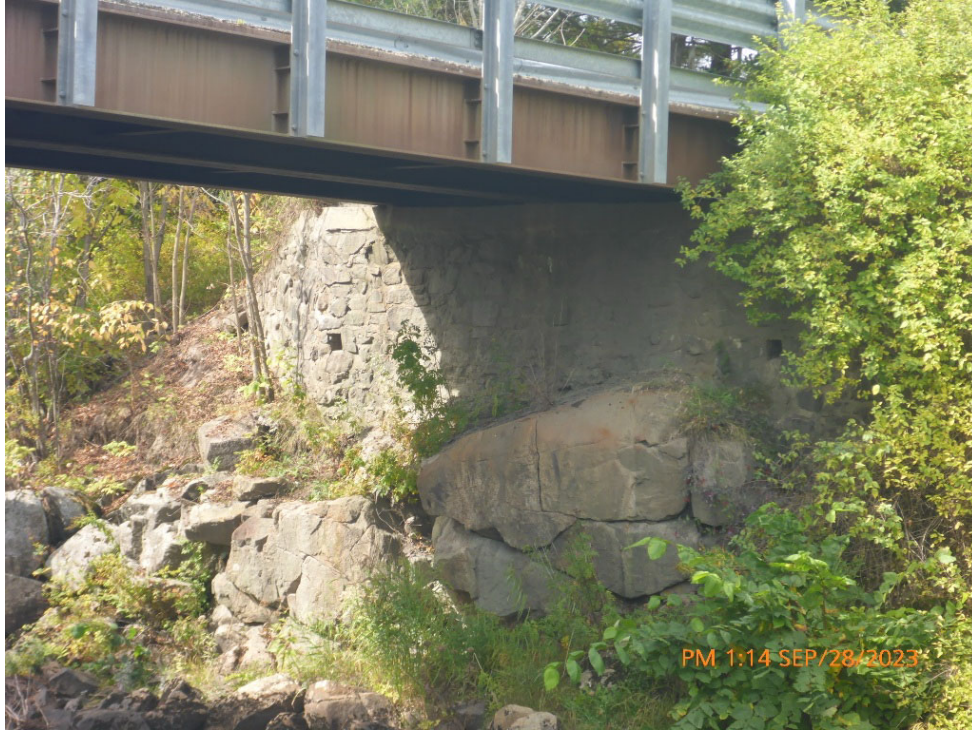
Comments: TYPICAL NORTH ABUTMENT
Path: P:\McKellar\2023\P1080215.jpg

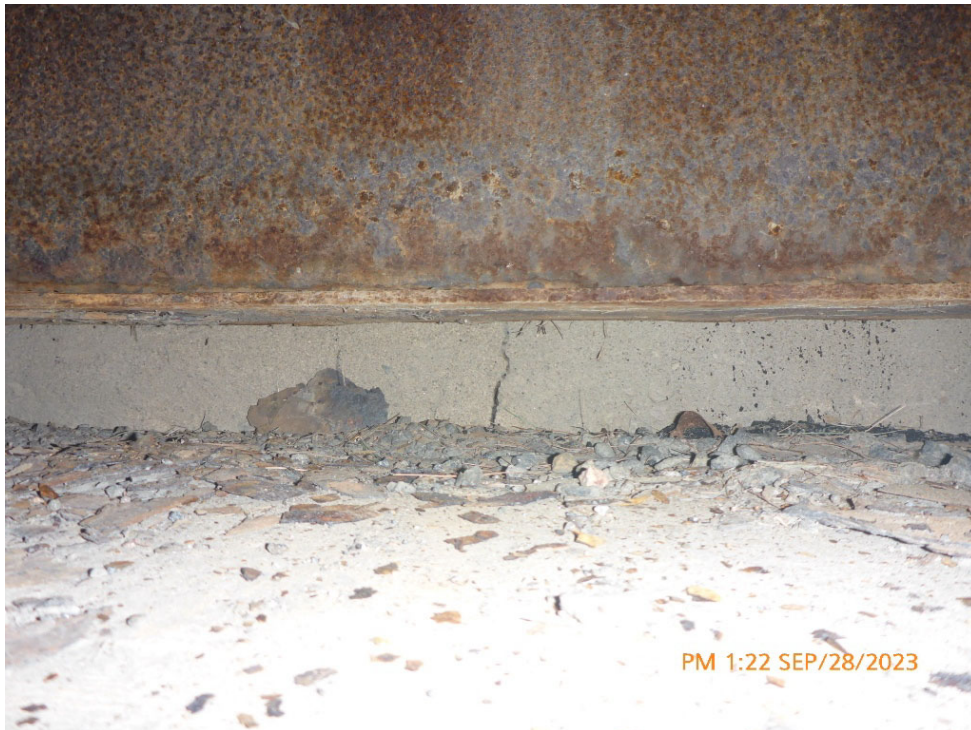
Comments: WIDE VERTICAL CRACK NORTH BALLAST WALL
Path: P:\McKellar\2023\P1080230.jpg

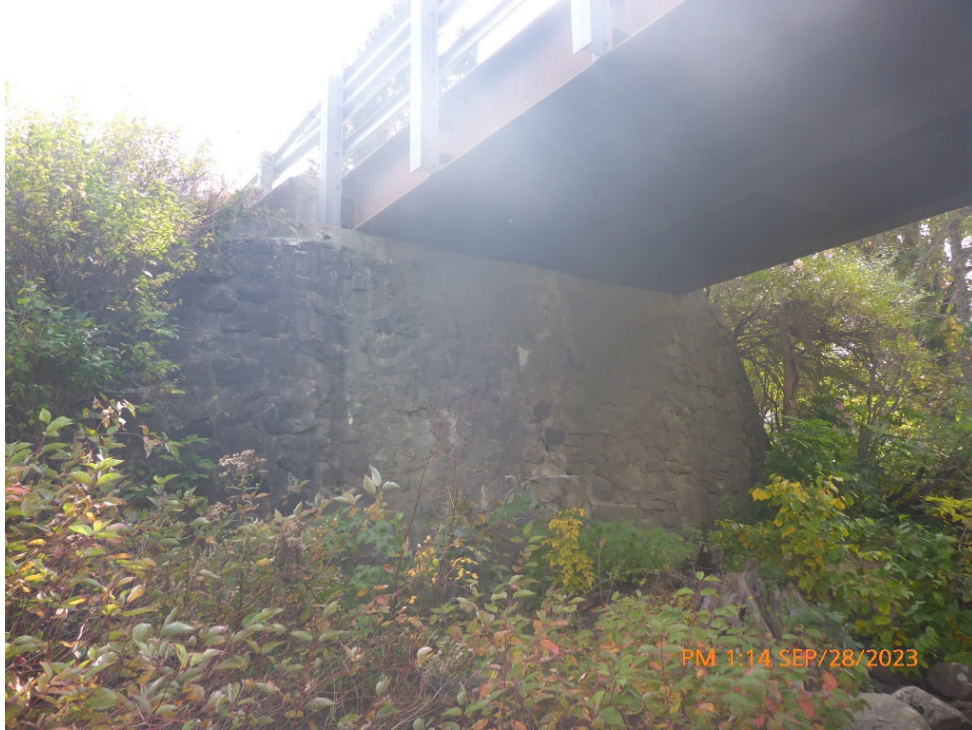
Comments: TYPICAL SOUTH ABUTMENT
Path: P:\McKellar\2023\P1080216.jpg

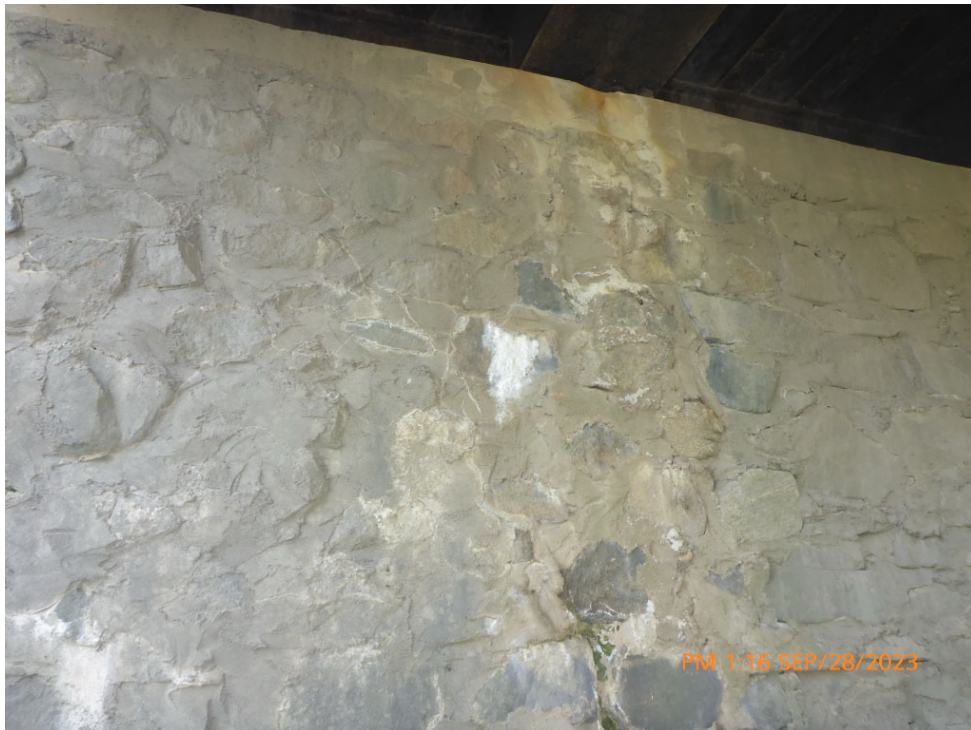
Comments: EFFLORESCENT STAINING SOUTH ABUTMENT
Path: P:\McKellar\2023\P1080222.jpg

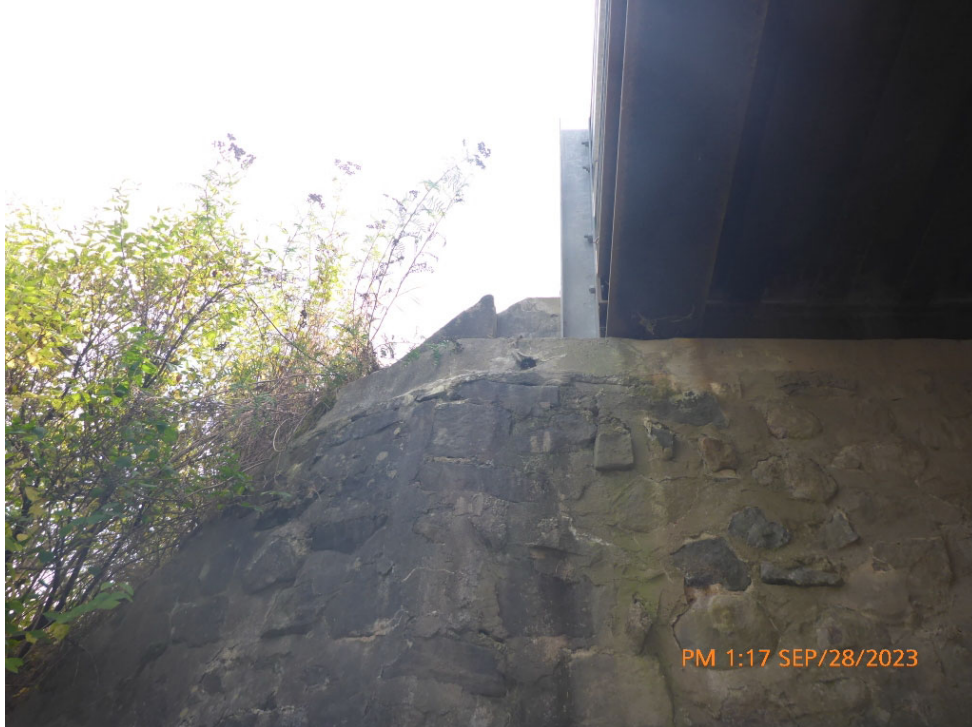
Comments: EFFLORESCENT STAINING SOUTH ABUTMENT CAP
Path: P:\McKellar\2023\P1080223.jpg

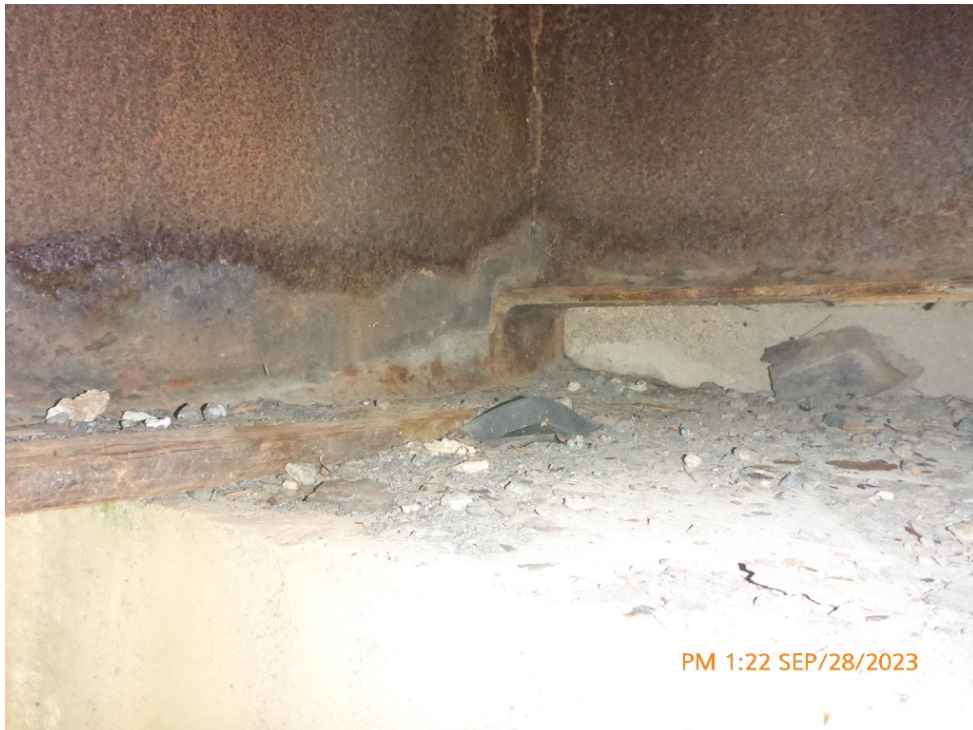
Comments: DISPLACED ELASTOMERIC BEARING PAD NORTH ABUTMENT
Path: P:\McKellar\2023\P1080231.jpg

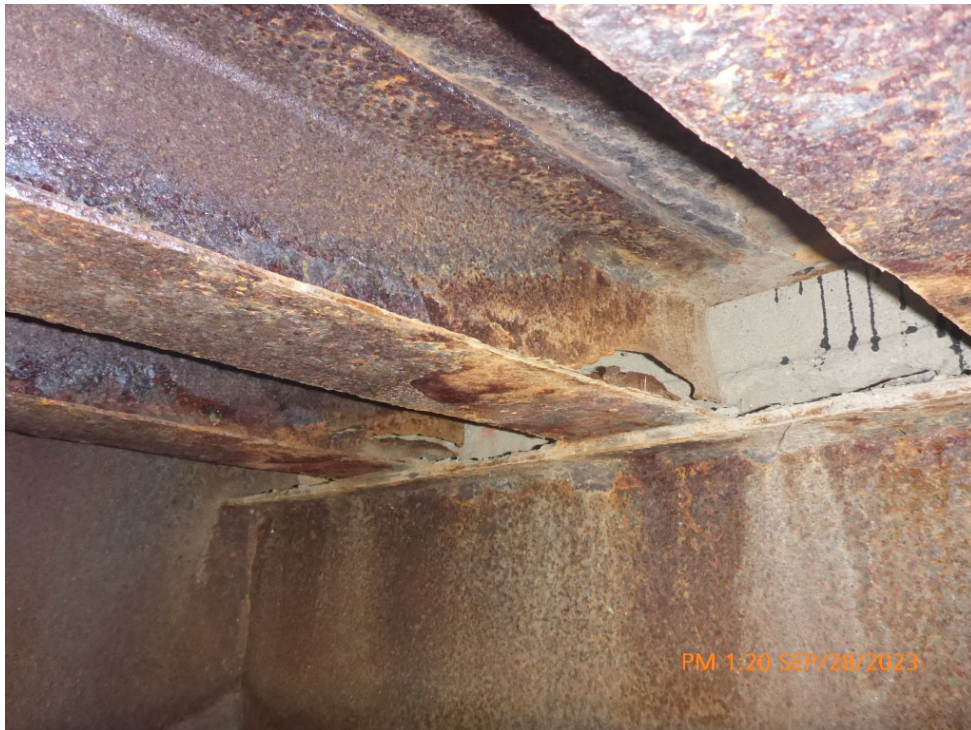
Comments: SEVERE CORROSION WITH SECTION LOSS FLOOR BEAM NORTH ABUTMENT
Path: P:\McKellar\2023\P1080229.jpg

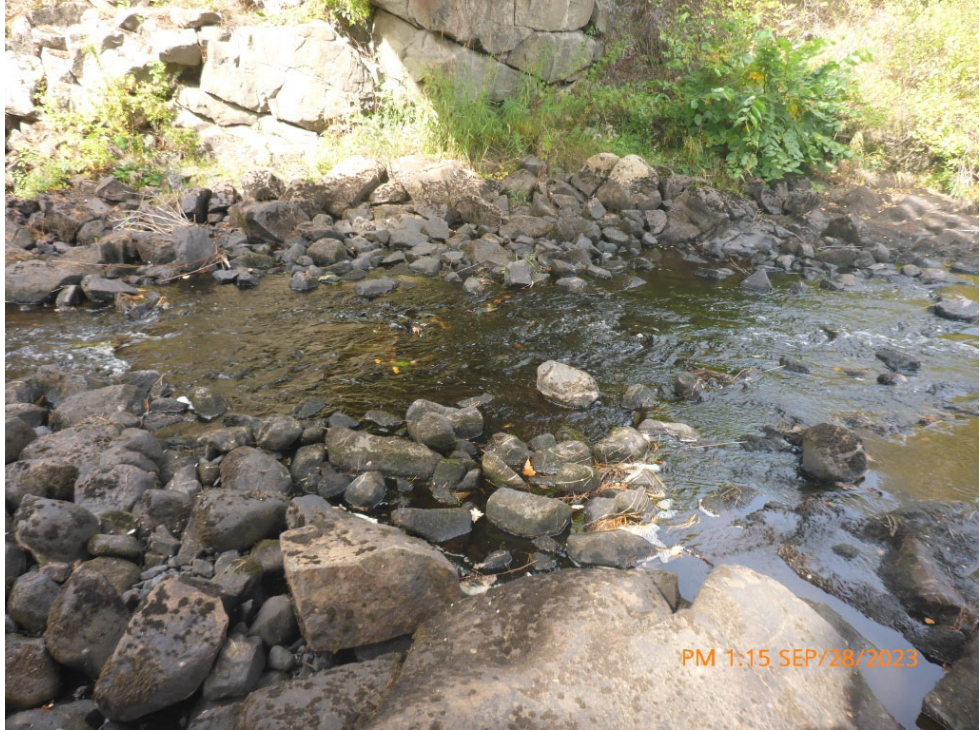
Comments: WATERCOURSE UNDER BRIDGE
Path: P:\McKellar\2023\P1080218.jpg

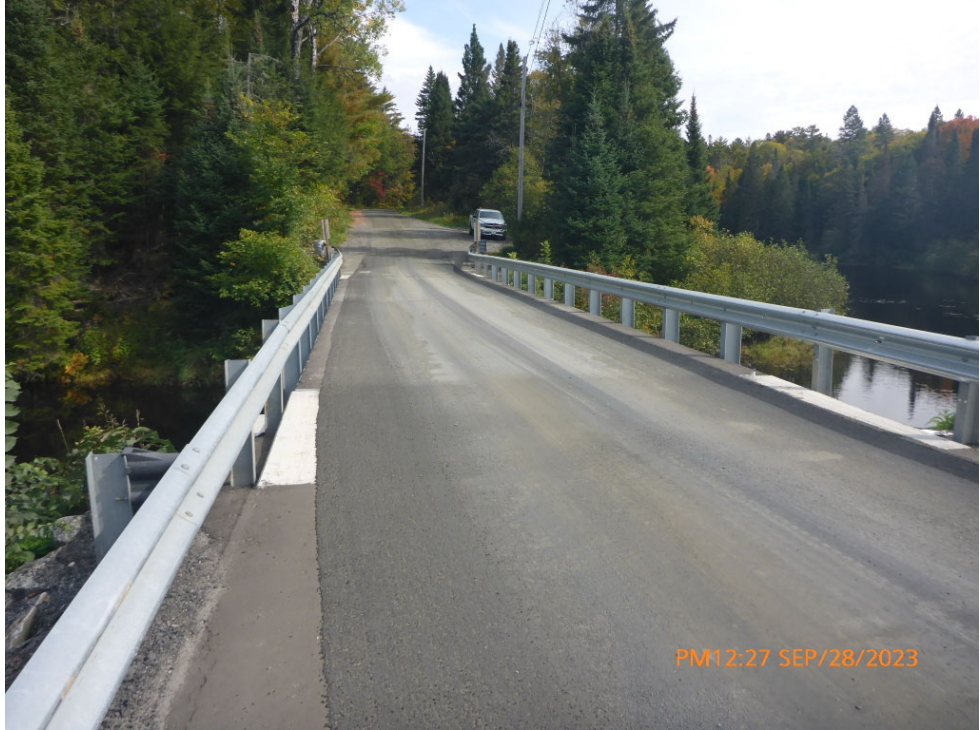
Comments: TYPICAL WEARING SURFACE
Path: P:\McKellar\2023\P1080188.jpg

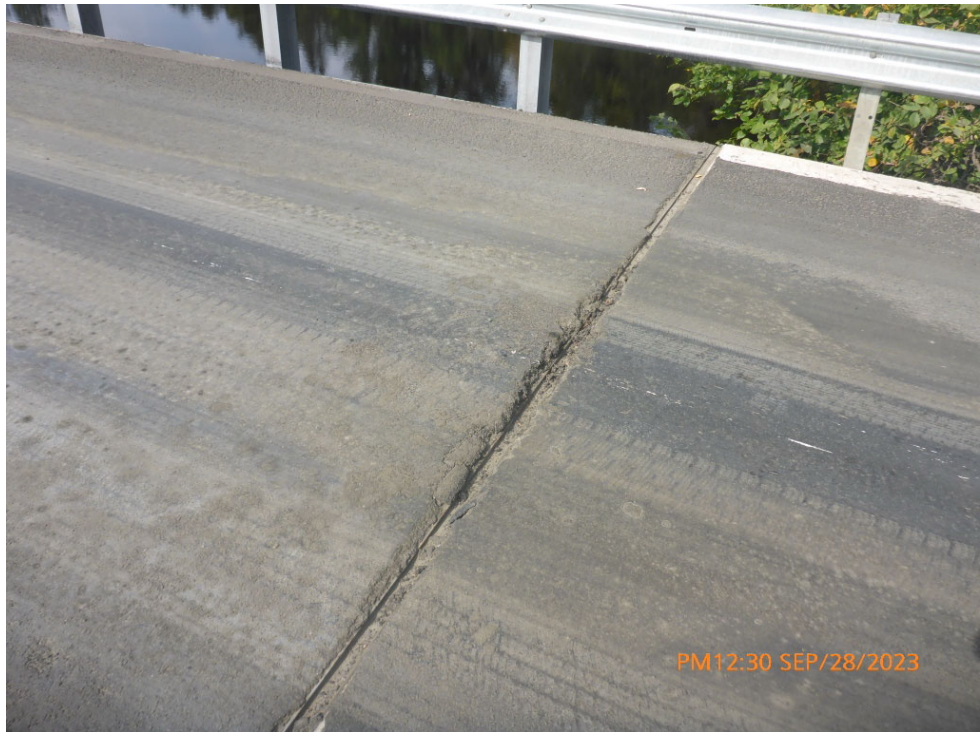
Comments: MINOR DETERIORATION OF ASPHALT AT DECK END
Path: P:\McKellar\2023\P1080188.jpg

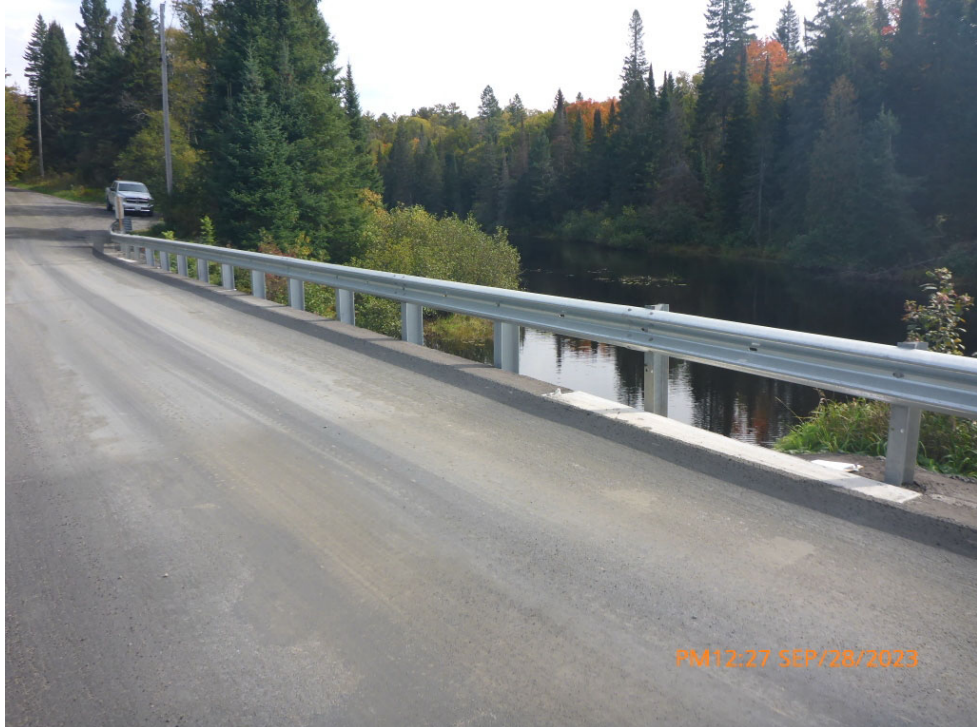
Comments: NEW GUIDE RAIL INSTALLED OVER DECK

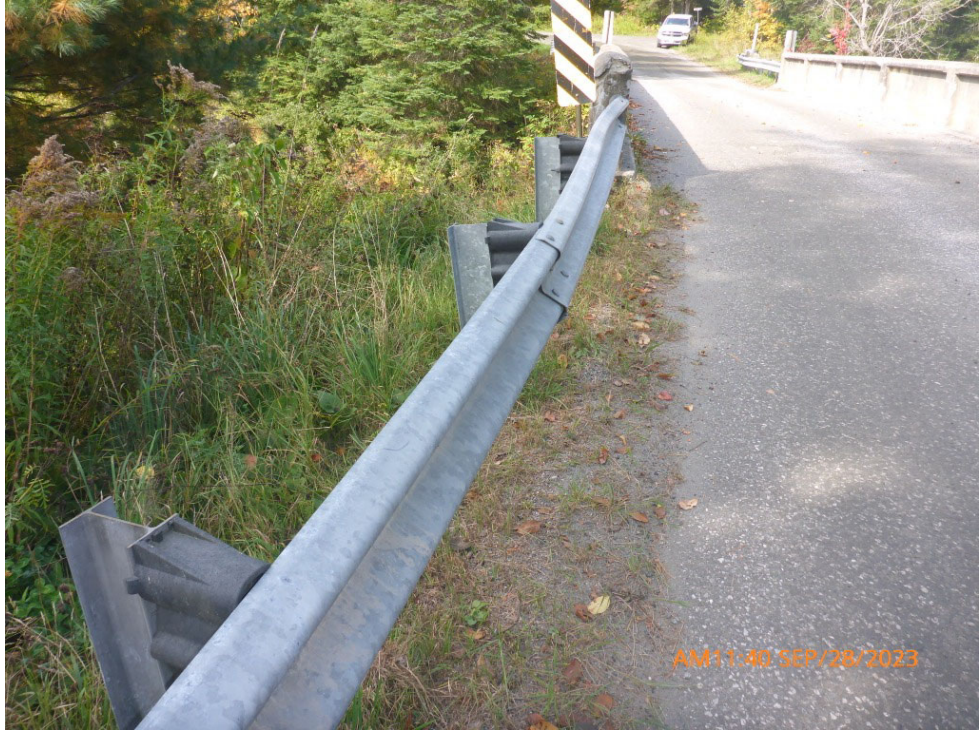
Comments: MINOR COLLISION DAMAGE GUIDE RAIL
Path: P:\McKellar\2023\P1080157.jpg

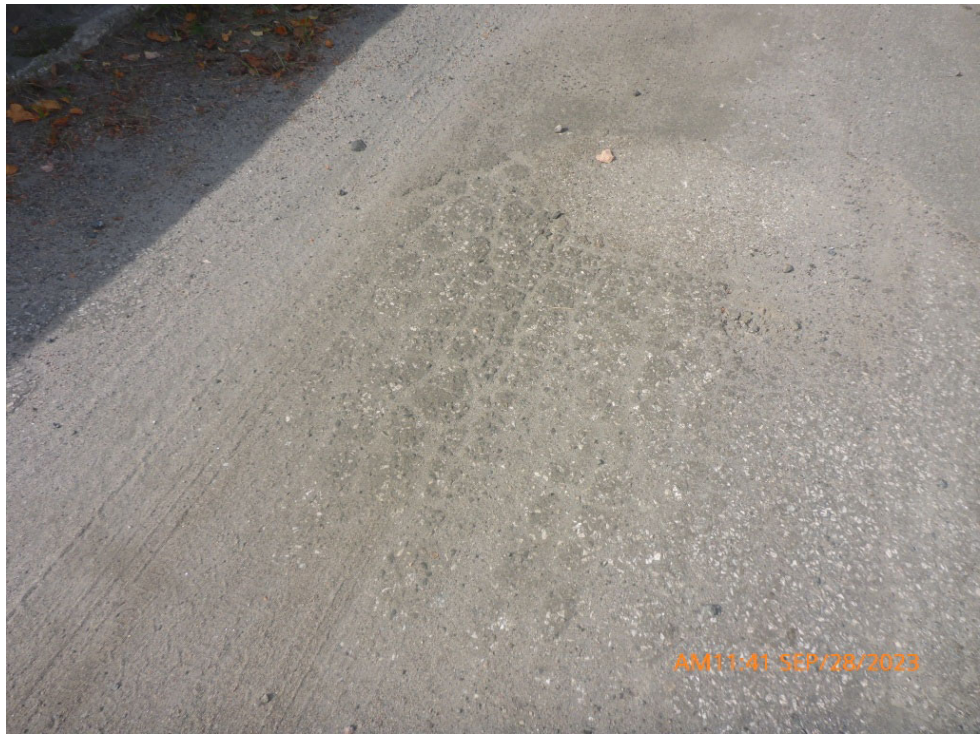
Comments: SEVERE MAP CRACKING APPROACH WEARING SURFACE
Path: P:\McKellar\2023\P1080158.jpg

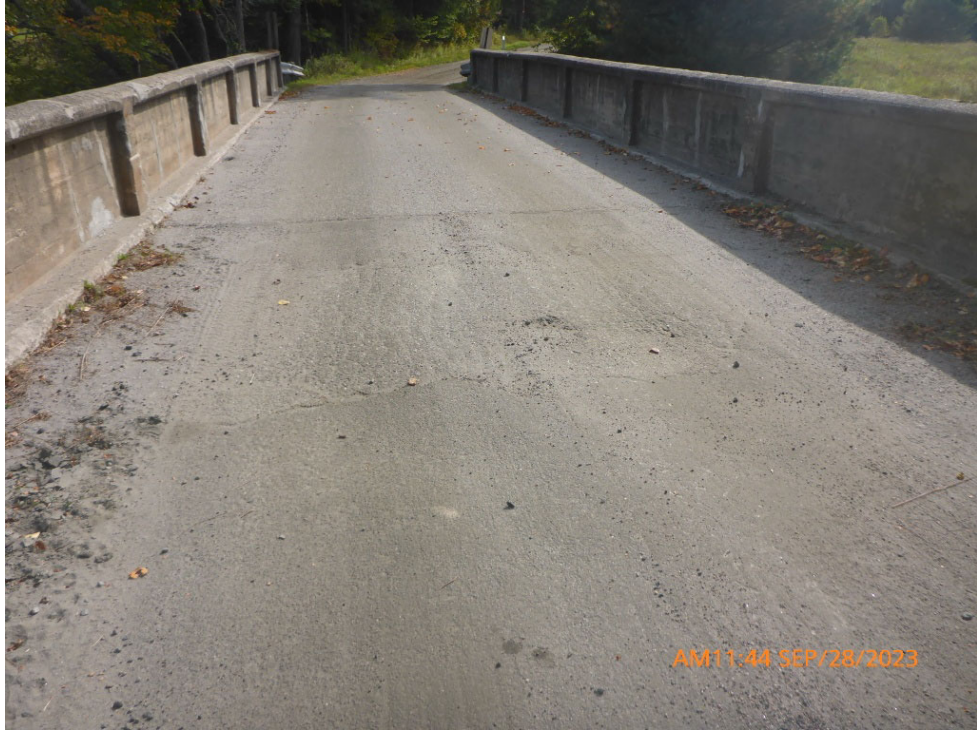
Comments: SETTLEMENT OF WEST APPROACH

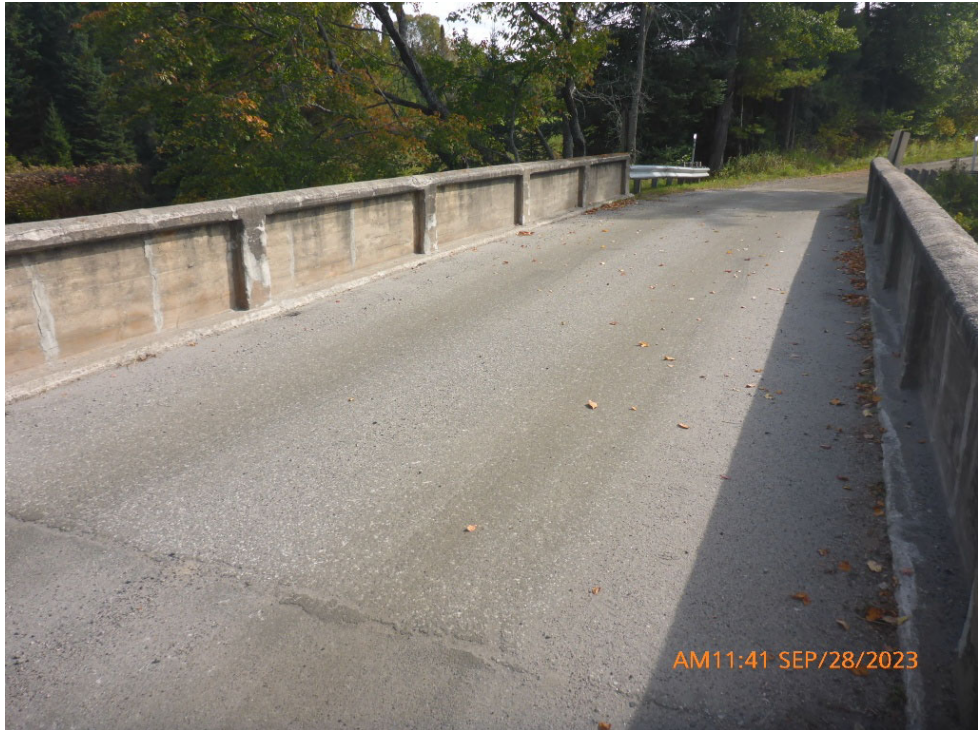
Comments: TYPICAL DECK WEARING SURFACE

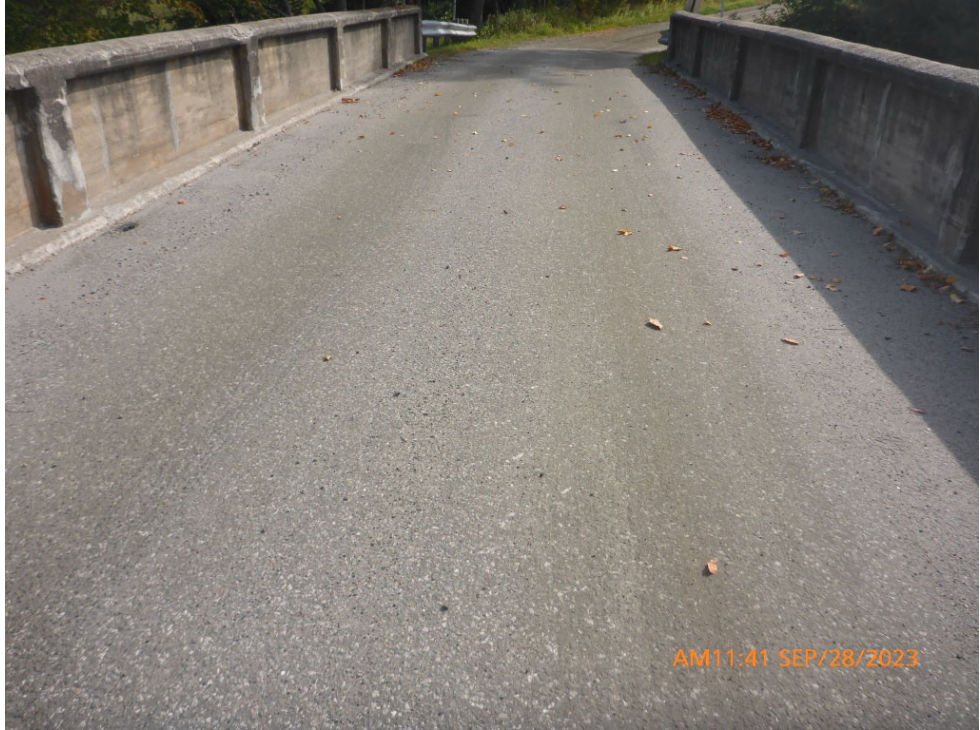
Comments: LIGHT FLUSHING OF DECK WEARING SURFACE

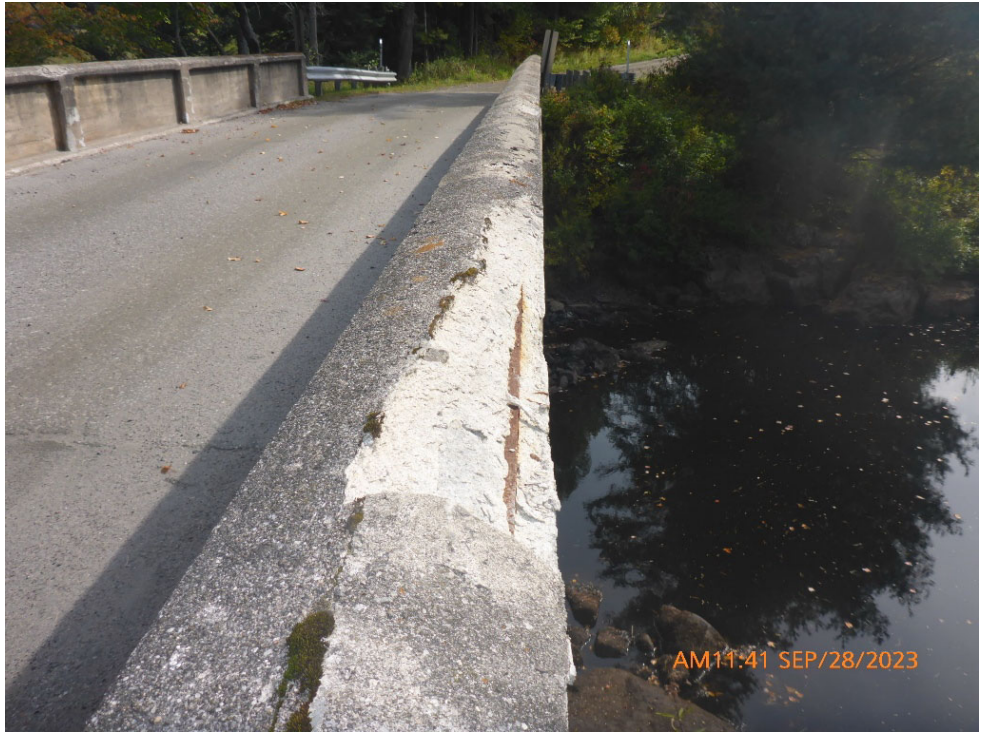
Comments: SEVERE SPALL BARRIER WALL

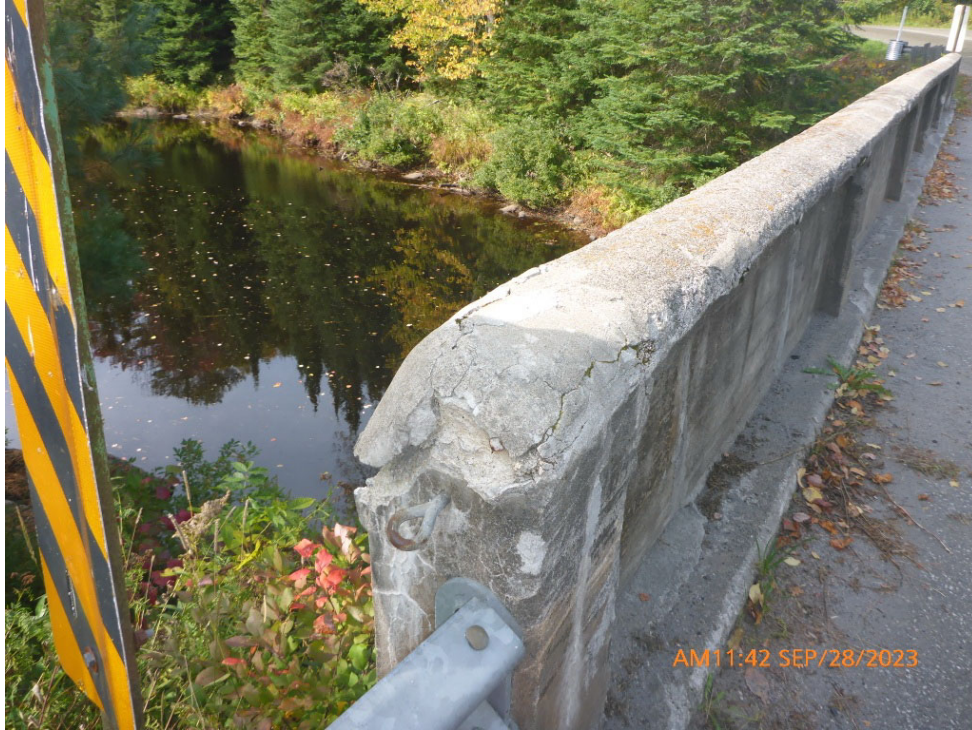
Comments: DEBONDED CONCRETE PATCH BARRIER WALL

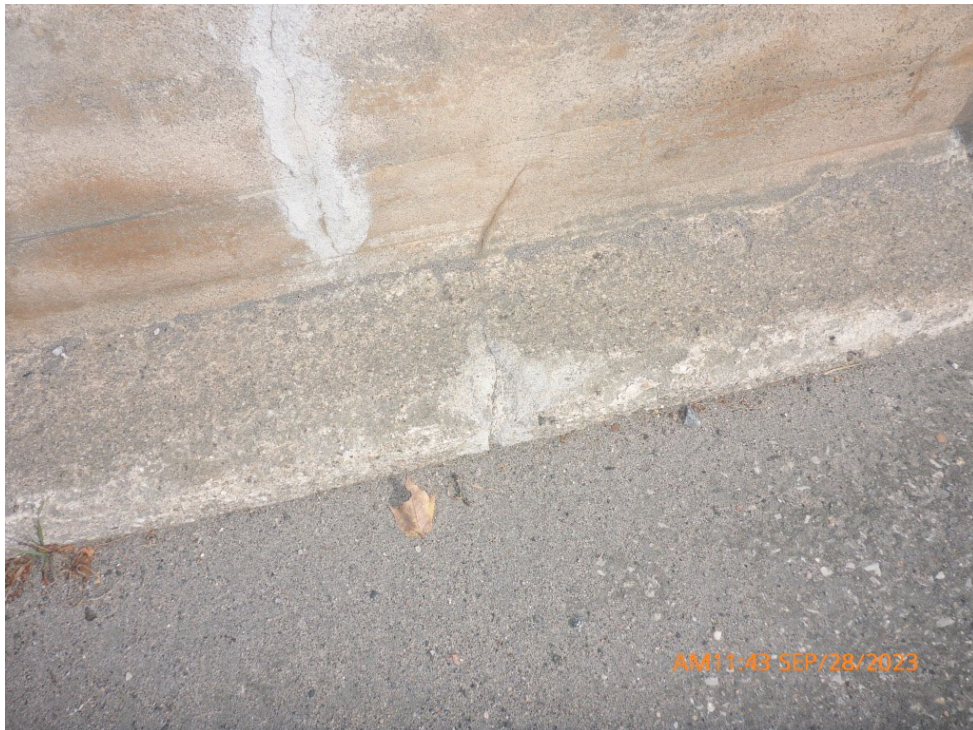
Comments: WIDE CRACK IN CONCRETE CURB

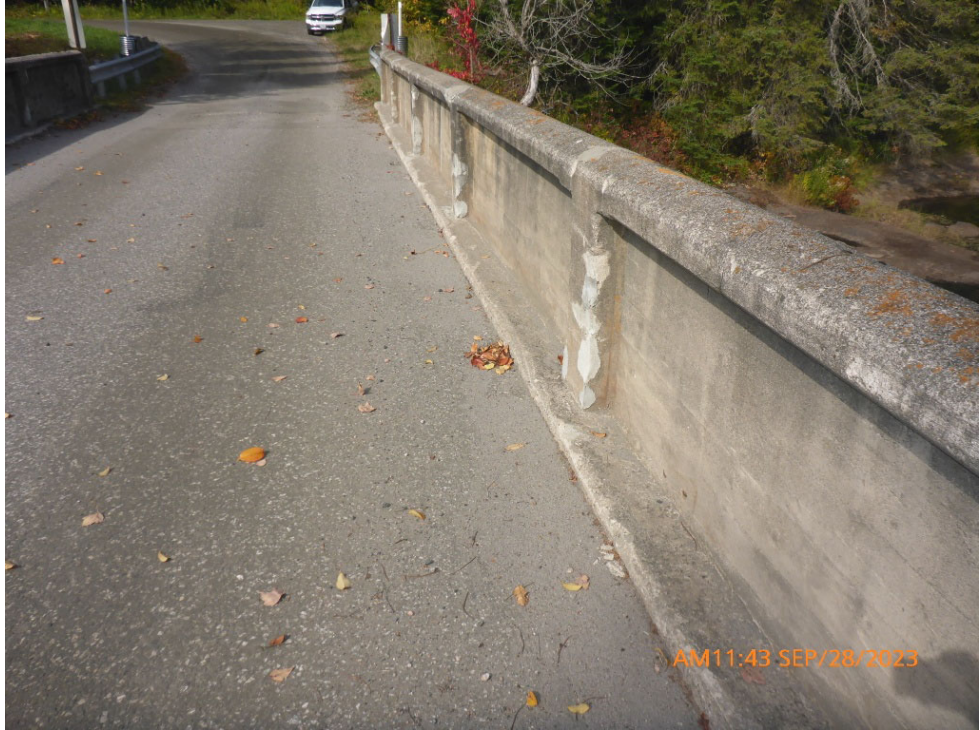
Comments: MEDIUM SCALING ALONG CURB LINE

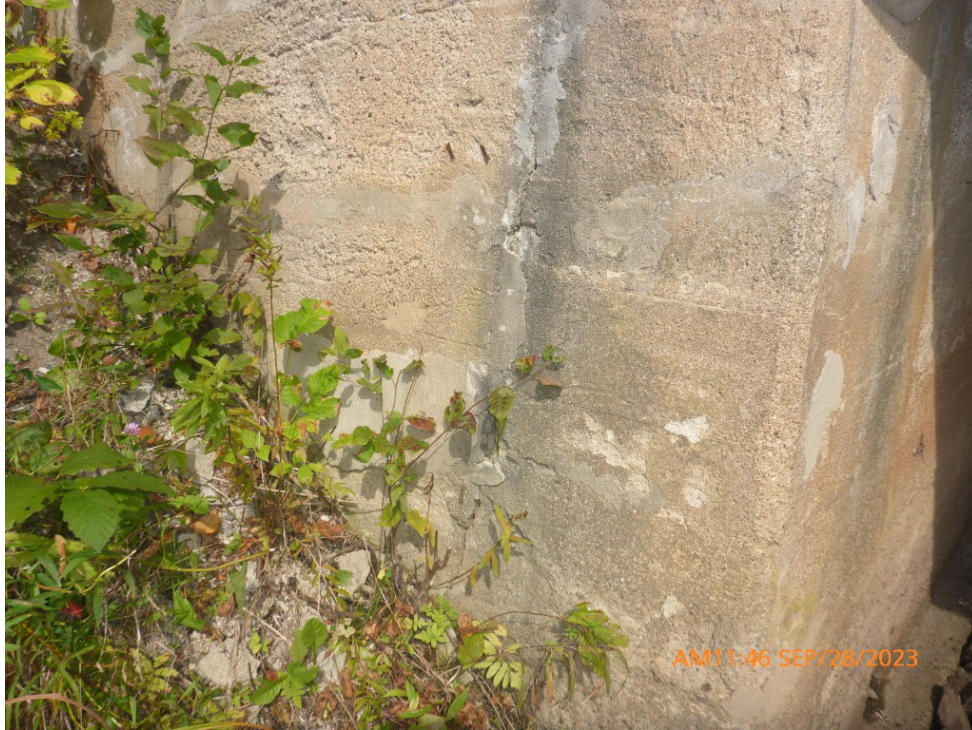
Comments: WIDE VERTICAL CRACK SOUTHWEST WINGWALL
