CORPORATION OF THE TOWNSHIP OF MCKELLAR

December 5, 2023 – 6:30 p.m.

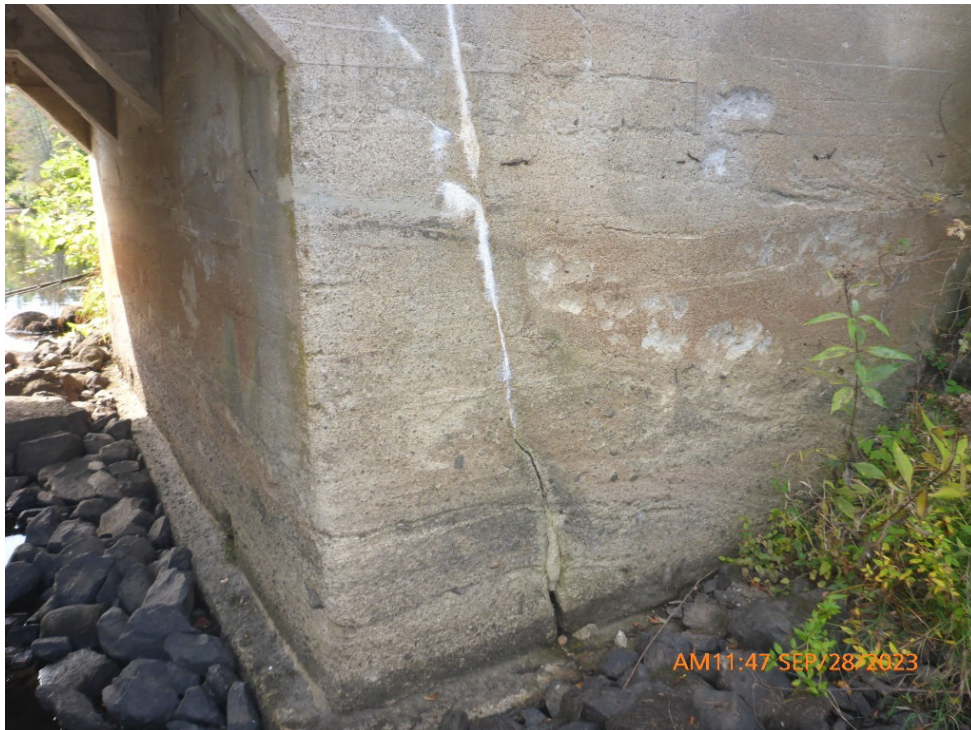
Comments: WIDE VERTICAL CRACK NORTHWEST WINGWALL

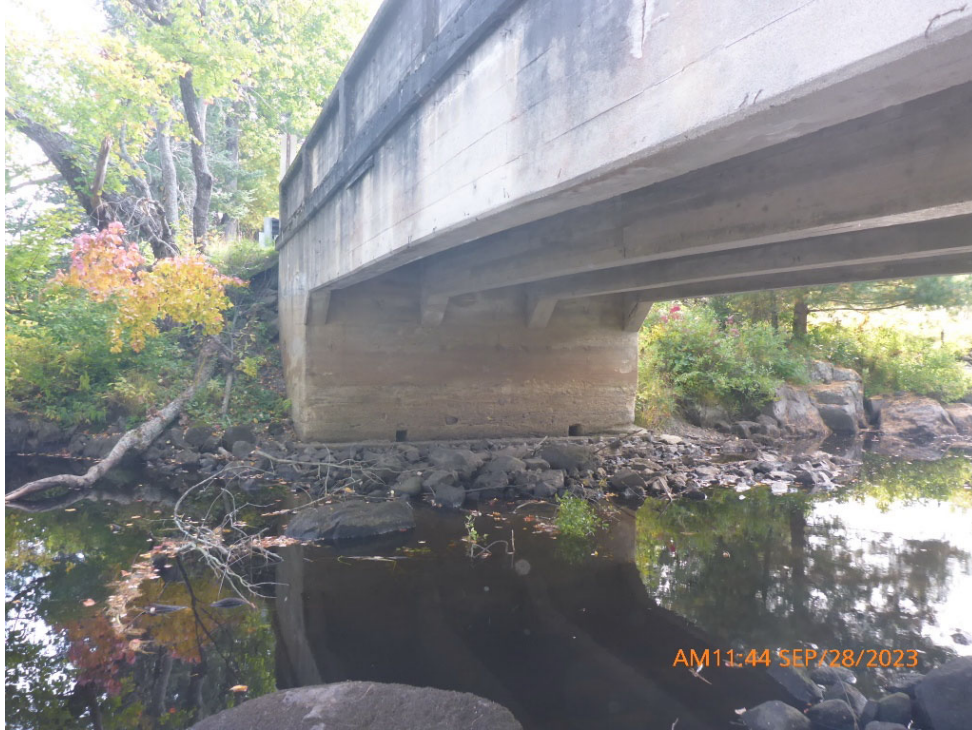
Comments: TYPICAL EAST ABUTMENT

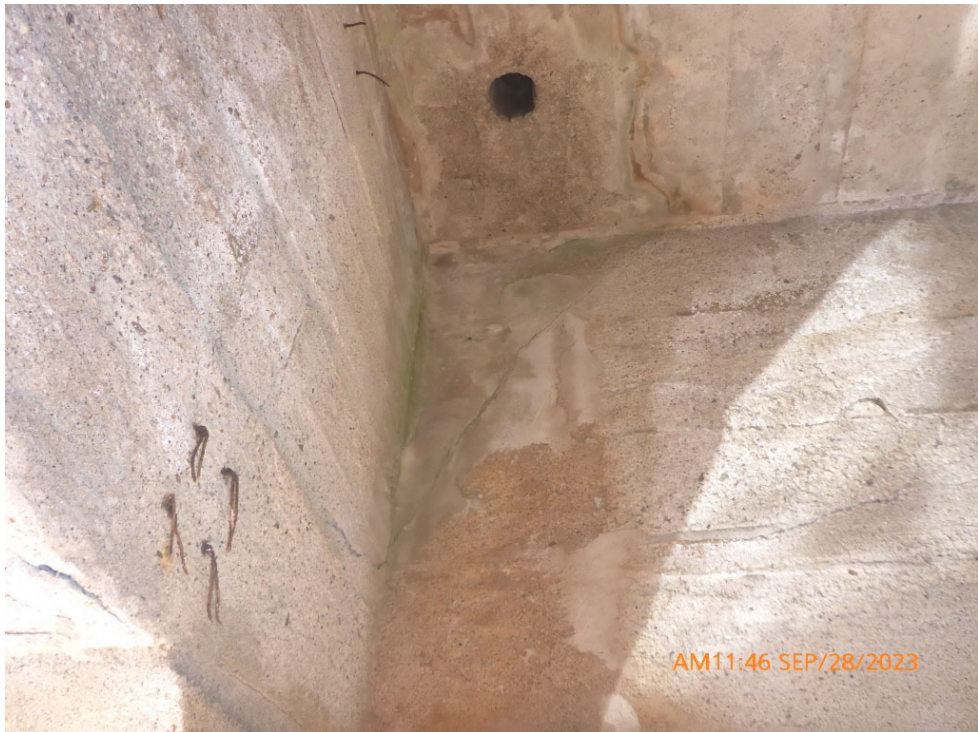
Comments: WIDE VERTICAL CRACK WEST ABUTMENT

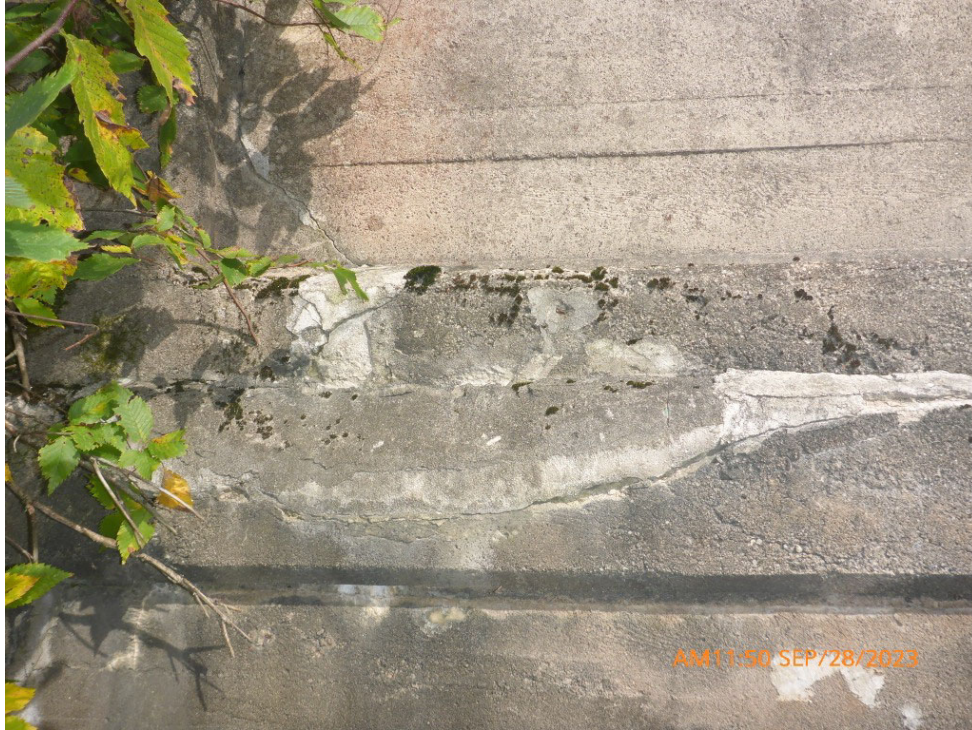
Comments: SEVERE DELAMINATION EXTERIOR FASCIA

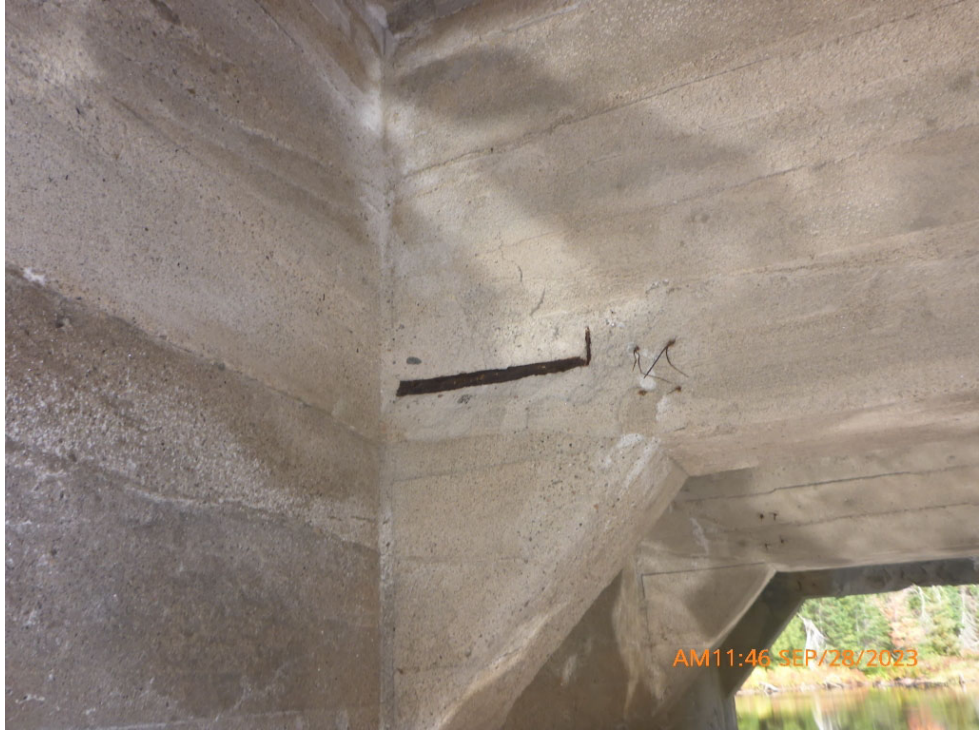
Comments: SPALLING OF T-BEAM GIRDER

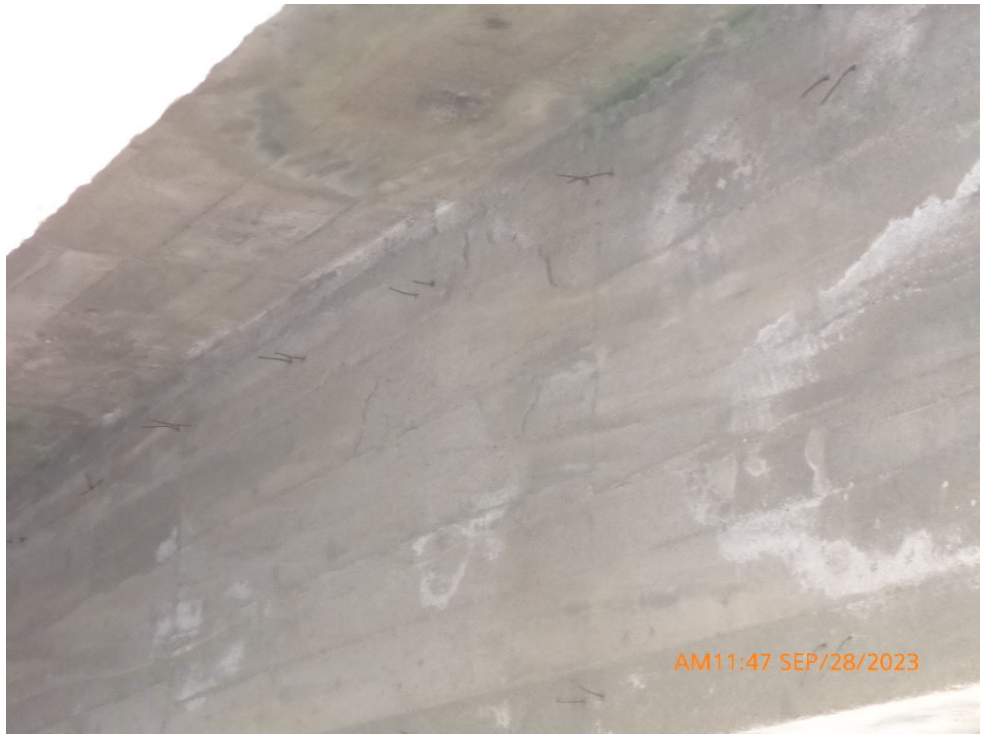
Comments: SEVERE DELAMINATION T-BEAM GIRDER

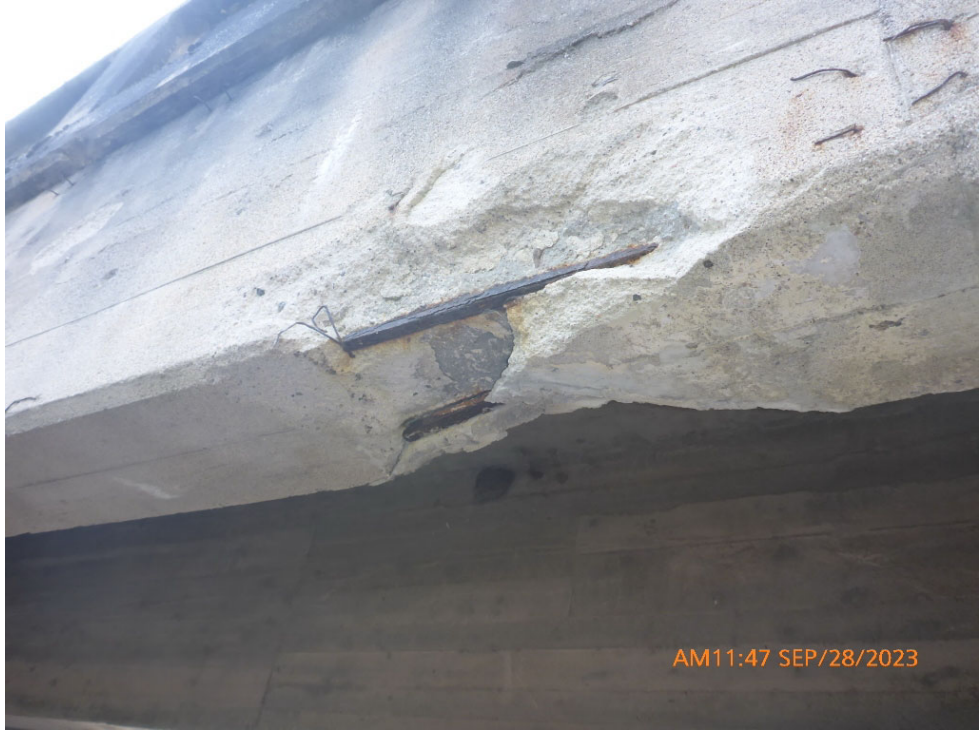
Comments: SEVERE SPALLING OF T-BEAM GIRDER
Path: P:\McKellar\2023\P1080179.jpg

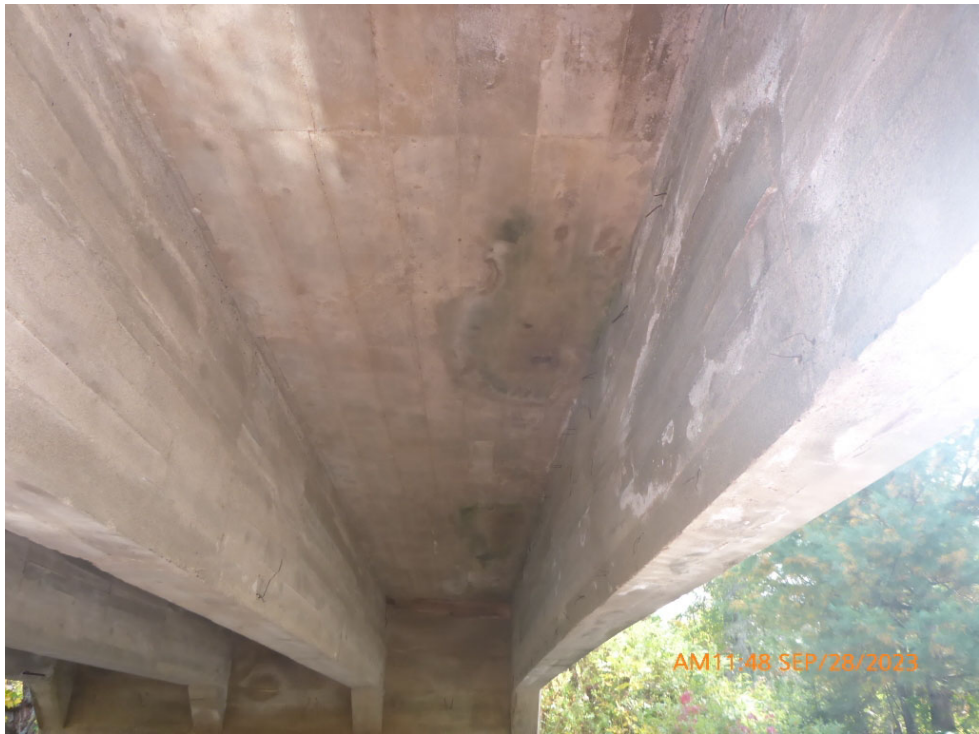
Comments: WATER STAINING INTERIOR SOFFIT
Path: P:\McKellar\2023\P1080180.jpg

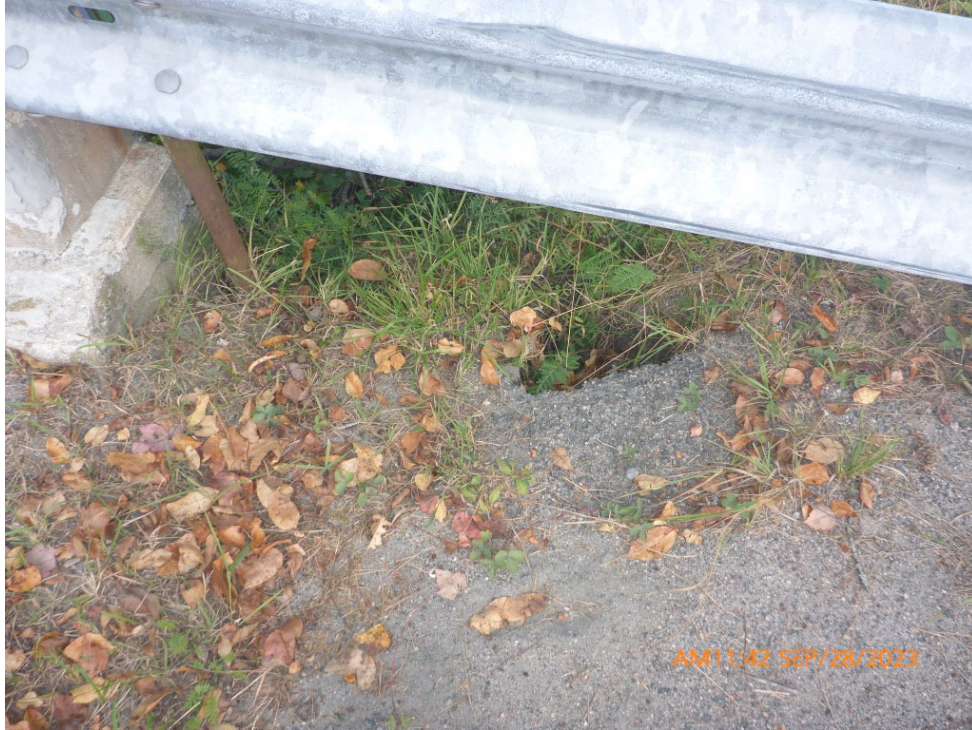
Comments: SEVERE EROSION OF EMBANKMENT NE QUADRANT

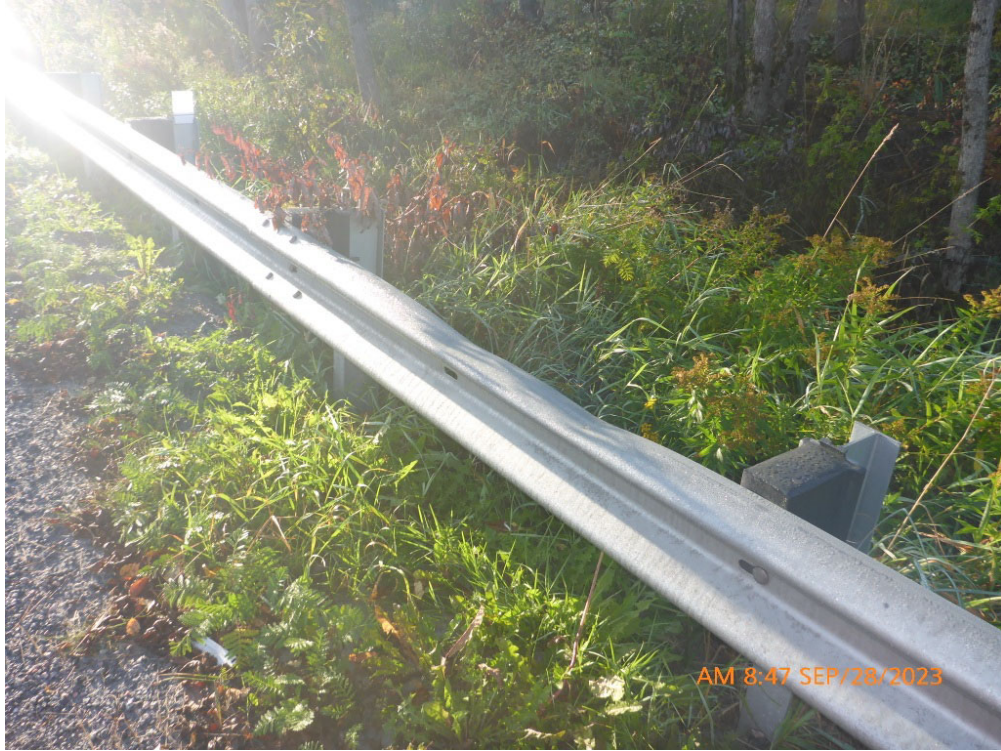
Comments: MINOR COLLISION DAMAGE GUIDE RAIL
Path: P:\McKellar\2023\P1080084.jpg

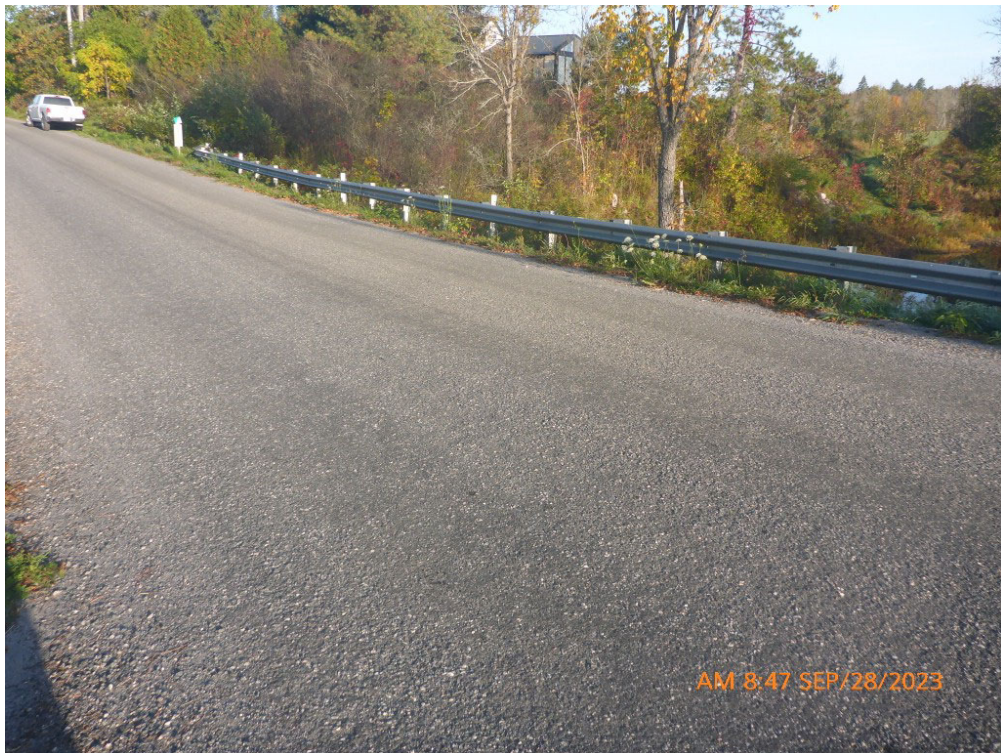
Comments: TYPICAL WEARING SURFACE
Path: P:\McKellar\2023\P1080083.jpg

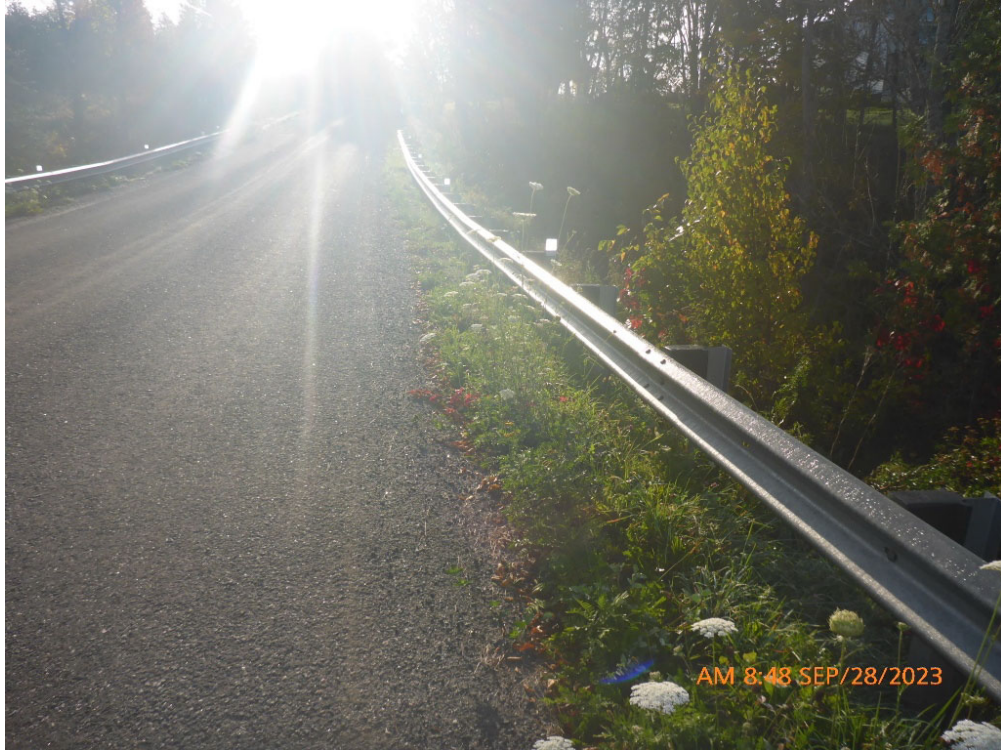
Comments: VEGETATION ALONG ROADWAY

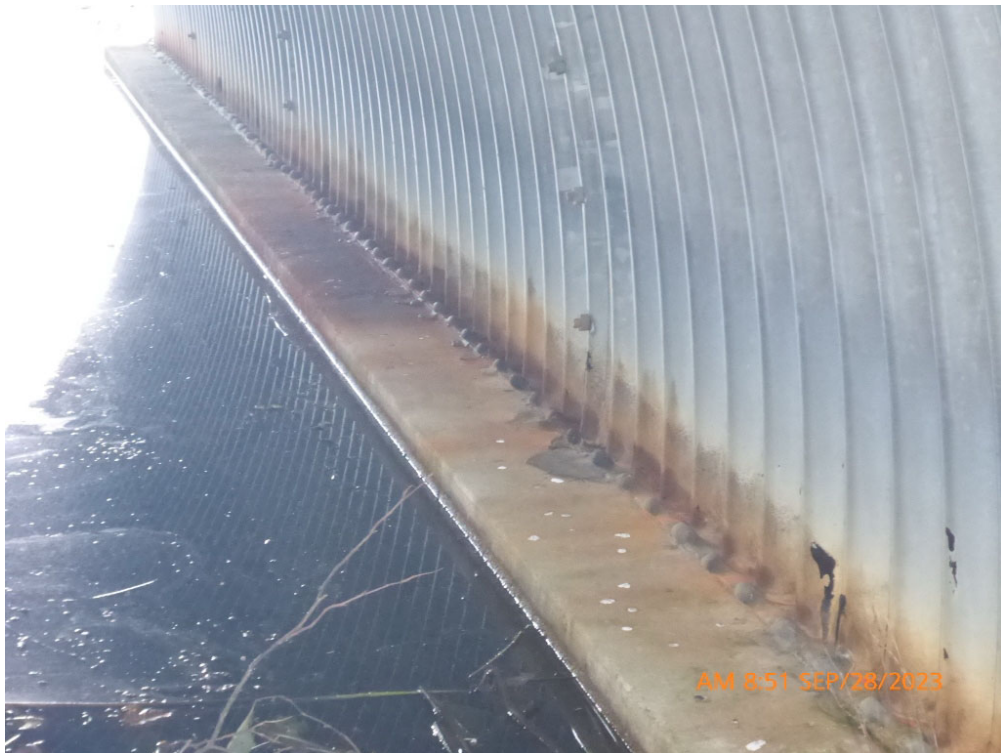
Comments: MEDIUM CORROSION OF EAST BARREL WALL AT FOOTING

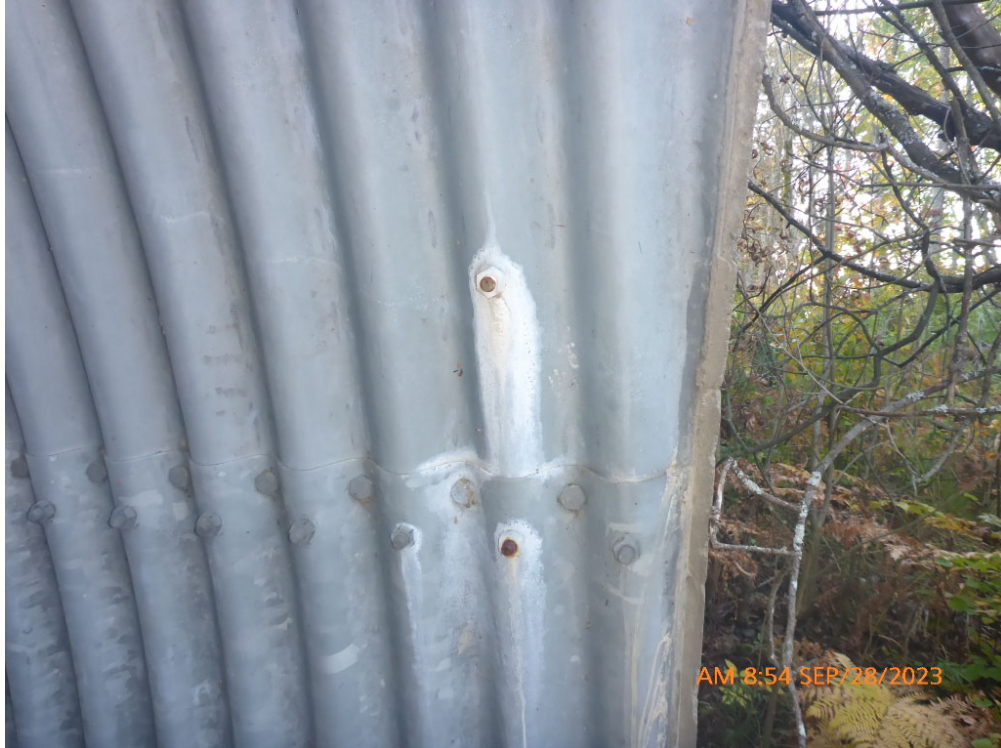
Comments: ENCRUSTATION AT BOLT LOCATION

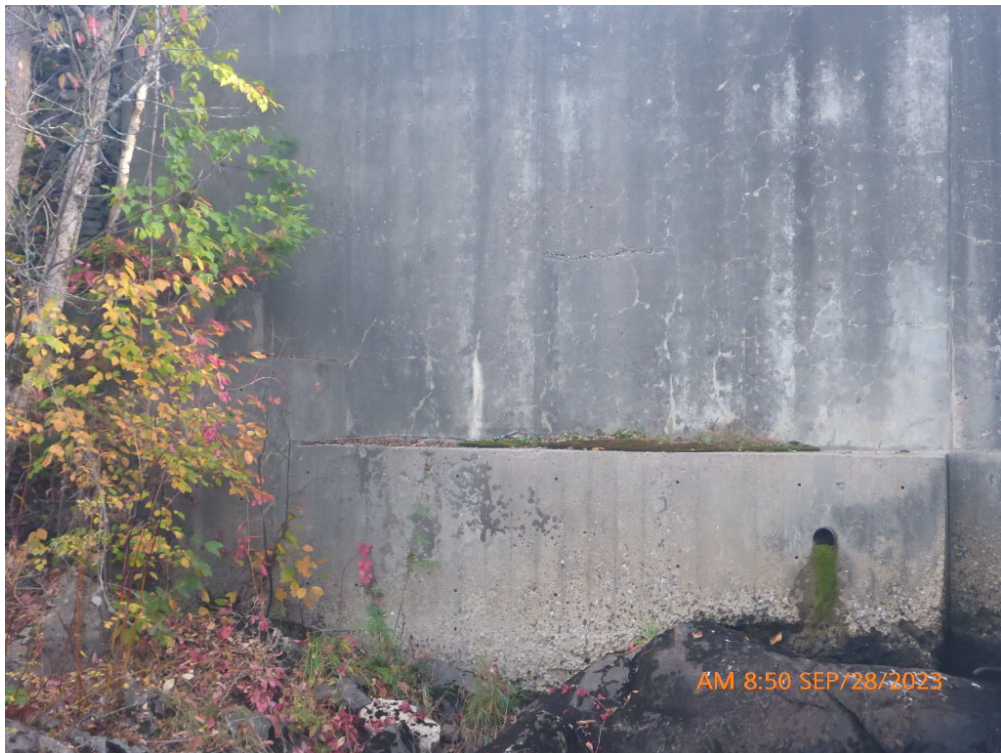
Comments: NARROW STAINED CRACK IN WINGWALL

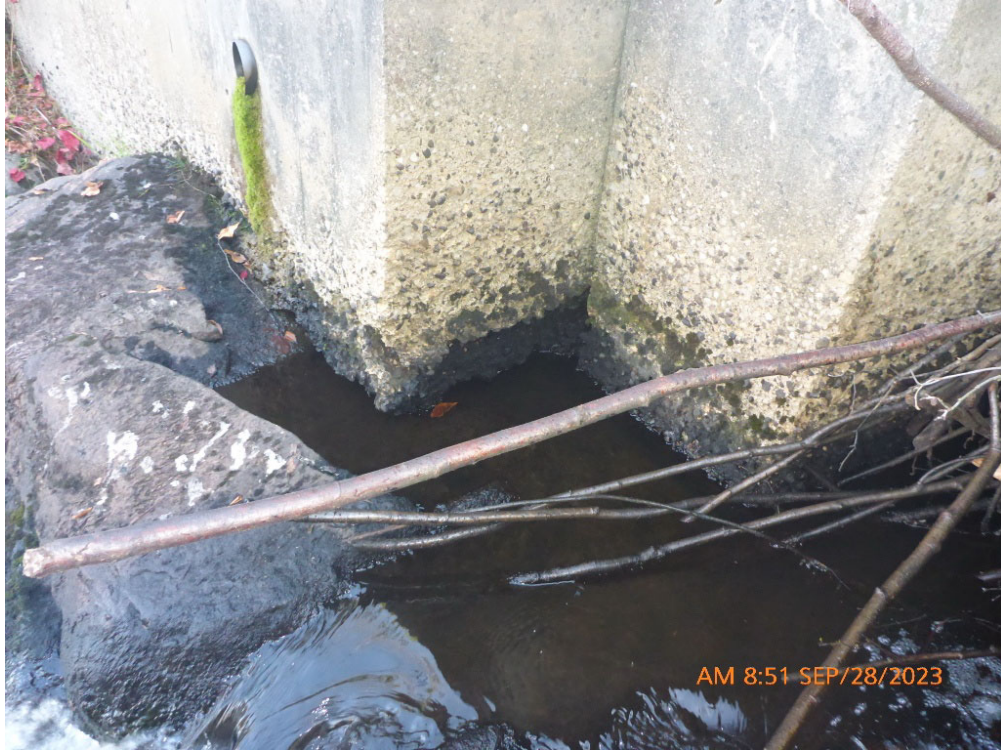
Comments: SEVERE EROSION OF CONCRETE FOOTING
Path: P:\McKellar\2023\P1080090.jpg

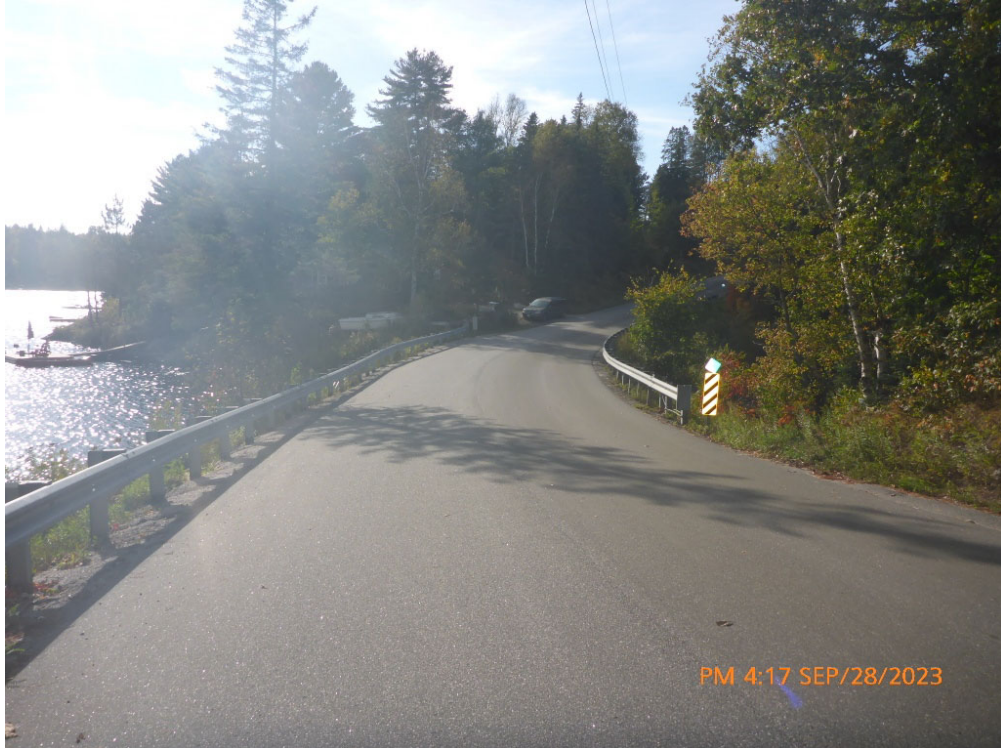
Comments: LOOKING WEST AT ROADWAY OVER CULVERT
Path: P:\McKellar\2023\P1080309.jpg

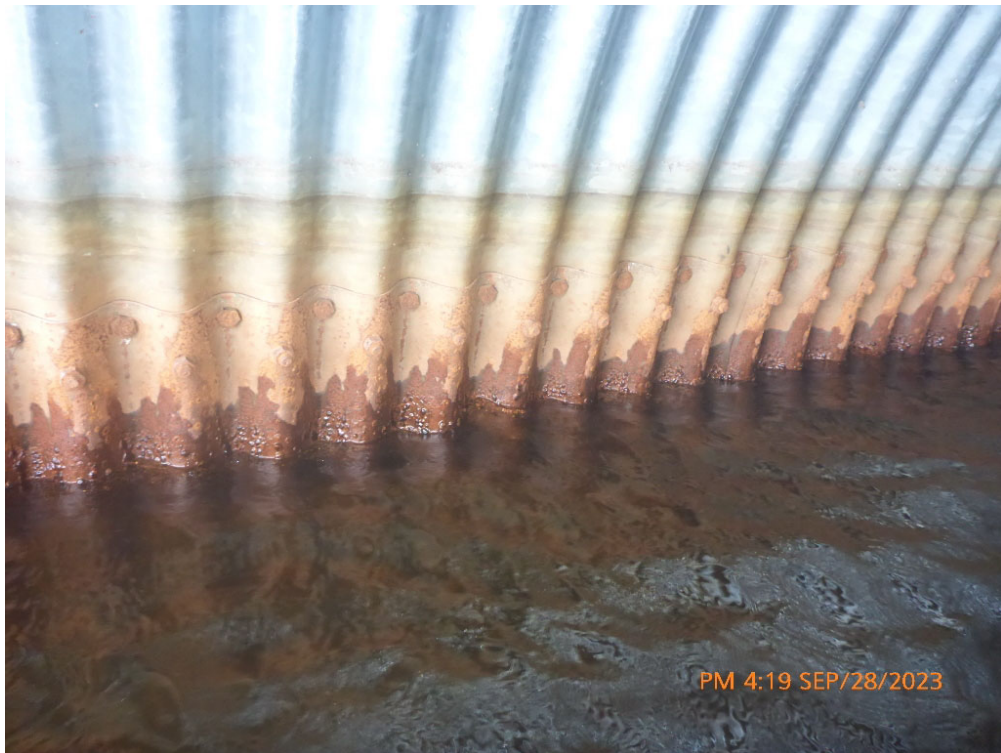
Comments: LIGHT CORROSION OF BARREL AT WATERLINE
Path: P:\McKellar\2023\P1080315.jpg
